## Adaptive Reuse of the Apex Hosiery Company Building

*Part 1: History of the Philadelphia Demolition Ordinance and the Apex Hosiery Building*

By D. Matthew Stuart, P.E., S.E., P.Eng, F.ASCE, F.SEI, A.NAFE, SECB

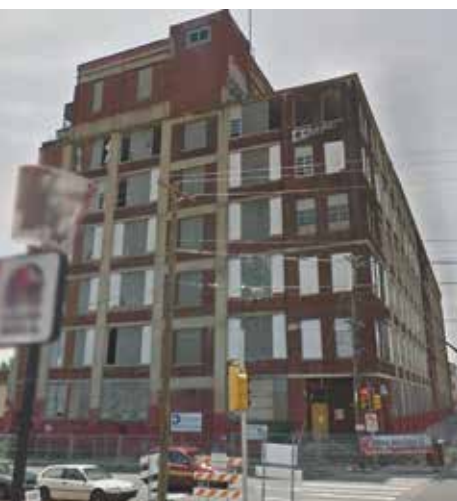
Figure 2. Apex Hosiery Company Building located in Philadelphia – prior to renovation.

As a result of the demolition Ordinance, the author became involved in a number of demolition projects. The services provided to clients for demolition projects included the development of demolition bid documents, which are not required by the Ordinance, the engineering review of Site Safety Demolition Plans (SSDP) developed by demolition contractors, and Special Inspections that are performed by a separate inspection and testing division of the author's firm, Pennoni. One of the most interesting demolition projects that the author has been involved with was the adaptive reuse of the Apex Hosiery Company Building located in Philadelphia, shown in *Figure 2*.

The renovation of the existing, six-story reinforced concrete manufacturing building involved the demolition of the Penthouse, roof, and 6<sup>th</sup> and 5<sup>th</sup> floors, leaving a three-story structure that was to be used as affordable rental housing. Structural engineering services for the project involved both pre-demolition and post-demolition condition assessments of the structure and façade, and Special Inspections during the demolition phase. The pre-demolition survey included the installation of several crack monitors at selected locations within the portions of the building that were to remain for the purpose of monitoring movement of the structure during the demolition phase. The pre-demolition effort also involved a peer review of the SSDP that had already been approved by another engineering firm.

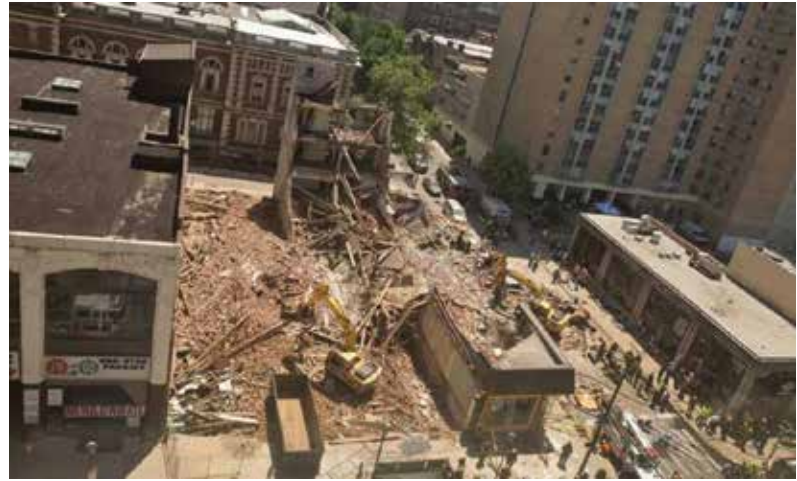
Figure 1. The aftermath of a June 5, 2013, building collapse associated with demolition of a series of adjoining two- and four-story mercantile loft structures onto the immediately adjacent, one-story Salvation Army Thrift Store building in Philadelphia. Courtesy of Lindsay Lazarski, WHYY.

The unintended collapse was precipitated by an unsupported, four-story masonry brick wall that was immediately adjacent to the Thrift Store. The unstable condition was created when the demolition contractor removed most of the floor and roof framing, originally connected to the same wall, using an 18-Ton excavator. The aftermath of the collapse can be seen in *Figure 1*.

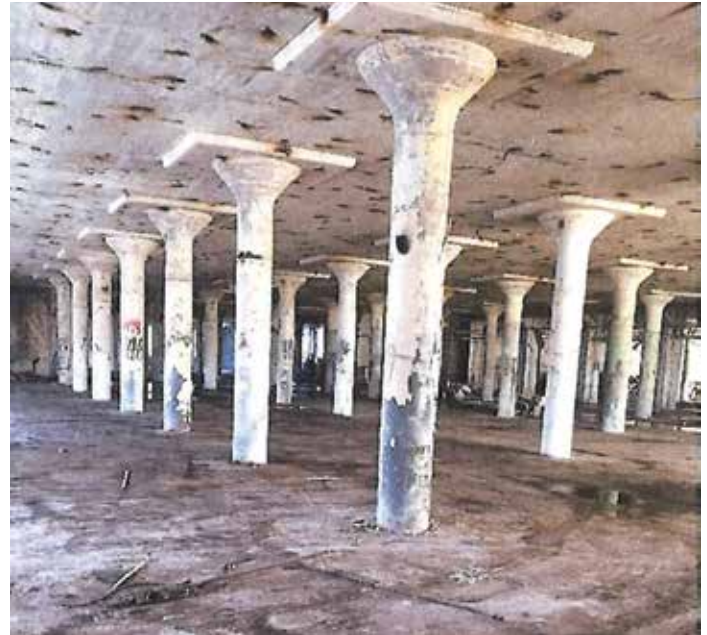
Figure 4. The 6-story structure was constructed as a reinforced concrete, flat slab supported by round and rectangular columns with column capitals and drop panels.

The footprint of the building, which somewhat resembled the shape of the letter F, occupied most of the triangular block bounded by North 5<sup>th</sup> Street, Rising Sun Avenue, and West Luzerne Street. The 6-story structure was constructed as a reinforced concrete, flat slab supported by round and rectangular columns with column capitals and drop panels, as shown in *Figure 4*. Laboratory material testing of the existing reinforcing samples and in situ non-destructive evaluation of the existing concrete compressive strength were performed along with field measurements of the critical structural components of a typical framed level. The average in situ concrete compressive strength of 6,000 psi was established via both a Schmidt Impact Hammer and a CAPO-TEST pullout device.

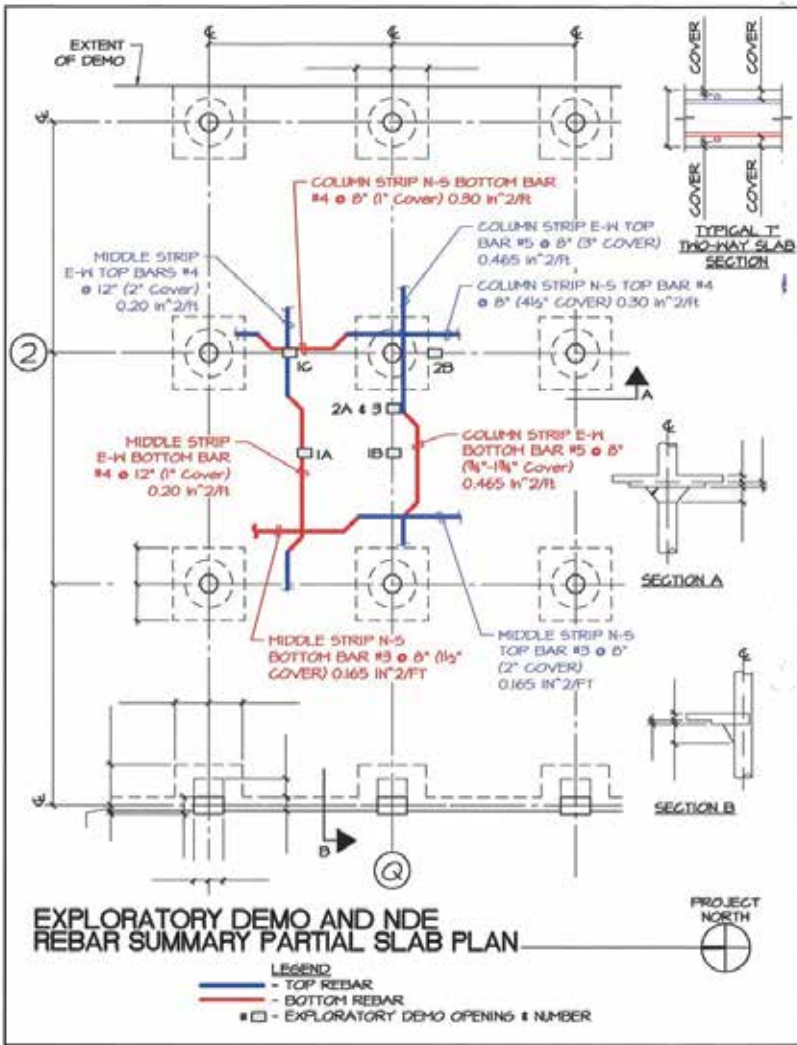
Figure 5. Two-way reinforcing was confirmed to be orthogonal and parallel to the main column grids and did not include any diagonal 4-way reinforcing.

Based on observations at several exploratory openings in the south end of the building, the two-way reinforcing was confirmed to be orthogonal and parallel to the main column grids and did not include any diagonal 4-way reinforcing (*Figure 5*). The top reinforcing bars were also “trussed,” in other words bent down, towards the bottom of the slab near the edge of the drop panels and thus became the bottom reinforcing, a common method of rebar placement during the era in which the building was constructed.

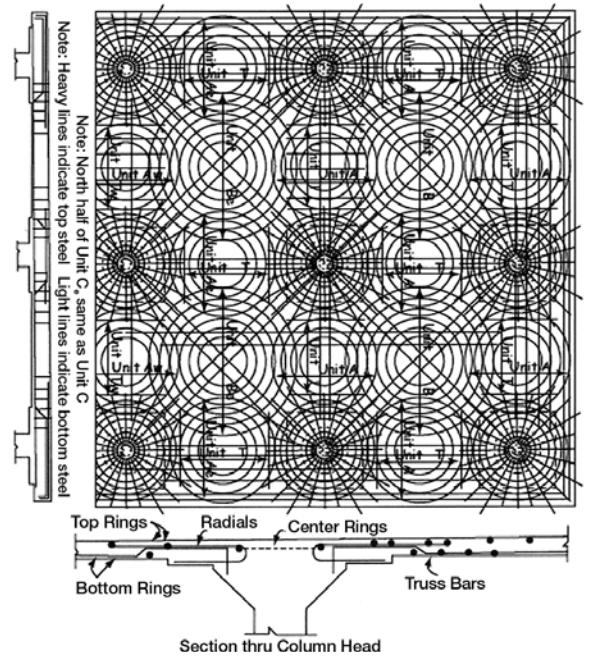
Figure 6. Based on observations, the reinforcing was confirmed to be the SMI, or Smulski Method system, which involved the use of smooth, round concentric rings, or hoops, of small-diameter steel bars. Courtesy of ACI Journal Proceedings, 1918. A Test of the SMI System of Flat Slab by Edward Smulski

Based on observations at additional exploratory openings in the north end of the building, the reinforcing was confirmed to be the SMI or Smulski Method system, which involved the use of smooth, round concentric rings, or hoops, of small-diameter steel bars as illustrated in *Figure 6*. The north and south sections of the main rectangular building footprint were separated by an expansion joint; therefore, it was evident that the separate north and south portions of the building had been built using two distinctly different methods of two-way flat slab construction that were available during the era the facility was constructed.
