Adaptive Reuse of the Apex Hosiery Company Building

Part 3: Adaptive Reuse Feasibility Analysis

By D. Matthew Stuart, P.E., S.E., P.Eng, F.ASCE, F.SEI, A.NAFE, SECB

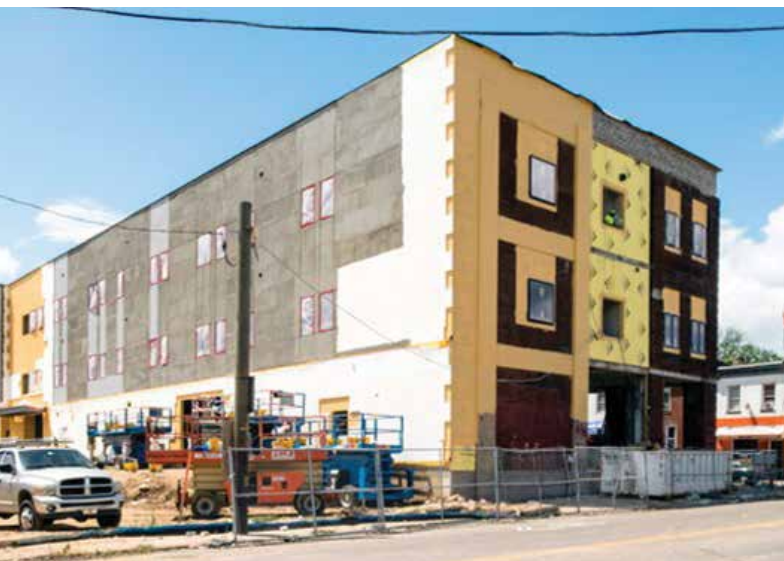
Figure 14. Lateral capacity of the post-renovation three-story building was assumed adequate based on the theory that the original six-story building sail area and mass translated to larger wind and seismic loads.

A lateral load analysis of the remaining existing building was not included as part of the assessment for the following reasons. The reduction in the height and footprint of the remaining building from its original configuration significantly reduced the sail area of the exterior vertical surfaces of the building. As a result, the lateral wind loads on the remaining building would be reduced considerably from that which it was assumed to have been initially designed for.

Therefore, because the lateral resisting capacity of the remaining three-story building seen in *Figure 14* was more than likely designed for a greater accumulated wind load of the original six stories, it was reasonable to assume that the lateral load resisting capacity of the remaining structure was adequate. Also, although it is unlikely that the original designer of the structure analyzed the building for lateral earthquake loads, for this investigation, it was assumed that, similar to the wind loads, the current Code-based seismic base shear for the remaining three-story building was significantly less than the potential seismic loads on the original six-story building.

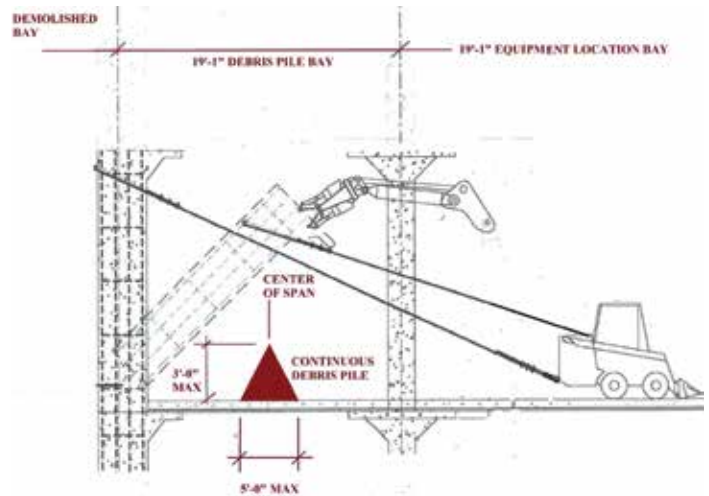
Figure 13. Analysis of demolition equipment and debris loading conditions revealed that proposed demolition equipment could be safely operated, but temporary storage of concrete debris was limited.

The investigation of the demolition equipment and debris loading conditions for the south side slab indicated that the existing distribution of top and bottom reinforcing in the east-west direction did not match the moment demand requirements of the spSlab software output. As a result, it was necessary to redistribute the negative moment provided by the software analysis to the positive moment region to justify the worst-case demolition equipment and debris loading conditions. The maximum negative to positive moment redistribution was limited to 20%, as allowed by Section 8.4 of ACI 318.

As a result of the analysis, it was determined that the proposed mechanized equipment could be safely operated inside the building during the demolition operation. However, the triangular volume of demolished concrete debris that could be temporarily stored in the span immediately adjacent to the span in which the equipment would be operating was determined to only include a maximum height of 3 feet and maximum width of 5 feet in the east-west direction in a continuous north-south mound, based on a unit debris weight of 120 pcf, as illustrated in *Figure 13*.

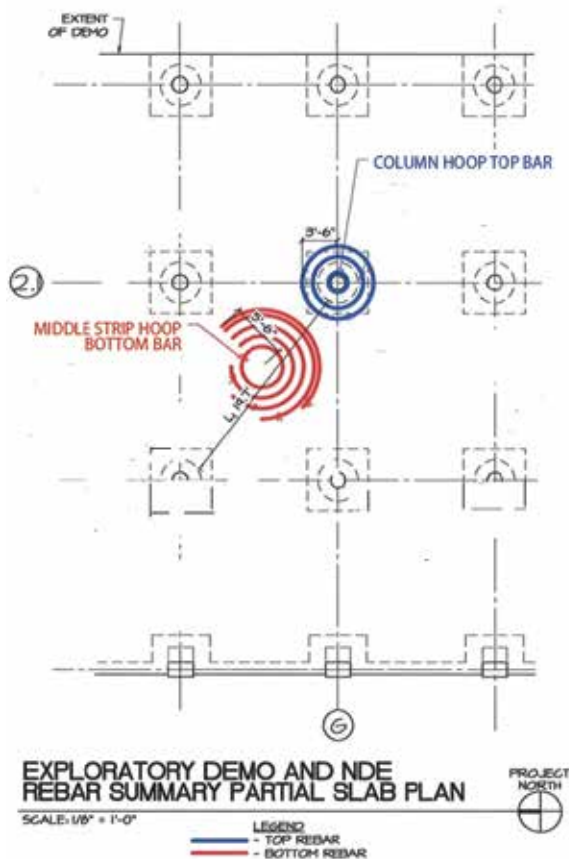
Figure 15. Analysis indicated that the north-side slab system could support a 120 psf superimposed uniform load similar to that established at the framed two-way slab on the building's south side.

capitals, and the slab, drop panel, and column capital cantilevered from the face of the column to support the end reaction of the Unit B diagonal span. The analysis was based on the bottom and top concentric reinforcing hoops documented as a part of the field assessment shown in Figure 15 and a yield strength of 27 ksi based on the laboratory test of one hoop sample shown in Figure 16 obtained from a slab that was scheduled to be demolished. An analysis of the SMI slab was also conducted for the same demolition equipment and debris loading conditions used for the south slab. The results of the analysis indicated that the northern SMI slab was capable of supporting the same demolition operations as the south slab.

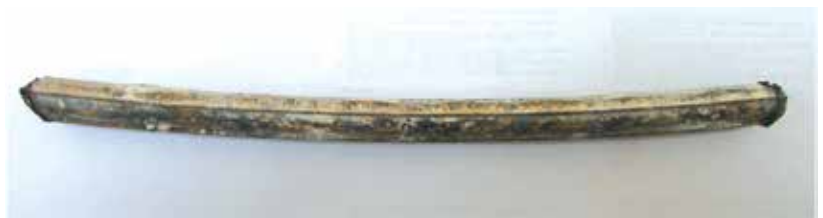
Figure 16. Feasibility analysis was based on top and bottom concentric reinforcing hoops with a 27 ksi yield strength resulting from a laboratory test of this sample.

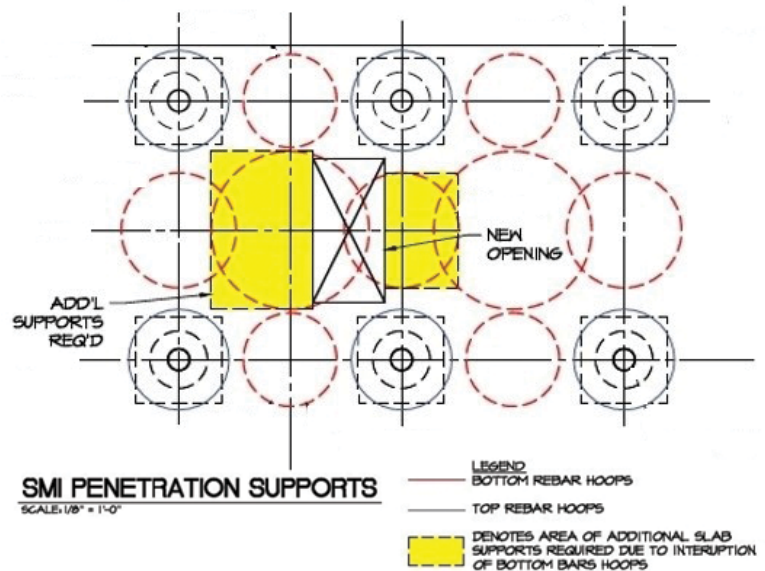
Figure 17. Interruption of SMI slab reinforcing hoops at new stair and elevator openings showing required additional slab supports.

For reasons similar to that described along the eastern edge of the demolition, interruption of the SMI slab reinforcing hoops at large openings associated with new stairs and elevators required additional slab supports beyond the new supplemental steel framing at the perimeter of the stair opening. This was also true for the new loadbearing CMU walls at the perimeter of the elevator opening shown on the renovation structural drawings. The approximate extent and location of the additional slab supports that were required at a typical large opening in the SMI slab was provided on a plan shown in Figure 17.
