## The Wilkes-Barre Tornado

### Masonry Damage and Modeling

By Heather A. Sustersic, P.E., Michael Kinzel, Ph.D.,  
and David Malyszek

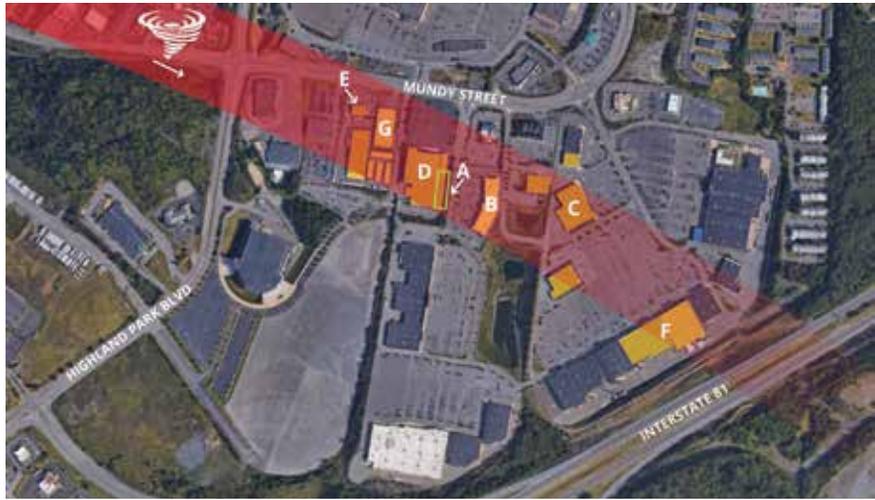
Figure 1. Path of Wilkes-Barre tornado, including impacted buildings. Aerial photo from Google maps.

Interior access to most of the damaged buildings in Wilkes-Barre was not available. However, observations and photos taken by the author during an independent site visit on June 19, 2018, and aerial drone video footage available from local online media coverage after the event, were analyzed to arrive at the conclusions presented herein. Specifically, damage to seven buildings was observed. These are labeled A through F in Figure 1, and described below:

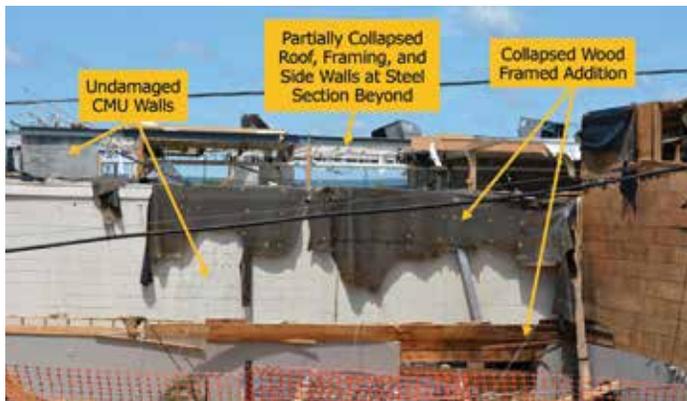
Figure 2. Building D (middle and background) and Building A (foreground) partial collapse of wood and steel framed elements in line with undamaged CMU walls.

Figure 2 shows an undamaged CMU wall of Building D in the middle ground with the collapsed wood-framed addition (Building A) in the foreground, and significant roof, framing, and sidewall damage to the structural steel portion of Building D in the background. At Building C, the CMU apron beneath the cold-formed steel stud exterior walls remained unscathed while the cold-formed framing above was destroyed. Unreinforced, architectural masonry, such as the decorative oversized piers at a sporting goods store main entrance, experienced failures ranging from stepped cracks in the mortar joints to partial collapse.

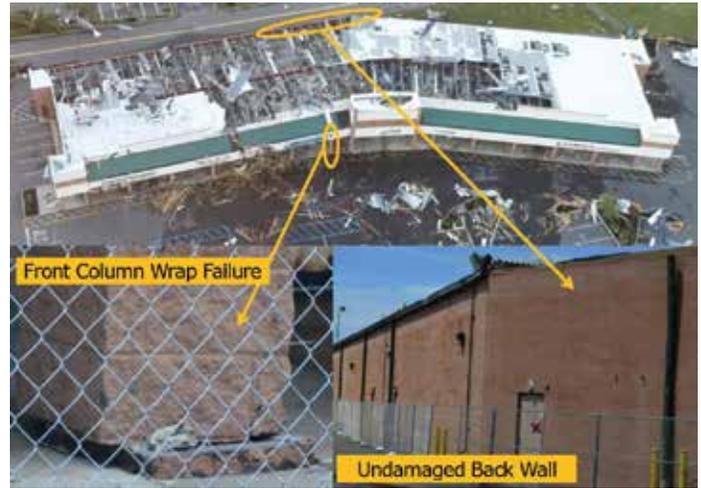
Even though the tornado passed directly over Building B, destroying 75% of the roof and causing significant damage to the storefront and soffit, the rear CMU wall of the building was undamaged (Figure 3, top and bottom right). Unreinforced masonry column wraps at the front of Building B experienced shear failures, some of which twisted at their base and translated laterally 2 to 3 inches (Figure 3, bottom left) with mid-height torsional shear failures as well; others had more subtle shear stress failure limited to the mortar joints. Roof joist-to-masonry wall connections remained intact.

Figure 3. Building B overall damage; typical front column wrap shear failure in mortar joint (left); back wall of building undamaged (right). Aerial photo from 570 Drone footage.

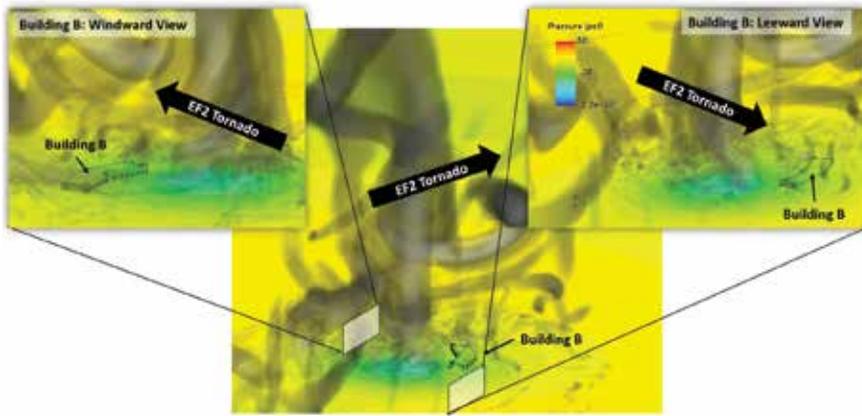
Figure 4. Building B subjected to simulated tornado (center); Blowup view of windward side (upper left); Blowup view of leeward side (upper right).

by steel tube columns with masonry wraps spaced at 17 feet on-center maximum. Parapet heights vary from 2 feet to 9 feet on the sides and front of the building. The building was modeled as a solid, fixed mass with no openings or deformation capability. Structure deformation using FSI is outside the scope of this preliminary model; however, a deeper investigation is planned for the future. The building model is then considered in the context of a CFD model with an EF-2 tornado (tangential speeds ~120 miles per hour) approaching Building B at 40 miles per hour. Overall views from the model, including the main view and blowups of the windward/leeward views of the building, are shown in Figure 4. The grey features in the flow highlight the tornado. Here the tornado itself, its tentacles, and complicated wakes forming around the building can all be observed. All surfaces are colored by surface pressure, and lines on the main plot indicate the local velocity direction on surfaces. With the model, loading details (from both pressure and viscous shear forces) are evaluated on each square inch of the building, providing highly detailed loading information that can supplement design. An animation of this model is available at <https://bit.ly/34iF8Ln>. Figure 5 illustrates the loading character on the building at first tornado contact. Note that the loads do not appear as pure constant pressure loading. Instead, the loading is complex and variable, with low pressures after each corner leading to a “bottle opener” effect applied to the roof, causing localized high pressures. This is consistent with the pattern of soffit, roof, and

column wrap damage observed on the real building after the real tornado. Building designs that can consider these complex loadings during atmospheric events, such as tornadoes, are where CFD and FSI can enable next-generation, tornado-resistant designs.

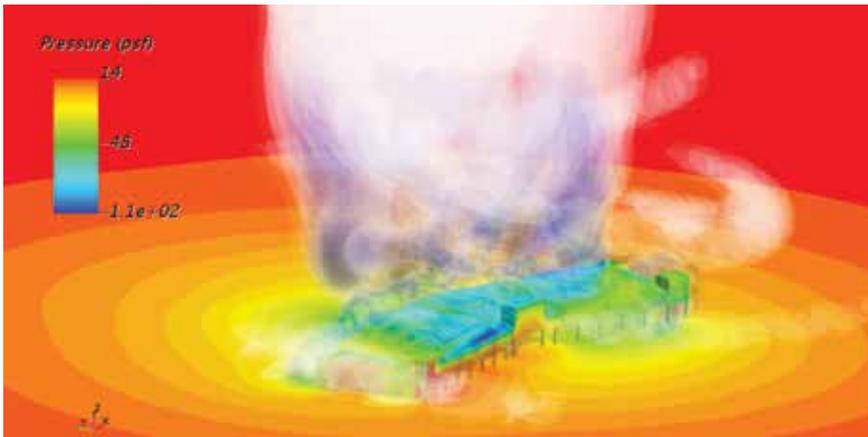
Figure 5. Surface pressure contour plot of Building B at the first contact of a simulated tornado.
