In the fall of 2016, a project team began to investigate the deterioration, causes, and possible treatments to stabilize and repair the limestone cladding panels of the former May Company department store (renamed the Saban Building). The building was gradually being renovated to form part of the new Academy Museum of Motion Pictures.

CONSERVATION OF A Historic Façade

By Maria Mohammed, S.E., John Fidler, RIBA, and David Cocke, S.E.

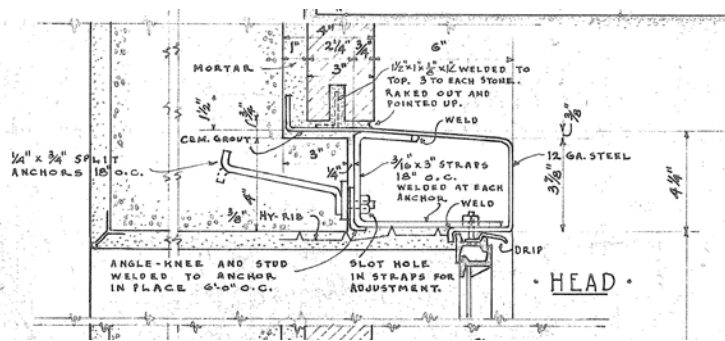
Original detail of the historic limestone panels and steel window boxes show embedded steel angles and kerf dowels into the limestone panels.

The historic Saban Building's exterior walls consist of steel beams and columns encased in reinforced concrete, infilled with reinforced concrete walls. The façade consists of 3-inch-thick limestone panels, approximately 4 feet wide by 5 feet tall, each weighing up to 900 pounds, with 1 inch of grout backing and joints with Type N and S mortar. Limestone panels consist of vein-cut panels and cross-cut panels across all

exterior elevations, vertically supported on unpainted mild-steel shelf angles that are welded to embedded steel plates in the concrete wall. As the limestone panels sit on the shelf angles, kerf anchors extend from the horizontal leg of the angle and sit in a kerf slot in the limestone panels. Mild-steel dowels provide side-to-side panel connections.

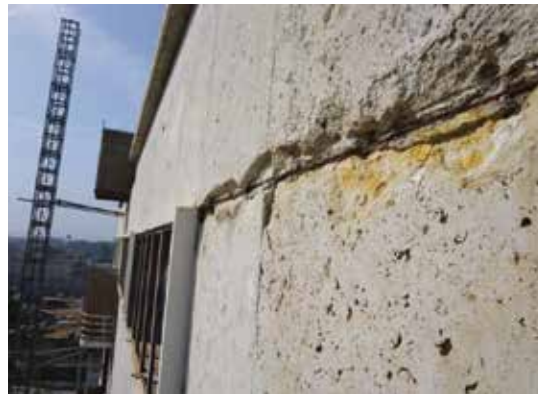
Limestone panel edges located along corroded steel shelf angles were spalling and cracking.

Moisture intrusion through open and cracked mortar panel joints caused corrosion of the steel shelf angles and kerf dowels. Water intrusion was exacerbated by the heavy stone panels sitting on top of the window boxes, depressing their thin steel box 'tails' and causing the top of the windows to drain into the wall. This condition was made worse by some

of the kerfs not welded to the steel box heads (as designed) but instead wire-tied through holes in the metalwork, thus affording more water ingress to the otherwise unprotected support structure. The volumetric expansion of the steel, from the corrosion spalled portions of the panel edges, caused cracks along some panel tops and bottoms. Thus, the out-of-plane restraint of the limestone panels was com-

promised. Vertical support at heavily corroded shelf angles posed falling hazard conditions along the exterior of the building.

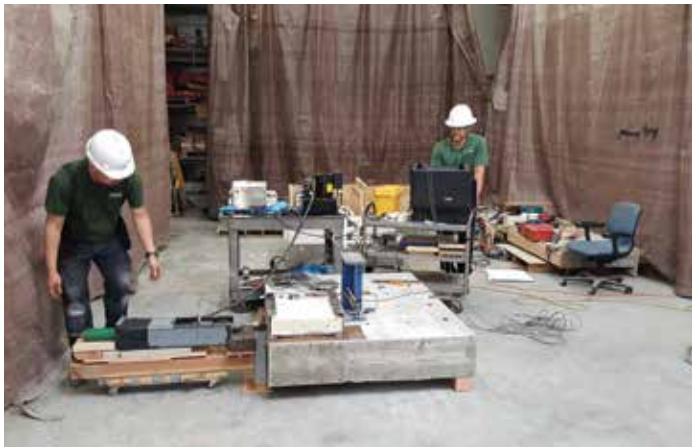
Test rig assembly shows shear loading on the helical anchor installed through the limestone panel. Courtesy of Specialized Testing Inc.

could not ordinarily be gripped by standard ASTM test apparatus. Instead of pulling the anchor out of the limestone and the concrete wall, the team decided to pull the limestone off the anchor embedded in the concrete. To do this, the testing laboratory devised and fabricated "steel shoes" to hold the limestone panels that were then pinned to the concrete with the helical friction anchors extending through a hole at the bottom of the steel shoes. The steel shoes were then pulled off the concrete wall panel to mimic tensile loading in the anchors due to out-of-plane seismic loads or were pushed sideways to mimic shear loading in the anchors due to gravity loads.

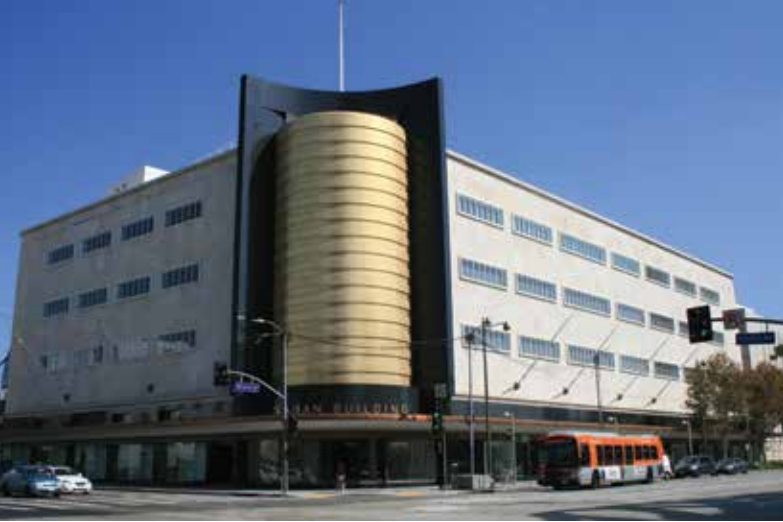
The newly restored façade.

Over 88 percent of the total historic surface area was retained and repaired, while only 12 percent was proposed for the replacement to match the original historic design. Of the original 1939 Texas Cordova Shelly Limestone, out of approximately 1,200 panels: 95.7 percent of panels were retained, cleaned, and repaired; 4.3 percent of panels were repaired by Dutchmen; 1.5 percent were replaced to match existing; and, approximately 40 percent of panels received minor mortar patch repairs. At the Steel Window Boxes and Frames, 100 percent of the panels were retained and repaired. ■

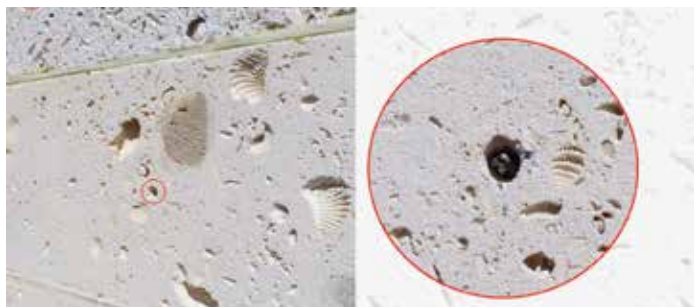
Countersunk anchors blend in with natural voids on the stone surface.

Anchors were installed through pilot holes drilled through both the limestone and concrete wall. Once countersunk, the final location of the anchors blends in with the natural voids on the limestone surface.

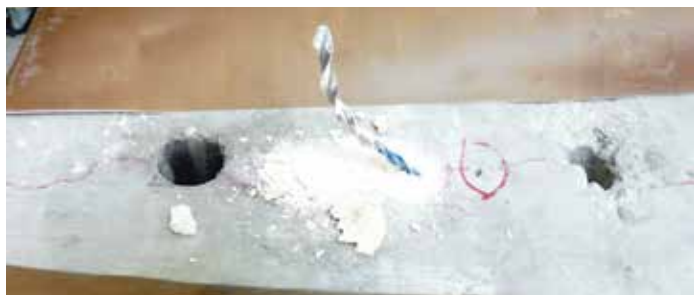
Anchors tested to shear failure showed localized crushing in the limestone in shear. Courtesy of Specialized Testing Inc.

Once enough tensile and shear tests were performed, results were presented to the Los Angeles Department of Building and Safety's Building Research Section for approval. The coefficient of variation of the test results was determined to be high enough that the lowest measured capacity of the anchors was to be used as the appropriate anchor capacity. A factor of safety was then applied to the appropriate anchor capacity to determine the required number of anchors for each limestone panel.

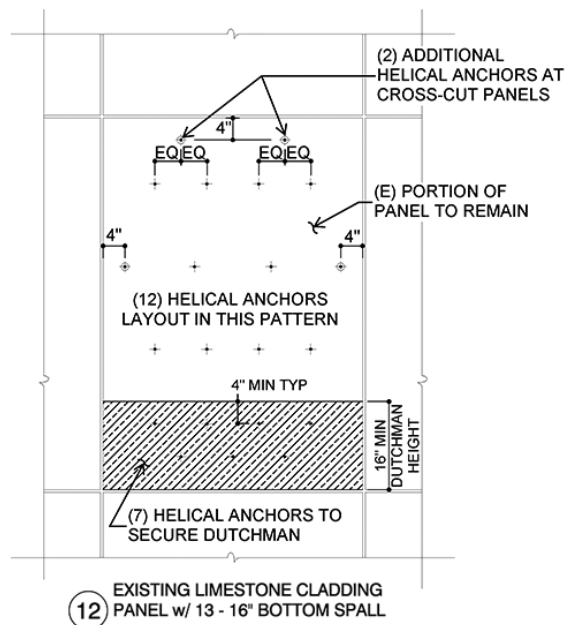
The pattern for helical anchors installed in Dutchmen and partial size panel.

Once the tensile and shear capacities of the helical anchors were determined, helical anchor patterns were designed for the weight and seismic load of each of the approximately 1,200 panels throughout the building façade. The patterns were selected based on the size of the limestone panels and Dutchmen. Depending on the location of the limestone panels, the anchors provide either out-of-plane restraint only, or both out-of-plane restraint as well as gravity support. At the former group of limestone panels, gravity support is provided by existing concrete curbs. Given the different anchor capacities for cross-cut and vein cut limestone panels, exterior elevations were prepared to map the type of each limestone panel across the existing façade. The types of panels were identified as vein-cut or cross-cut through close visual inspections of the natural voids in the existing limestone panels.
