# Reinvigorating a Historic Giant

## ROW DTLA Building 2

By Samuel Mengelkoch, S.E.

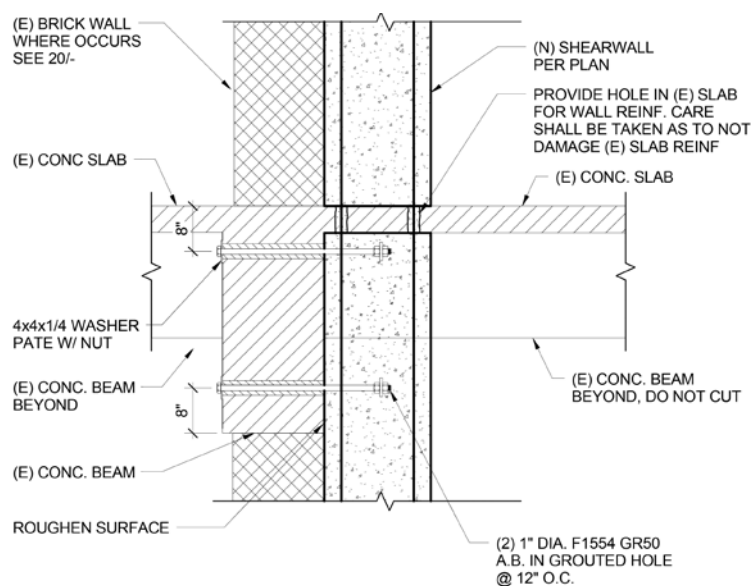
Figure 2. Detail at the thru-bolt connection between the new shear wall and existing girder. Also showing vertical wall bars passing through cores in the slab.

specially reinforced concrete shear wall cores, the collection of forces was critical. The team employed the robust and generously reinforced existing beams and slabs, designed to support a historic warehouse live load of 250 pounds per square foot, for double duty in collecting forces in compression, tension, and shear and delivering the load to the new shear walls (*Figure 2*).

Because shear wall cores were employed inside the building, the contractor was able to utilize the existing structure for construction staging as they went up the building, largely eliminating the need for extensive scaffolding. Existing beams were attached to new shear walls with thru-bolts, providing easy access and a visible link to the existing structure (*Figure 3*). Suspecting they would exhibit good behavior, the team performed nonlinear finite element analysis on the existing round, spirally-reinforced concrete columns, and compared their inherent ductility to anticipated building drifts. The goal was to achieve a maximum 2% inter-story drift without inducing a column shear failure. The drift behavior of each column was analyzed by inputting linear and nonlinear properties and axial loads into the MATLAB program CUMBIA, used for force-displacement response of reinforced concrete members under moment. Only columns that could not sustain the imposed drift at the damage control limit were strengthened with Fiber Reinforced Polymer (FRP). This strategy allowed the team to eliminate the need for FRP wrapping on hundreds of sufficiently reinforced concrete columns throughout the building.

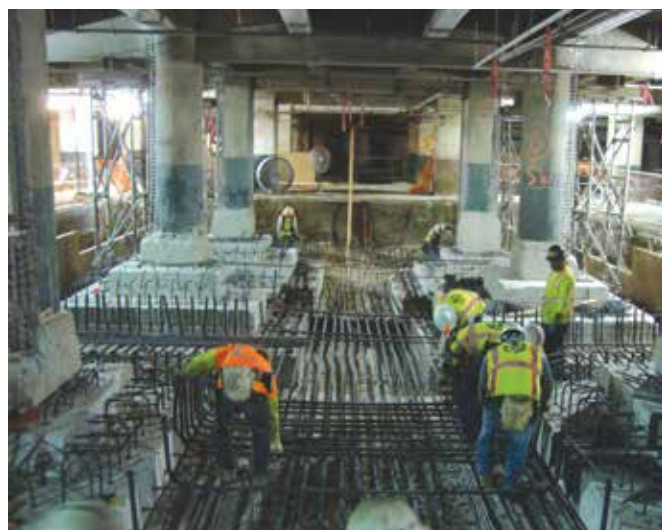
Figure 4. Crews install foundation reinforcement at the bottom of the new mat foundation. Notice “wedding-cake” style original concrete foundations at varying elevations.

The four new shear wall cores required substantial mat foundations which had to be integrated with the existing spread footings. Each original column was supported by a multi-tiered, “wedding-cake” style spread footing. In the original construction, there was evidently no set footing elevation. Rather, crews likely excavated only until competent soil was reached, and that is where each footing went. Since the depth to competent soil varied across the large building footprint, footing elevations varied randomly within an approximately five-foot range. The bottom of the mat sloped to accommodate the varying elevations, always matching the bottom elevation (*Figure 4*). Since the top of the mat was level, the mat thickness varied as well, while maintaining a required minimum thickness

of 60 inches. Several thousand epoxy dowels were required to integrate the existing footings with the new mat system.

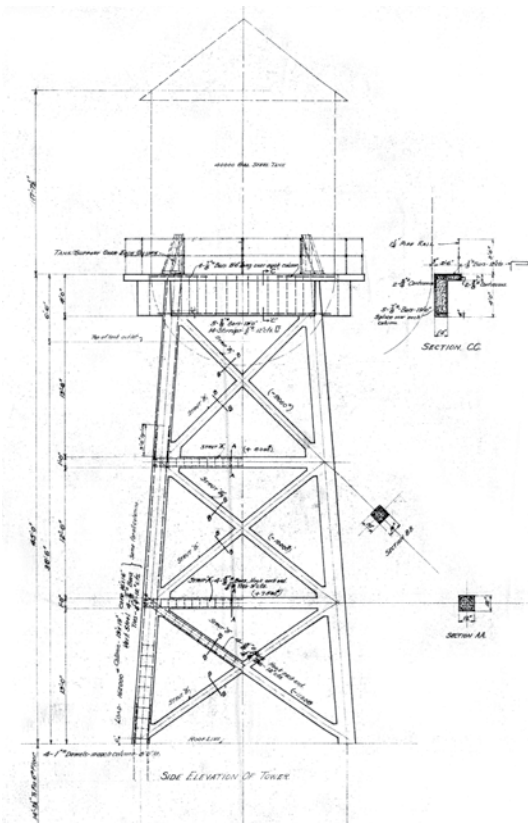
Figure 5. Rooftop water tower elevation from original 1916 Parkinson drawings. Notice support frame is of reinforced concrete.

To maintain the early 20<sup>th</sup>-century charm of the building, engineers carefully surveyed and analyzed the rooftop water tower and façade fire escapes to prove that they could safely remain (*Figure 5*). With a few suggested upgrades from the team, the water tower sits proudly on top of the finished building; ultimately, however, the five 100-year old fire escapes could not be saved. Untenable strengthening requirements from the City of Los Angeles would have dramatically changed their visual character and proved cost-prohibitive.
