Revisiting Lessons Learned

from the Nicoll Highway Collapse

By Hee Yang Ng, MStructE, C.Eng, P.E.

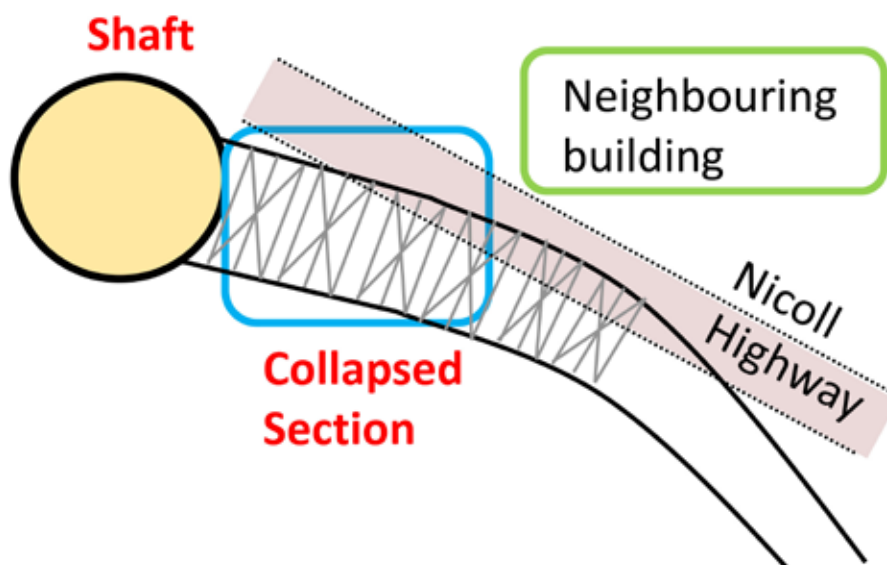
Plan view of the collapse area.

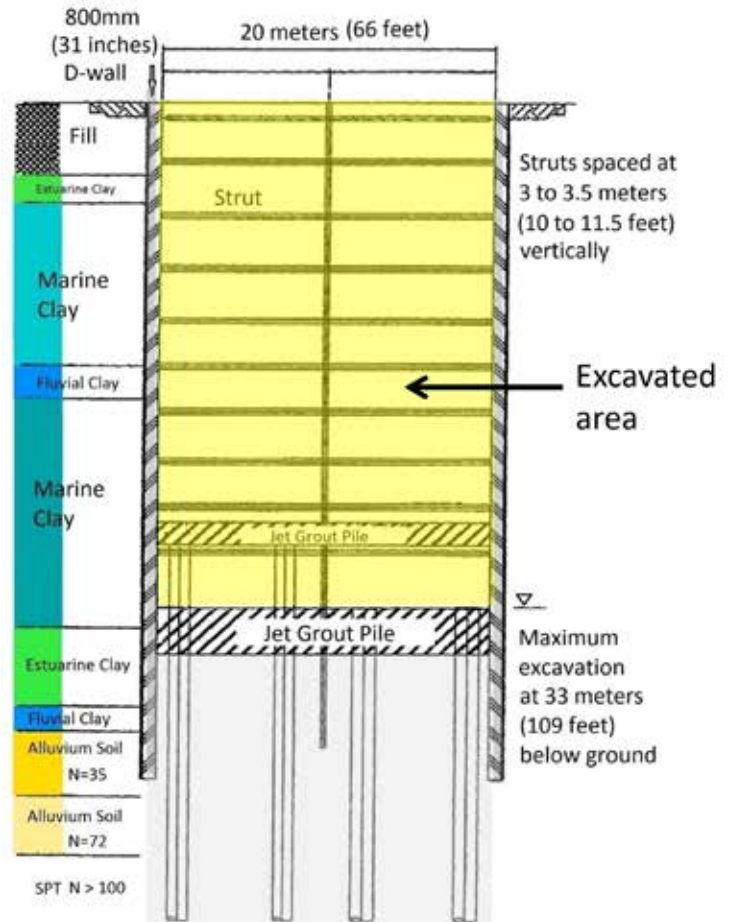
Section of the cut-and-cover tunnel.

The 20-meter-wide (approximately 65.6 feet) cut-and-cover tunnel had to be constructed by excavating to 33 meters (approximately 108.3 feet) below ground level. The ground consisted of deep layers of soft marine clay with very low shear strength (20 kPa to 40 kPa), which typically increased linearly with depth. 800-millimeters-thick (approximately 2.6 feet) reinforced concrete diaphragm walls (D-walls) were used as earth-retaining structures, supported by 10 levels of steel struts, spaced at about 3 to 3.5 meters (approximately 9.8 to 11.5 feet) vertically. Two levels of Jet Grout Pile (JGP) near the base of the excavation were constructed to provide strength and stability to the soft soil as the base was being excavated. It is worth noting that such a deep excavation in adverse ground conditions would typically require a wall thickness of about 1500 millimeters (approximately 4.9 feet). That thickness is twice the size of the wall used in C824.

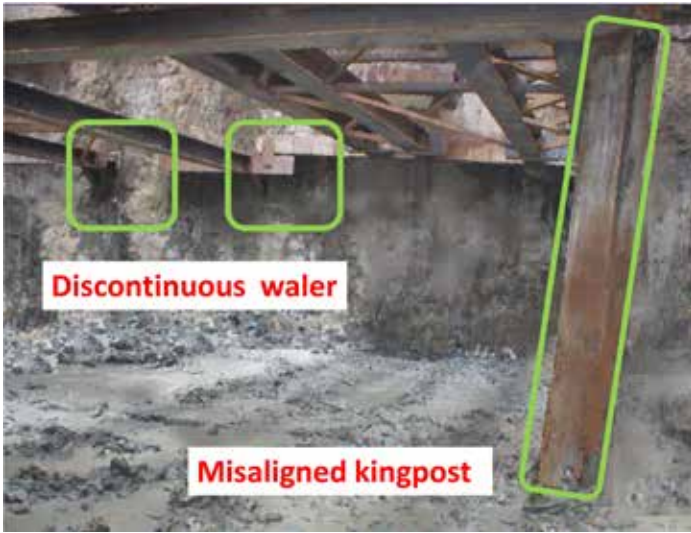
Poor strutting design and construction.

There were many inadequacies in the design of the strutting system in C824. Due to the design-and-build nature of the contract, the contractor wanted a very lean design. The curved diaphragm walls and close vertical spacing of the struts (obstructing ease of construction) did not help. In C824, it was found that some walers were discontinuous. Some struts were installed without splays. There were also cases where struts were bearing directly onto D-wall panels without a waler. The waler's fundamental purpose was to provide continuous line support to the retaining wall so that loads could be redistributed, and the effects of eccentricity could be mitigated. When this was omitted, the effectiveness of the strutting support system was somewhat compromised.

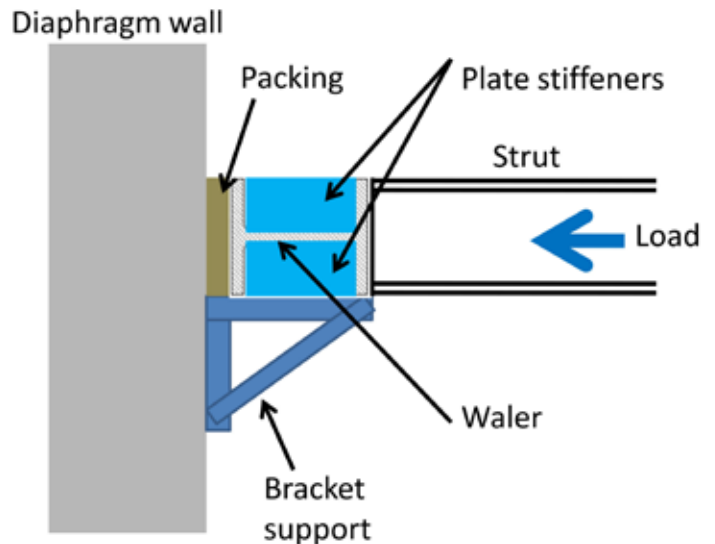
Replacing plate stiffeners with C-channel stiffeners.

The contractor then replaced the steel plates with C-channels, thinking that the "bigger" C channel sections would perform better as stiffeners. This proved to be a costly mistake, as it was one of the main contributing factors leading to the strutting system's inadequacy.

The contractor did not realize that the C-channels acting as stiffeners had resulted in an "open" stiffening system. This means

that the “opening” created had an inherent weakness, a failure by sidesway. Sidesway failure mode is dangerous because of the after-peak brittle response. Once the system is overloaded beyond capacity, failure occurs suddenly and the load-carrying capacity decreases sharply.

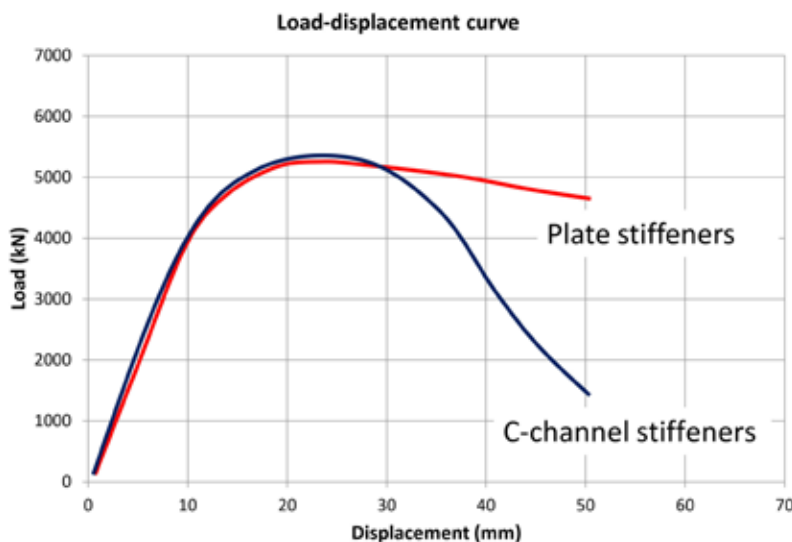
Conceptual load-displacement curve showing sudden failure due to sidesway.

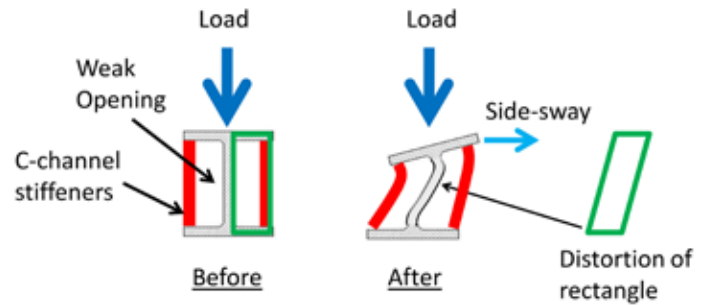
Sidesway failure mode of “open” stiffeners.
