## Underwater Weld Repairs

By Uwe W. Aschemeier, Axel Mutzeck, Kevin S. Peters and Jarrad A. Schmerl

This article introduces the basics of underwater wet welding, including two case studies for underwater repair – a pier in the port of Kiel in Germany and the underwater repair of two rudders on a cruise ship in various ports in the Caribbean.

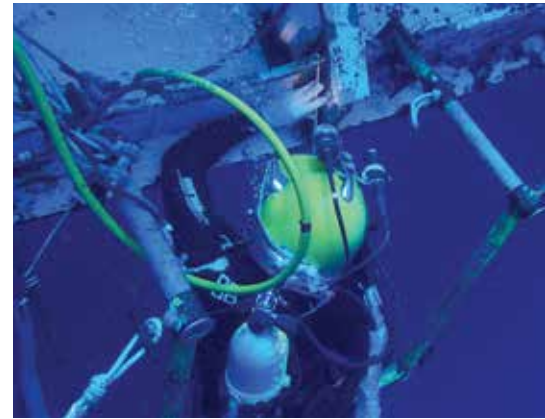
Per AWS D3.6, *Underwater Welding Code*, underwater wet welding is performed at ambient pressure with the welder diver in the water without any physical barrier between the water and the welding arc (Figure 1).

Figure 1. Welder diver performs underwater wet welding.

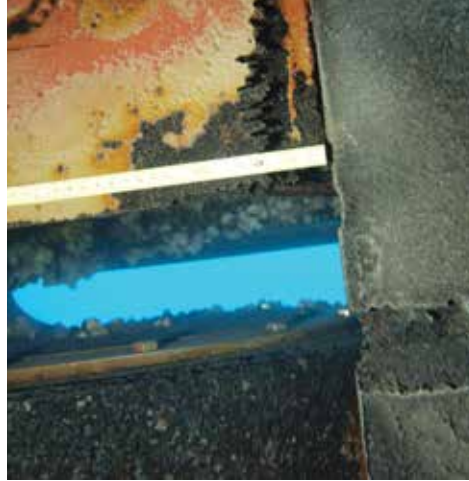
An in-water survey, performed by divers on the underwater part of a 317-yard-long and 125,323-gross-tonnage cruise ship revealed heavy cavitation and erosion damage caused by galvanic corrosion on the inboard and outboard side of the port and the starboard rudder. The port side rudder revealed a total section loss in some areas of the rudder plating, which caused the rudder to flood with seawater (*Figures 2 and 3*).

Figure 2. Condition of the starboard side rudder.

The first step was to determine the extent of the damage via an inspection dive. Material certificates for the steel used on the rudders were not available. Since a chemical composition is required to determine the wet weldability of the material, steel samples were retrieved from the rudder during the inspection dive. The results of the analysis were within the limits of wet weldability. A repair plan was developed to clean and restore the deteriorated areas to the original plate thickness. Some of the rudder plating in specific locations could be cropped. The leading edge of the rudder with total section loss was repaired with a doubler plate that matched the curvature of the leading edge.

A total of approximately 4,500 underwater wet welding electrodes were used to restore the cavitated/eroded sections of the rudders. In some locations, the original plate thickness of  $1\frac{1}{16}$  inches was deteriorated to  $\frac{5}{16}$  inches. It took the dive teams six attendances, each lasting 2 weeks, to repair the damages. Diving was performed during scheduled port stops without interrupting the itinerary of the vessel.

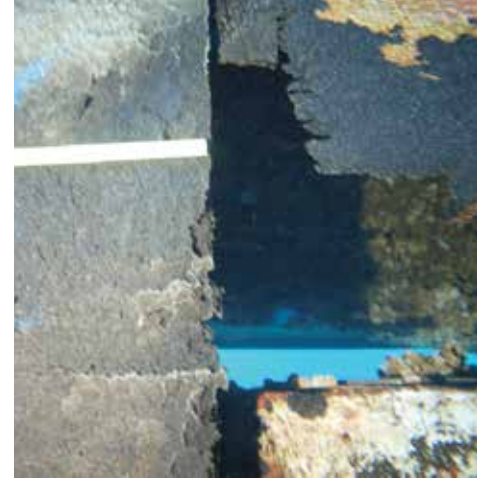
Figure 3. Condition of the port side rudder.

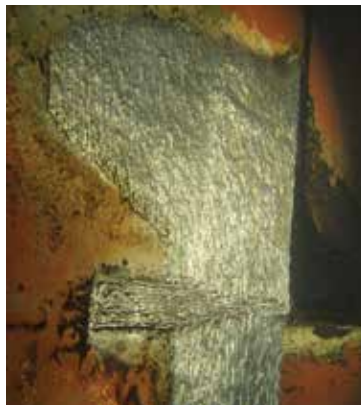
*Figure 4* shows the completed build-up welds in a particular area on the port side rudder.

Figure 4. Build-up weld on port side rudder.

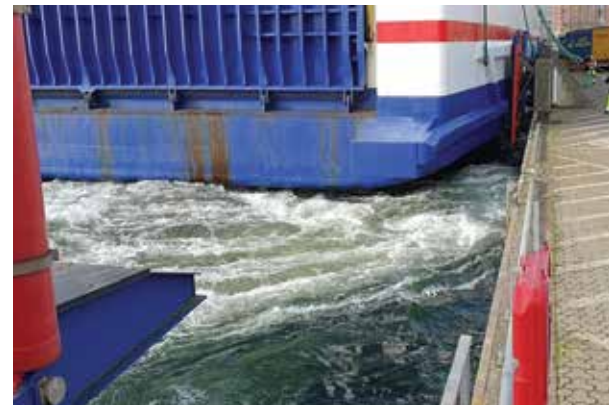
The sheet pile wall of the Stena Line pier was found to be heavily corroded over a length of approximately 1,000 feet. Typically, corrosion damage on sheet pile piers is contained within the splash or tidal zones, 3 feet above and 5 feet below the waterline. However, this sheet pile wall was different and exhibited corrosion holes with total section loss into the mudline, to a depth of approximately 36 feet. One of the reasons for the unusual corrosion pattern was due to the daily arrival and departure of the largest Stena Line ferries. The propellers on the three bow and two stern thrusters of these vessels stir up the water, bringing oxygen to the bottom and causing heavy corrosion to the sheet pile wall (*Figure 5*).

Figure 5. The propeller of the ferries swirls the water.

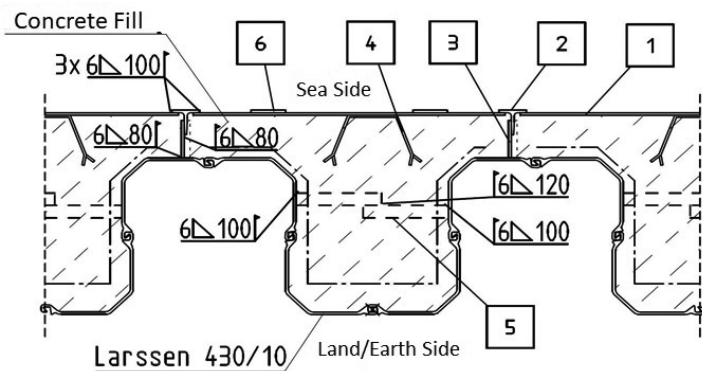
Figure 6. Detailed view of a sheet pile field.

- 1) Installation of prefabricated reinforced steel forms that wrapped around the existing sheet pile wall,
- 2) Installation of support brackets (Item 5 in Figure 6) inside the sheet pile fields between the upstream and downstream wall,
- 3) Installation of structural T-profiles (Item 2 in Figure 6) welded with shear tabs to the seaside face of the existing sheet pile wall, and
- 4) Installation of sealing plates (Item 1 in Figure 6).

39 U.S. tons of structural profiles T 120 (Item 2 in Figure 6), each approximately 25 feet in length, were welded onto the seaside face

567 pieces of sealing plates (Item 1 in Figure 6) fabricated from ½-inch-thick higher tensile steel S355 were installed. The sealing plates were installed from the bottom to top elevation in between the T 120 structural profiles. They were secured in position with stitch welds between the plates and the T 120 on the sides, and with weld tabs on the top and bottom. Three seal plates were used to achieve the required height. The height of the plates varied between 94.5 inches and 102.4 inches.

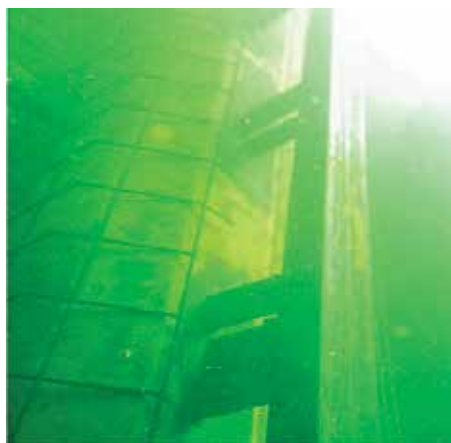
of each sheet pile field to guide and secure the seal plates into position. The T 120 structural profiles were welded with shear tabs 6 x 3 x ½ inches to the seaside face of the existing sheet pile wall (4,611 pieces) (Figure 7).

Figure 7. Aligned and welded T 120 structural profiles. Approximately 14 feet of linear weld was placed for the installation of each structural profile T 120.

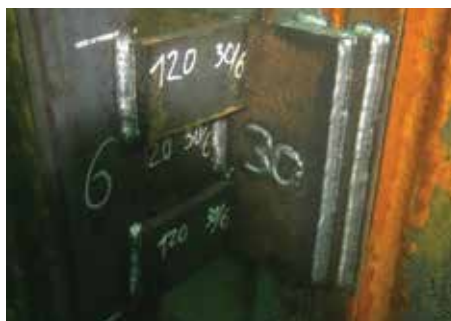
Adjustment tabs were used to fine-tune and to align the T 120 structural profiles and to support the sealing plates (Figure 8).

Figure 8. Adjustment tabs.
