Earthquake Aftermath

SALT LAKE CITY & COUNTY BUILDING

By Jerod G. Johnson, S.E., Ph.D., and Mason T. Walters, S.E.

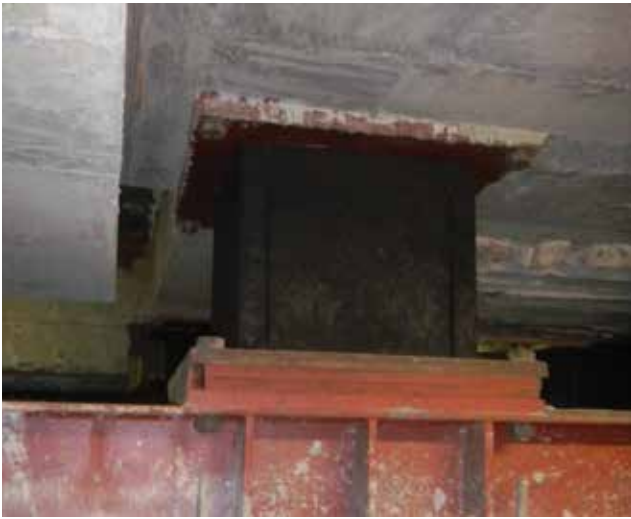
Figure 1. Seismic base isolator.

Although seismic base isolation technology was in its infancy, project stakeholders saw its value as a means to reduce seismic demand on the structure. The new technology would alleviate the need for massive seismic retrofitting of unreinforced walls throughout the building. It would also make the Salt Lake City & County Building the world's first seismic isolation retrofit project. As a result, 443 cubic isolators now de-couple the building from the earth, thereby filtering much of the frequency content that would otherwise result in damaging acceleration in the building's superstructure (Figure 1). Also, an armature of red-iron bracing was developed and installed for the clock tower to address its potential seismic accelerations, which, although reduced by base isolation, were still large enough to be a concern.

Based on the isolation system's engineering design, the building's fundamental period was lengthened to approximately 2.5 seconds, a shift correlating to nearly an 80% reduction in spectral acceleration and forces when compared to the non-isolated condition. Such comparisons were derived from a site-specific spectra study developed as part of the renovation design. Interestingly, the 1985 *Uniform Building Code* (UBC) prescribed lateral design accelerations of 0.1g for ductile structures in the region of the building's location. Owing to the project's importance, stakeholders increased this acceleration to 0.2g in the development of spectra and time history records to use for design, taken as scaled versions of the 1979 Imperial Valley Earthquake, Bond Corner Accelerograms.

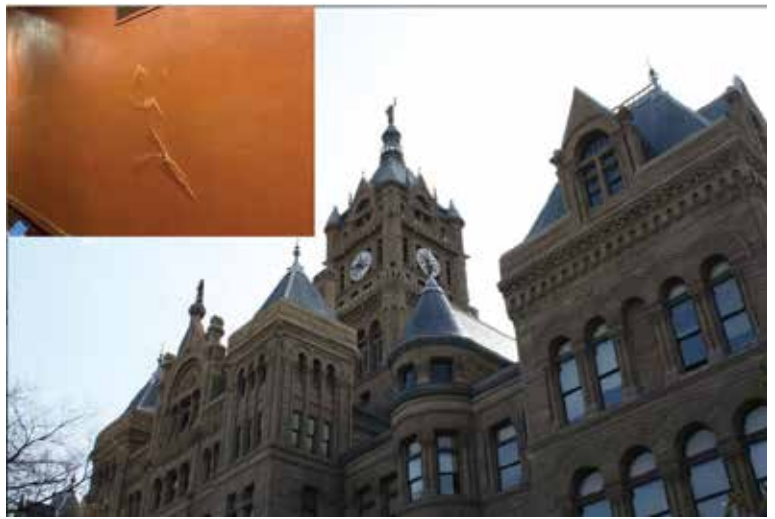
Figure 2. Masonry cracking manifested in plaster coating (inset).

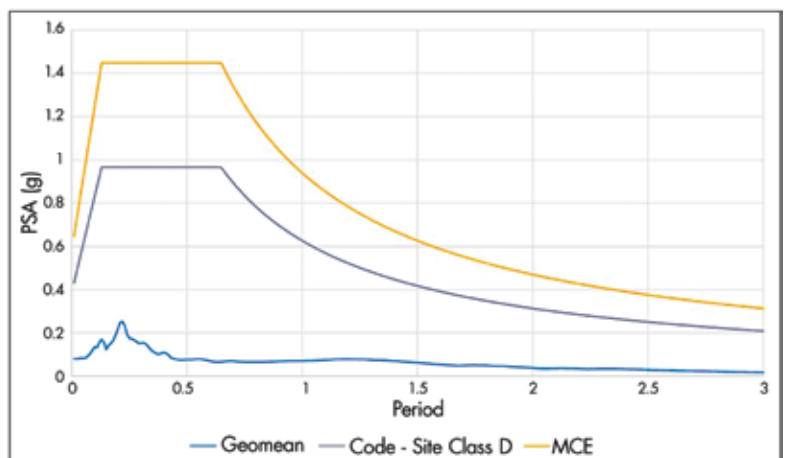
Figure 3. Downtown Salt Lake City Acceleration Spectrum, Magna Earthquake and Code Spectra.

Instrumentation records reveal that structures in Salt Lake City's downtown area experienced about 20% of the shaking intensity of structures closer to the epicenter (about nine miles to the West). Figure 3 displays a spectrum developed from the event at a site not far from the Salt Lake City & County Building. When compared to the code-prescribed spectrum, this was clearly a small event. The fact that damage was limited primarily to archaic URM structures should not be surprising. Figure 4 displays the correlating displacement spectrum developed for the same site as Figure 3 (motions available through the Center for Engineering Strong Motion Data, CESMD; see www.strongmotioncenter.org). Interestingly, recordings from instrumentation on the site and in the building are either not available or non-existent.

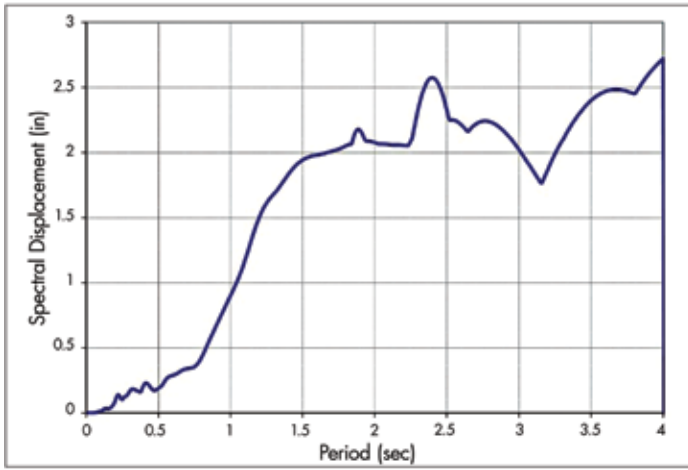
Figure 4. Downtown Salt Lake City Displacement Spectrum.

The base isolation system design of the City & County renovation targeted a fundamental period of approximately 2.5 seconds. Considering the displacement spectrum of Figure 4, peak displacements for the City & County Building with its isolation system should be approximately 2 to 2.5 inches. Examination of stonework abutting the isolated plane reveals that the displacement

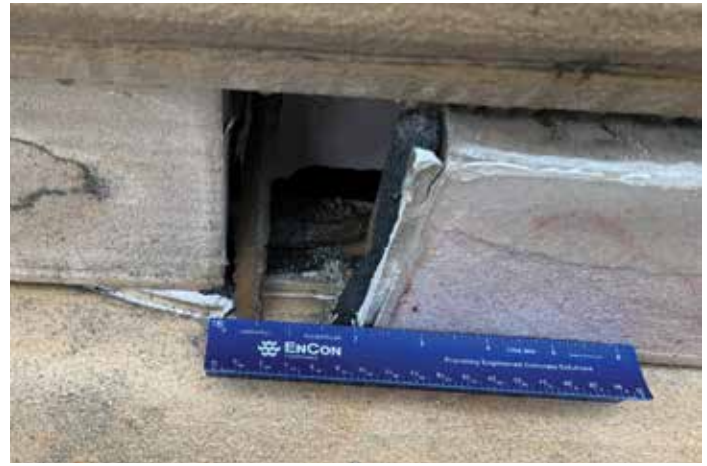
Figure 5. Salt Lake City & County Building – displaced stone at isolated plane.

experienced is consistent with the spectrum of Figure 4. In particular, displaced stones (Figure 5) indicate a maximum isolation system displacement slightly higher than 2 inches. A rough comparison of other spectral ordinates suggests that peak accelerations for the overall building were roughly 0.03g. A comparable, non-isolated building could have experienced accelerations of nearly 5 times higher or more.
