Building Safety Assessments Following the Sparta Earthquake

By Colby Baker, P.E.

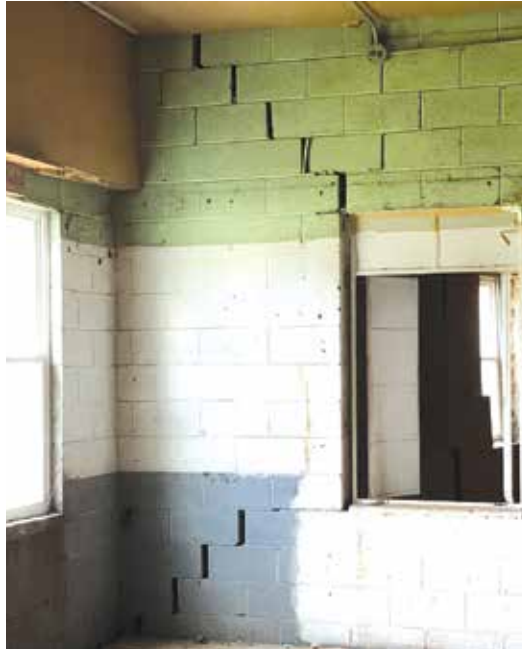
Displacement of unreinforced masonry at an industrial building in Sparta, NC, following the August 9, 2020, earthquake.

Unsurprisingly, the most visible damage was non-structural and included collapsed ceiling finishes, toppled chimneys, bowed or collapsed brick veneer, and displaced contents. Structural damage was generally limited to those systems known to be seismically hazardous such as plain (i.e., unreinforced) brick, concrete block, and stone masonry. While most single-family residences were wood-framed construction, their foundations were often composed of plain concrete block masonry. In general, short unreinforced masonry stem walls survived with minor cracking; however, deep crawl spaces and walkout basements suffered considerably, developing wide cracks and lateral differential displacement within the mortar joints.
