FRP Column Retrofit for Mt. Zion Housing

Part 2

A recent seismic retrofit project provided an opportunity to test an interior concrete column retrofit with a three-sided, fiber-reinforced polymer (FRP) wrap with FRP through-anchors on the fourth side. The testing demonstrated the effectiveness of this application, which could be applied to columns or beams with deficient shear strength in situations where site conditions prevent access to one side of the member. Please refer to Part 1 (*STRUCTURE*, January 2022) for additional testing information.

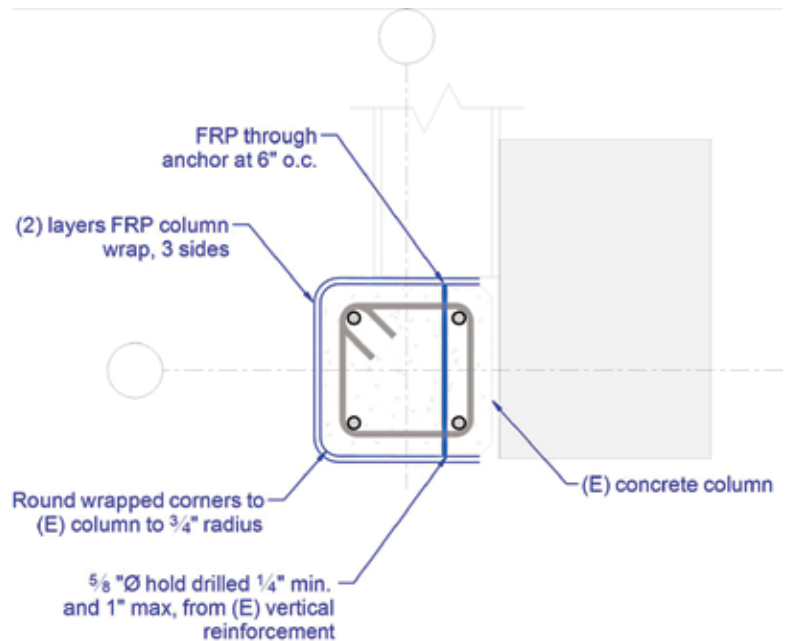
Figure 13. Three-sided FRP column wrap, with FRP through-anchors parallel to the fourth side.

Simpson proposed a solution using FRP through-anchors in place of the fourth side of wrapping (*Figure 13*). Such through-anchors are used in other FRP wrapping applications, such as for long narrow columns. Another FRP supplier and designer, Aegion/Fyfe, has also tested a three-sided FRP wrap using an approach that includes through-anchors.

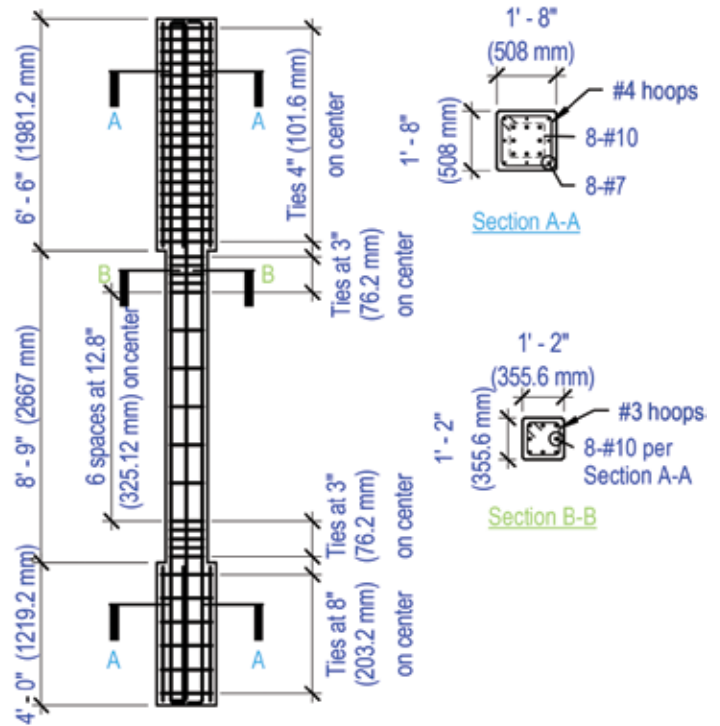
Figure 14. Test column. The central portion represents the column between floor slabs of the building.

The testing included one control column (*Figure 14*), i.e., a column without retrofitting, and two identical specimens of a column with the three-sided FRP retrofit.

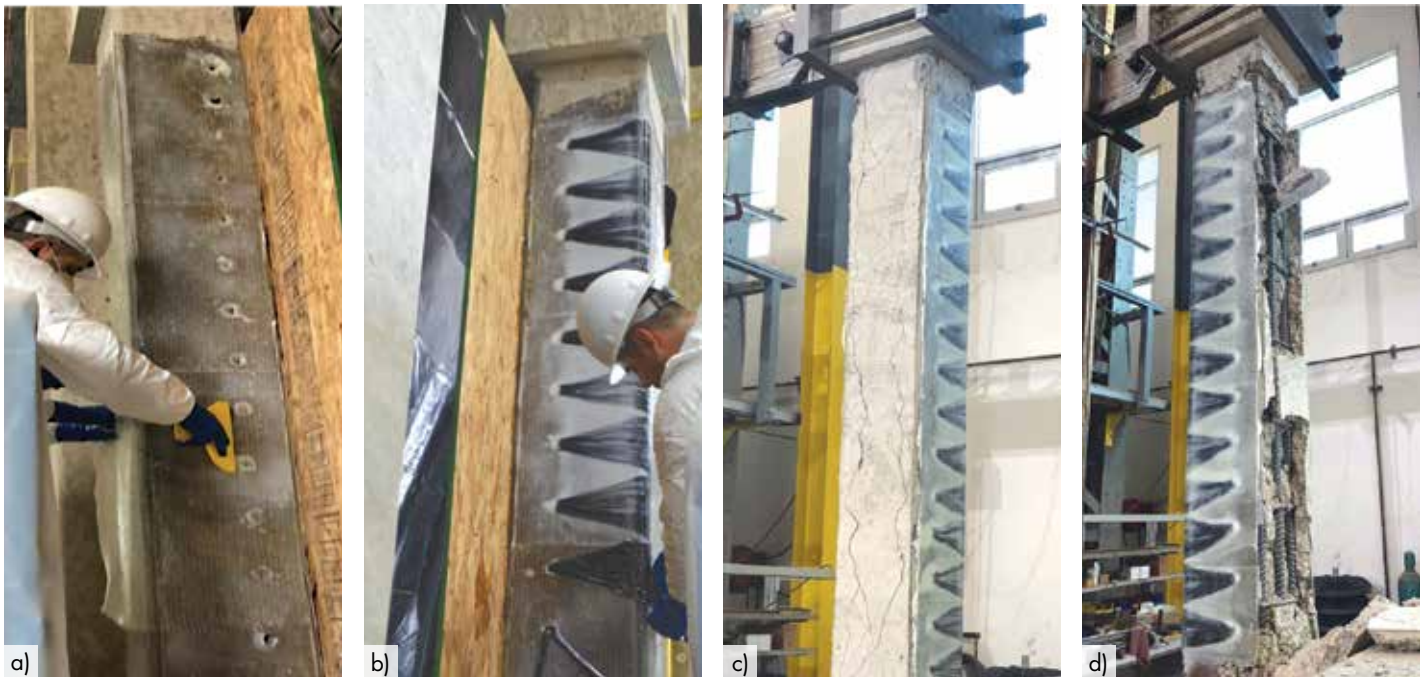
Figure 15. a) Installation of three-sided FRP wrap, including drilled holes that receive the FRP through-anchors. The holes are countersunk in a trumpet shape at the column; b) Installation of the FRP through-anchors, showing the splaying of the carbon fibers of the anchors onto the first layer of FRP wrap; c) Retrofitted column tested parallel to through-anchors, shown after reaching a peak lateral story drift ratio of 5.5% to the left followed by 11% to the right; d) Retrofitted column tested perpendicular to through-anchors, shown after reaching a peak lateral story drift ratio of 5.5% to the left followed by 11% to the right.

After the specimens were cast and cured, two were placed in an upright position. The three-sided FRP wrap was then installed under conditions that represented the field conditions, including a sheet of oriented strand board that blocked access to the fourth side in a manner similar to the field conditions (*Figures 15a* and *15b*).

The retrofit prevented the shear failure that occurred in the control column by increasing shear strength and enabling flexural yielding to govern the nonlinear behavior (Figures 15c and 15d).

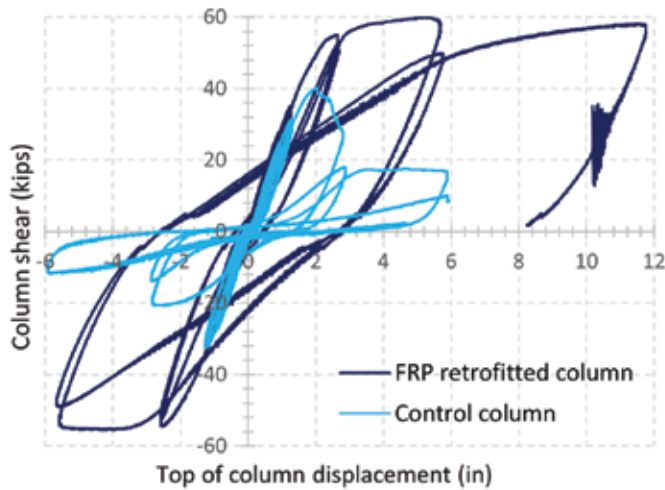
Figure 16. Force versus displacement hysteresis output for the retrofitted column tested parallel to the through-anchors.

The retrofitted columns showed the ability to displace beyond a story drift ratio of 0.05 without substantial damage that would create a risk of collapse. Furthermore, the column suffered no strength degradation for loading parallel to through-anchors even up to a story drift ratio of 0.11 (Figure 16).

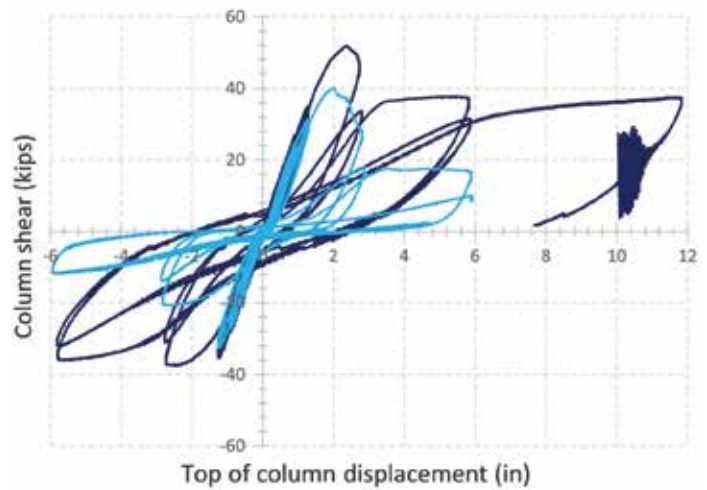
Figure 17. Force versus displacement hysteresis output for the retrofitted column tested perpendicular to the through-anchors.

Spalling occurred on the unwrapped face as the cover concrete was subjected to high compression strains for the column with loading perpendicular to through-anchors. The spalling of the cover concrete reduced the effective section depth for flexure. As a result, the lateral strength of the column reduced from its peak strength of 52 kips to a strength of 37 kips, which it maintained without further degradation up to the maximum story drift ratio of 0.11 (Figure 17).
