# Seismic Retrofit of the Atascadero Printery

By Jillian van Enkevort, S.E.

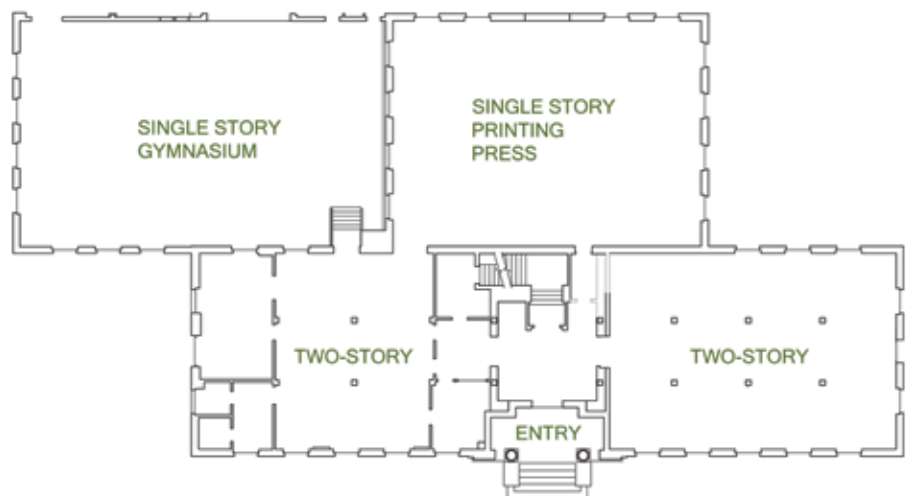
Figure 2. Existing floor plan.

The building was designed by Bliss and Faville Architects out of San Francisco and Engineer M.C. Couchot out of Oakland. The main portion of the building is a rectangular-shaped 2-story structure with a partial basement. At the rear is an original single-story room that housed the printing press and another single-story annex, constructed later, used as a gymnasium for a boy's home tenant (*Figure 2*). The foundation, basement, and second floor are of concrete construction with 1/2-inch-square smooth bar reinforcing with unreinforced brick masonry bearing walls. The first story walls are 4-wythes-wide, and the second story walls are 3-wythes. Roof framing in the two-story section consists

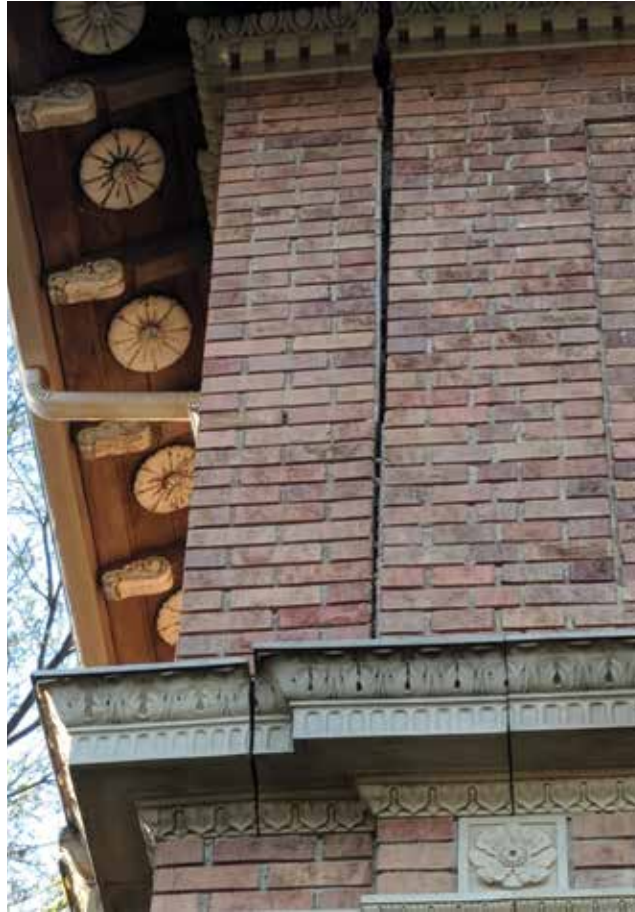
Figure 3. Cracking at the southwest corner.

One of the most noticeable deficiencies of the existing building after the earthquake was the inadequacy of the anchorage between the walls and the roof. The walls showed signs of pulling away from the

roof in numerous locations and have since been shored to prevent further movement and possible collapse. In the years since the San Simeon earthquake, the crack at the southeast corner of the building appeared to be worsening (Figure 3, page 35). In addition to adding shoring, a mason was hired to reconstruct the interior wythes of brick to restore the wall's structural integrity.
