HISTORIC ALAMEDA HIGH SCHOOL RETROFIT

PART 2: PRESERVING HISTORIC VALUE, PROVIDING MODERN SEISMIC SAFETY

By Nik Blanchette, P.E., Steve Heyne, S.E., and Chris Warner, S.E.

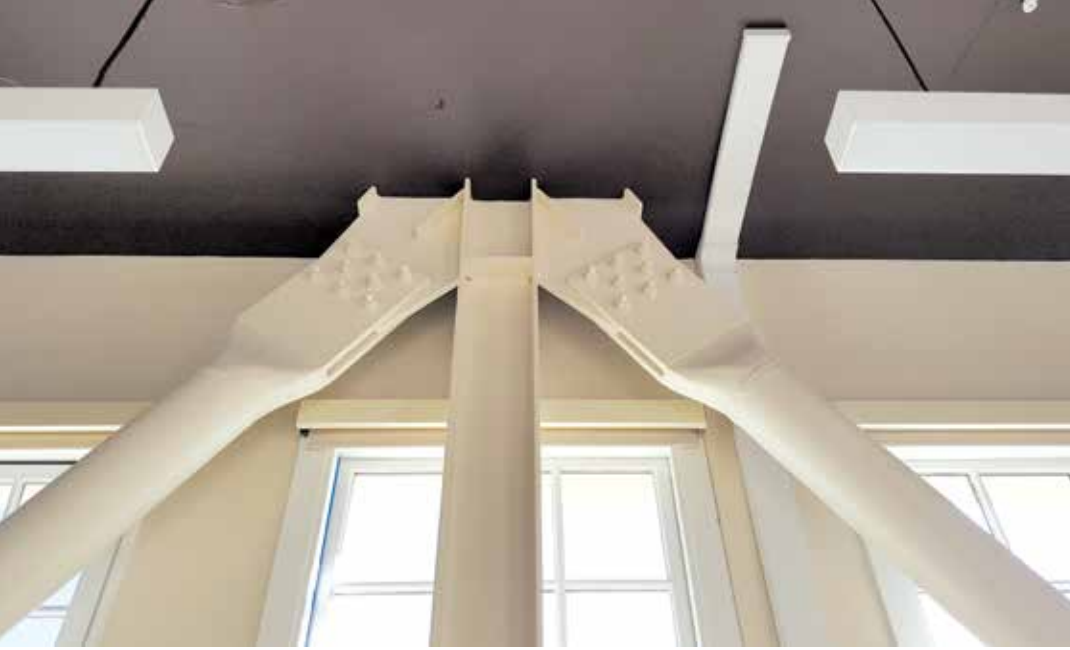
Cast Connex HSC brace connection.

A new steel SFRS was another option to evaluate. Steel offers an efficient, compact, and modular solution. Relatively lightweight elements can be fabricated offsite then installed through small openings in the building. Comparing braced frames and moment frames, braced frames were selected due to their greater stiffness, which was required to limit in-plane drift of the existing concrete walls. Drift was limited to prevent yielding of the existing reinforcing steel in the concrete walls supporting floor and roof gravity loads. Braced frames also integrate better with wood-framed floors since the beam bracing requirements for moment frames are difficult to resolve into wood framing. Architecturally, it was decided not to encase the frames in finishes, so Cast Connex High-Strength Connectors were utilized at brace to gusset plate connections instead of traditional welded or bolted connections. The connectors are more

visually appealing and allow for field bolted connections, which was more cost-effective to install.

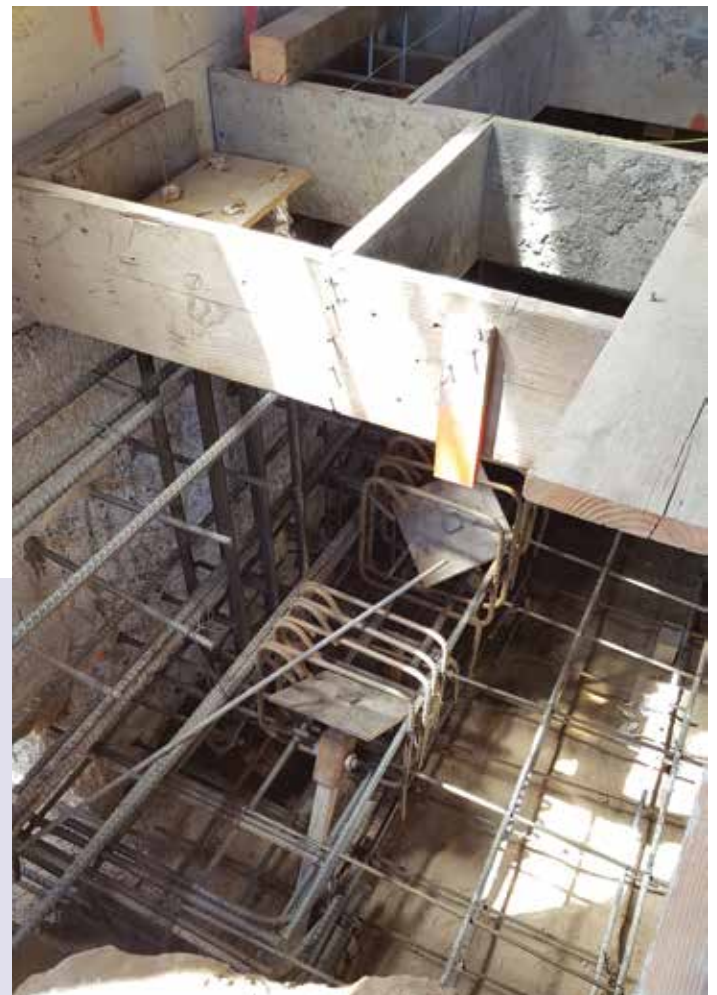
Top of battered helical piles at pile cap.

Three-story-tall braced frames supporting concrete wall construction result in sizeable seismic overturning demands. High demands combined with the need to fit new foundations within the footprint of an existing building, with pad footings throughout, required deep foundations. Due to limited access and vertical clearances within the existing building, helical piles were chosen for the new foundations that were installed under the braced frames. Helical piles are modular elements composed of relatively slender steel shafts with larger diameter helical plates on the lead end; essentially, a large screw torqued into the soil. These piles come in short lengths and can be installed with a hydraulic head mounted on a Bobcat, perfect for working inside an existing building. After one shaft is driven flush with the ground or slab, another shaft is added using a bolted coupler. Helical piles are stiff along their axis but weak perpendicular to the shaft. Therefore, vertical piles were used to support vertical forces but, to resolve base shear at the braced frames, battered piles at an angle of thirty degrees to vertical were used.

The pile manufacturer was unsure if the piles could be driven through the grout injection columns without damage and/or refusal. Therefore, the piles were installed first. After grout injection was performed, the foundations were excavated, taking care not to damage the embedded pile shafts. This was an unusual sequence but turned out to be successful.

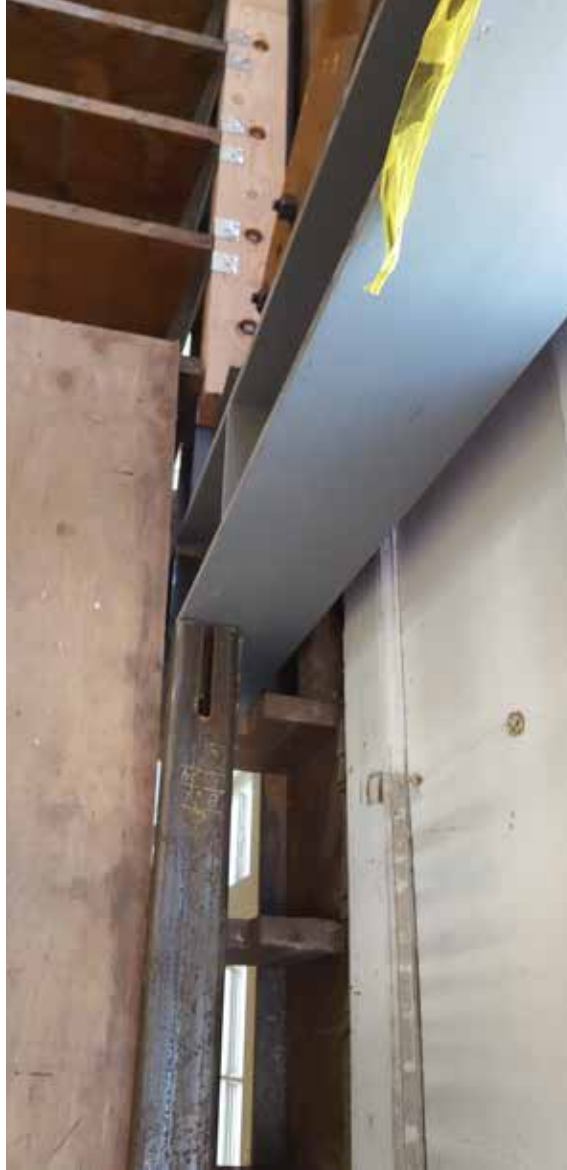
HSS collector recessed into the top of floor framing.

Existing concrete beam reinforcing was already fully utilized for gravity loads, so new collectors had to be introduced. It was challenging to integrate the new collectors with the existing gravity framing because they needed to occupy the same space to hide them from view and maintain historic visuals as much as possible. Braced HSS beams offered a small profile, which was hidden in the top of notched floor joist ends. Roof collectors were hidden in the attic. This resulted in only braced-frame elements being exposed in a limited number of rooms.

New steel collectors had to pass through perpendicular concrete beams in many locations. An elaborate set of condition-specific details was developed, using steel rods to limit the extent of concrete removal. Field welding was avoided in most cases, favoring a threaded rod and nut solution.
