Relocation Sestoration

Belleview Biltmore Hotel

BY E. MICHAEL MCCARTHY, P.E.

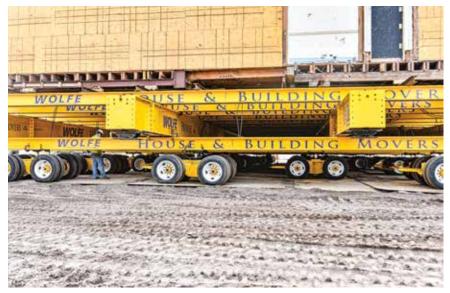
Wheeled dollies. Courtesy of Wolfe House & Building Movers.

installed temporary steel beams under each load point along with 45 Buckingham wheeled dollies. Finally, the entire structure was lifted, rotated, and moved via remote control to its new location, where a new concrete mat foundation, cast-in-place concrete walls, and concrete piers were built. This presented an unusual phasing challenge because the new walls and piers needed to be positioned under the load-bearing points that were being supported by the temporary steel beams during the move. To resolve that problem, the SEOR modified the design of the piers and walls to allow for the phased removal of the beams without losing support under the building.

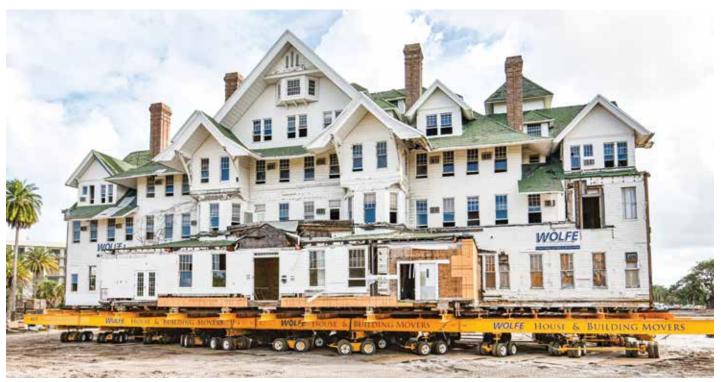
Moving of the Hotel. Courtesy of Wolfe House & Building Movers.

from Pennoni Associates Inc., the structural engineer of record (SEOR), Wolfe House & Building Movers rotated the original section of the old hotel 50 degrees. Then, they moved it about 350 feet as part of a significant redevelopment project. According to Wolfe, the structure weighed 1,750 tons, making it one of the heaviest framed
