UCSF CLINICAL SCIENCES BUILDING

Seismic Rehabilitation

By Steve Marusich, S.E.,
and Andrew Salber, S.E.

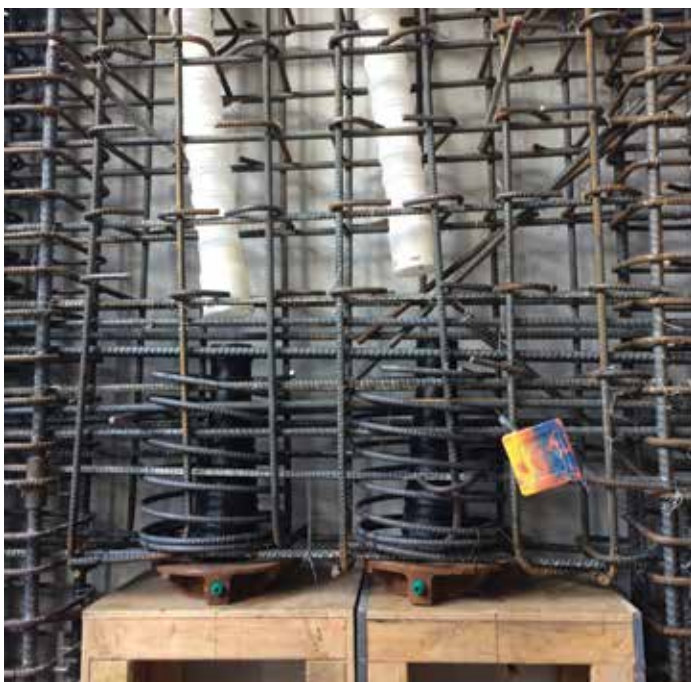
Post-tensioning anchorage and ducts.

An unbonded multi-strand post-tensioning system was used for the walls to maximize the available vertical post-tensioning force. For similar bar strain reasons, the vertical post-tensioning was unbonded and ran in ducts the entire height of the walls. The tendons were anchored just above the foundation and at the top of the wall in locations that could be easily accessed in the future. Because the tendons are unbonded, a fully encapsulated system was used for

corrosion protection. The vertical post-tensioning was proportioned so that the restoring force would overcome the BRBs compressive strength, ensuring re-centering of the wall.
