Precedent Deflected: Cantilever Design Extrapolated

By Julie Mark Cohen, Ph.D., P.E.

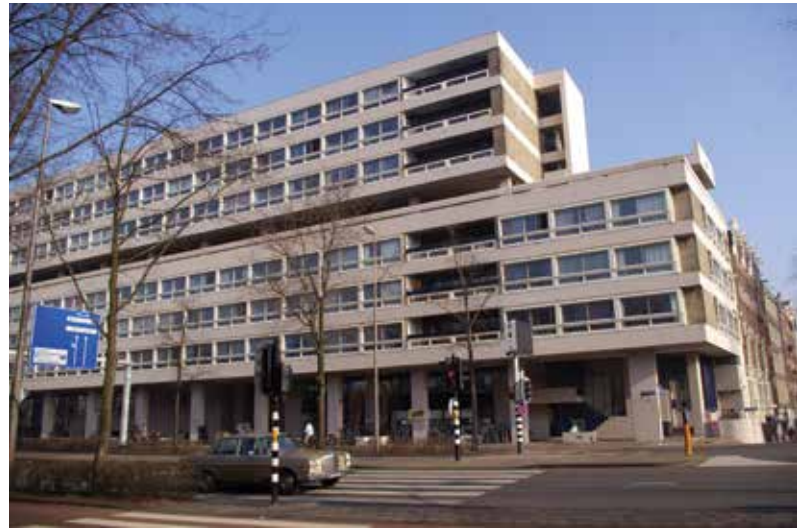
Figure 1. Studentenhuis Weesperstraatm, University of Amsterdam, The Netherlands. Courtesy of Gerardo Brown-Manrique, photographer.

won the design competition for a University of Amsterdam student housing building, Studentenhuis Weesperstraatm, with a Dutch structuralism design that paralleled Brutalism in the early post-War period. For this building, constructed from 1959 to 1965, the two large enclosed volumes are cantilevered beyond the outermost row of columns. The visual impression of these cantilevered floors is one of substance and structural integrity (Figure 1).

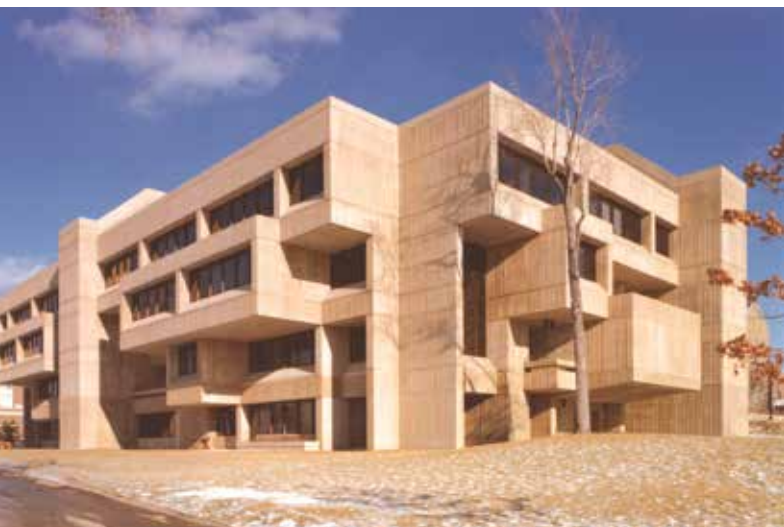
Figure 2. Folsom Library, Rensselaer Polytechnic Institute, Troy, NY. Courtesy of Folsom Library, AC19 Institute Archives and Special Collections, Rensselaer Polytechnic Institute, Troy, NY.

From the early 1960s through the 1970s, several U.S. buildings were also designed in the Brutalist style. The predominant feature of this style continued to be the use of concrete, at least in façades. Another distinguishing feature was large rectangular *boxes* that protruded (cantilevered) from the main portion of the buildings, typically along one or two bays and over one to two stories in height. Concrete structural members framed the protruding volumes with minimal glazing in the façades. In these boxes, the structural floor depths of the cantilevers and back spans followed long-standing rules of thumb. The ratios of cantilever lengths to back span lengths were no more than 1:3 and sometimes closer to 1:4 (the maximum ratio the author learned as an architecture student). These rectangular protuberances read as rigid sub-assemblages. An example of a U.S. Brutalist-style building is the Folsom Library at Rensselaer Polytechnic Institute in Troy, NY, which was designed by Quinlivan, Pierik & Krause and constructed from 1972 to 1976 (Figure 2). Here, some of the cantilevered volumes appear to be supported from framing just above, but their actual cantilevered lengths are relatively short.

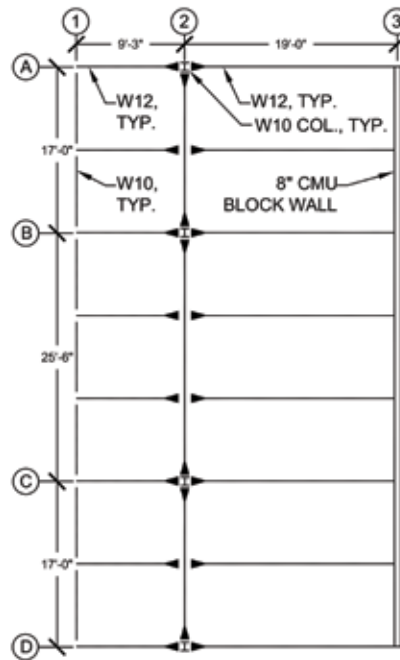
Figure 3a. Structural plan of typical floor with building-length cantilever.

On a typical floor, there are two apartments, one between lines A and B.5 and the other between lines B.5 and C. The façades along Lines A and E contain windows. In Floors 2 through 6, bedrooms are between Lines 1 and 2, between A and B, and between Lines C and D. The kitchens are located back-to-back between Lines B and B.5 and between Lines B.3 and C.

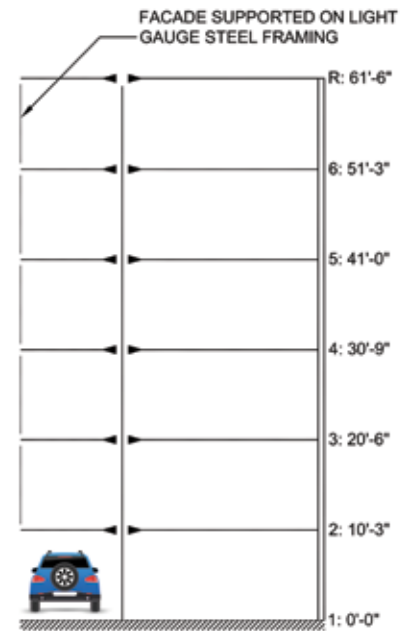
Figure 3b. Structural section of building.

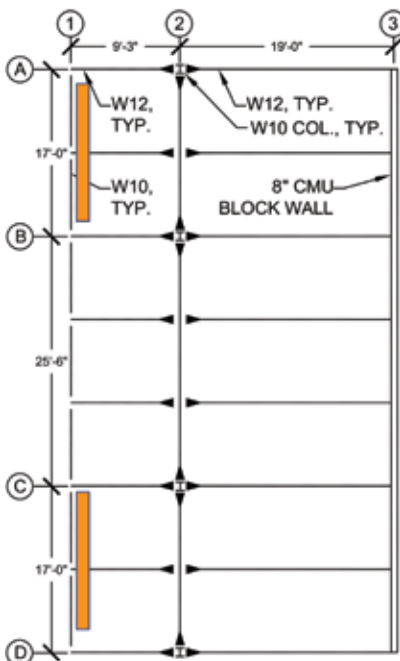
Figure 4a. Localized line load at exterior.

Although several loading scenarios may occur, they are not included in building codes. For example, in *Figures 4a* and *4b*, fully loaded 6-foot-tall bookshelves can be placed very close to the tips of the cantilevered steel beams. The bookshelves may be placed in various patterns both in plan and elevation. Their line loads can be significant, perhaps on the order of 72 lbs/ft.

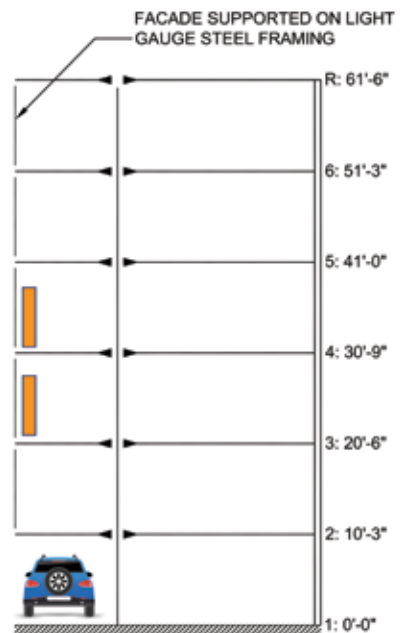
Figure 4b. Structural section of building.

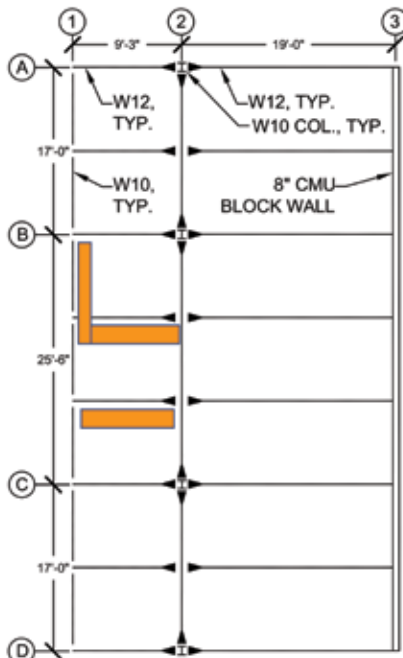
Figure 5a. Localized interior line load.

In another example in *Figures 5a* and *5b* (page 16), the kitchens are (over)loaded with heavy pots, pans, and equipment. Again, the loading patterns in plan and elevation may differ from kitchen to kitchen. The loads adversely affect the deflections of the cantilevers and result in differential deflections being imposed on the façade material and the glazing in the façades on Lines A and D.

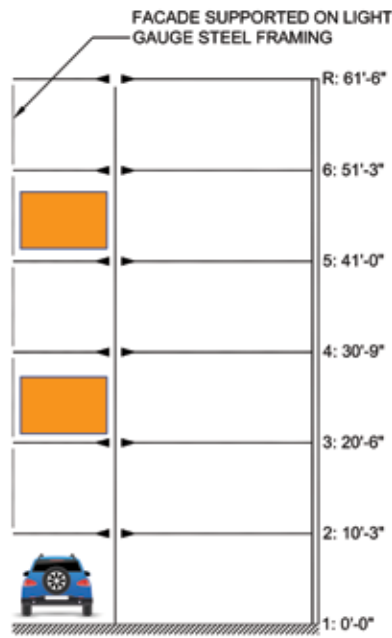
Figure 5b. Structural section of building.

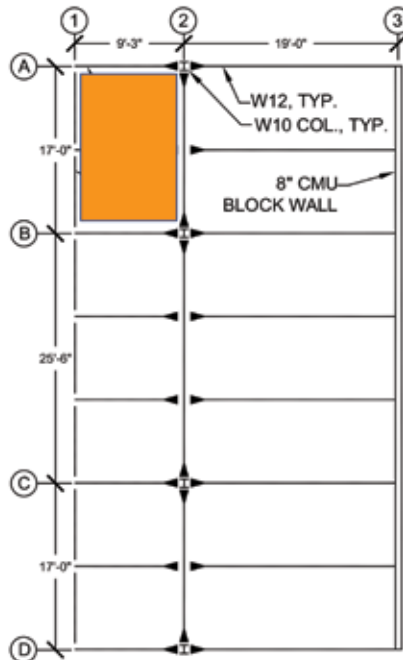
Figure 6a. Localized heavy area live load.

In a third example, an occupant may decide to have a dance party in one of their unit’s bedrooms (*Figure 6a*). The vibration adversely affects their floors and the others that are “ganged” to it through the light gauge steel framing behind the façade (*Figure 6b*). Again, the loads adversely affect the deflections of the cantilevers and result in differential deflections being imposed on the façade material and the glazing in the façades on Lines A and D.

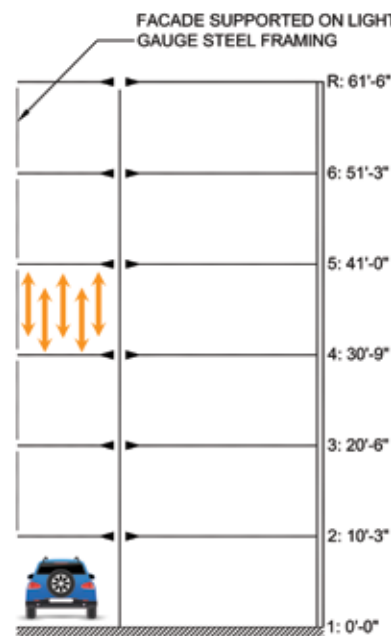
Figure 6b. Structural section of building.
