# ELEVATING HISTORY

## AT PIER 70

By Robert Graff, S.E.,  
Damian Gronsky, P.E., and  
John Leventini, P.E.

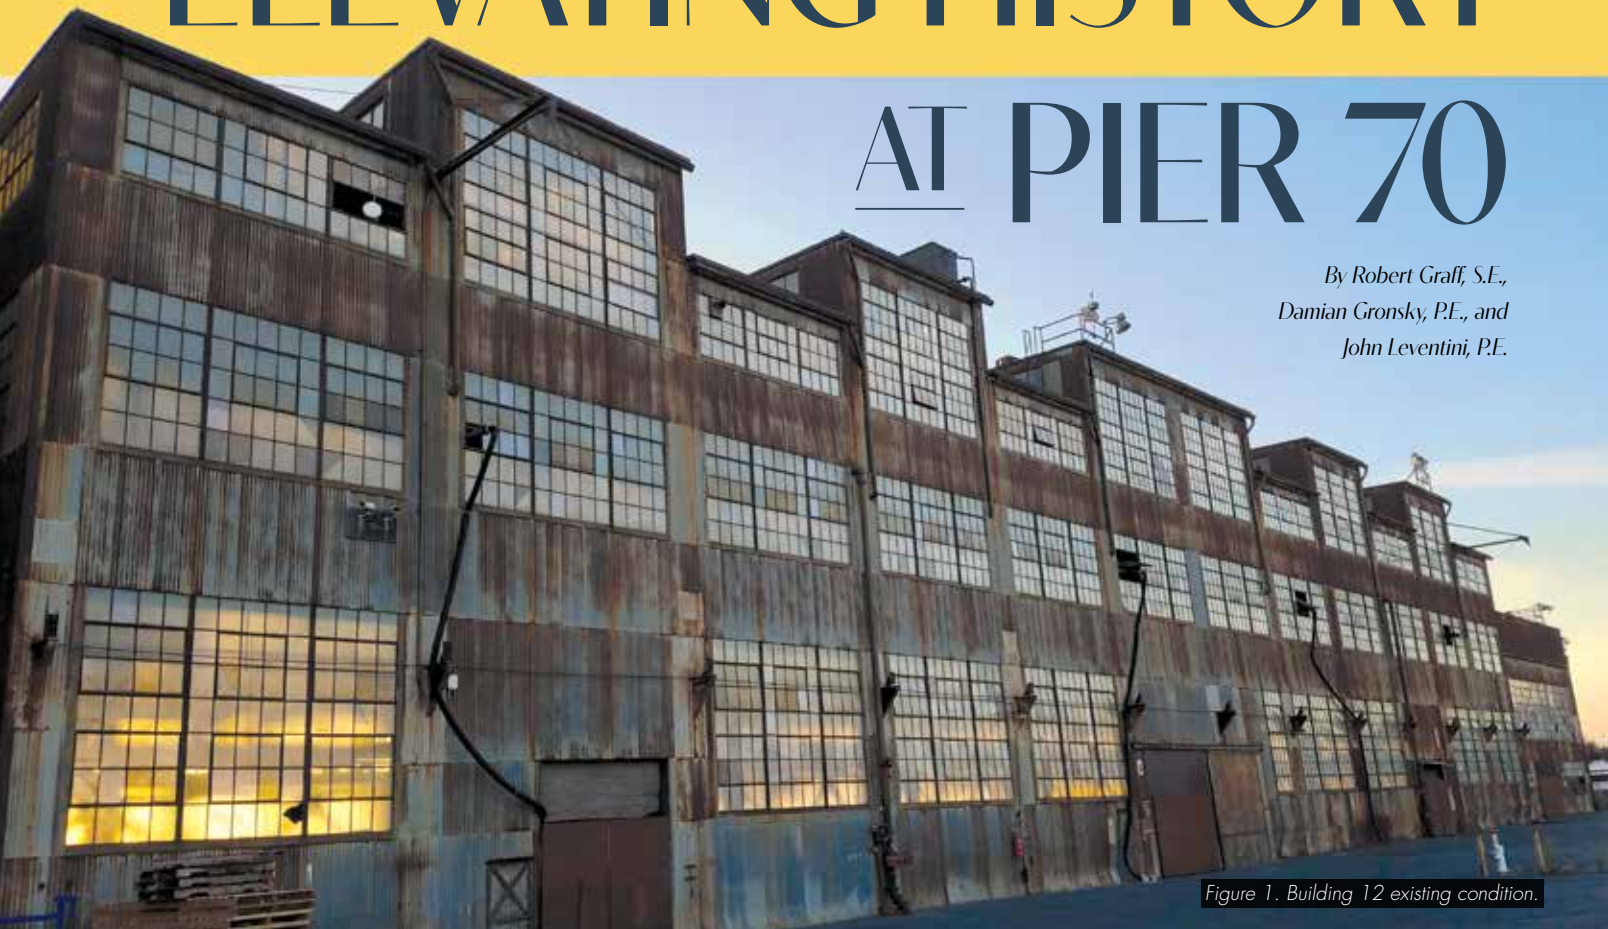
Figure 1. Building 12 existing condition.

Building 12 at Pier 70 in San Francisco has a long history that continues evolving. The building was originally constructed in 1941 and was used by Bethlehem Steel for shipbuilding in World War II. The building continued to be utilized for the construction of ships after the war and later was used to build the Bay Area Rapid Transit (BART) tunnels that cross under the San Francisco Bay. Unfortunately, in the recent past, the building has been essentially abandoned and fallen into disrepair until this project came to rescue it (Figure 1).

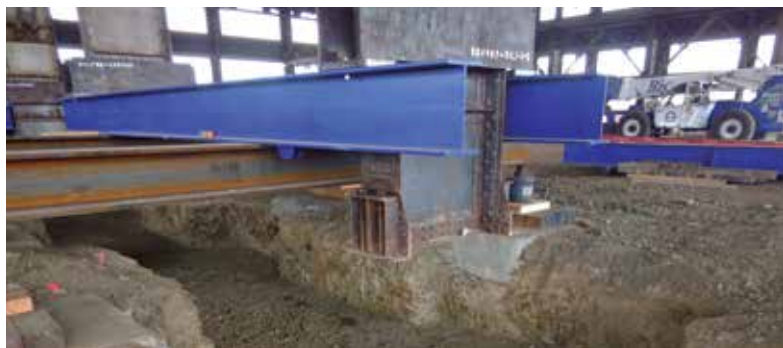
Figure 2. Initial lift with new foundations excavated.

The initial lift took the load off the existing building foundations and brought the building up approximately one-half inch. This allowed for the demolition of the existing building foundations and

placement of the new foundations and grade beams. It also kept the building relatively low to the ground, significantly reducing the shoring system's overturning loads (Figure 2).

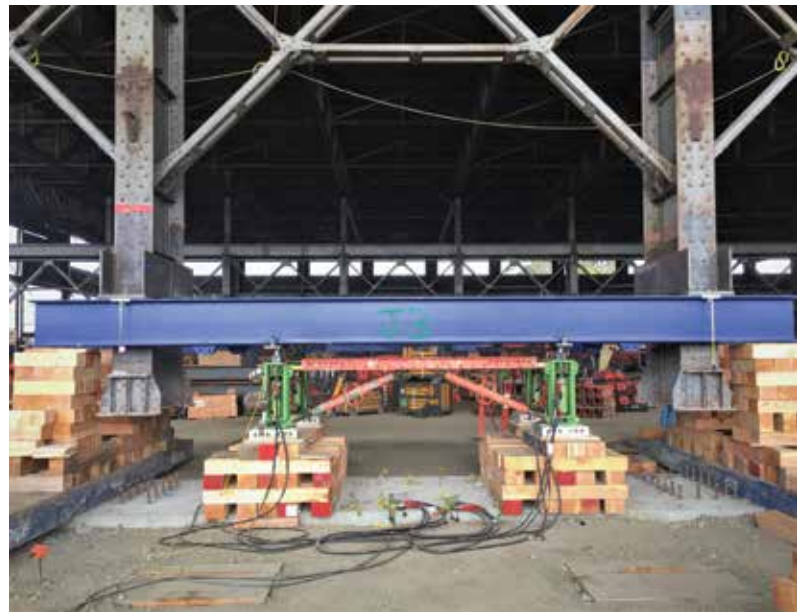
Figure 3. Partial lift shoring.

With the new foundations in place, the main lift could occur. First, the shoring/jacking system was installed under the shoring/jacking beams and pushed off the new foundations. The lifting operation proceeded in a rhythmic fashion: the jacks extended to raise the building just enough to install a new 5.5-inch layer of cribbing material at the ends of the jacking beams, then retracted the center jacks to set the building down to allow for the installation of another layer of cribbing under the center jacks (*Figure 3, page 43*).

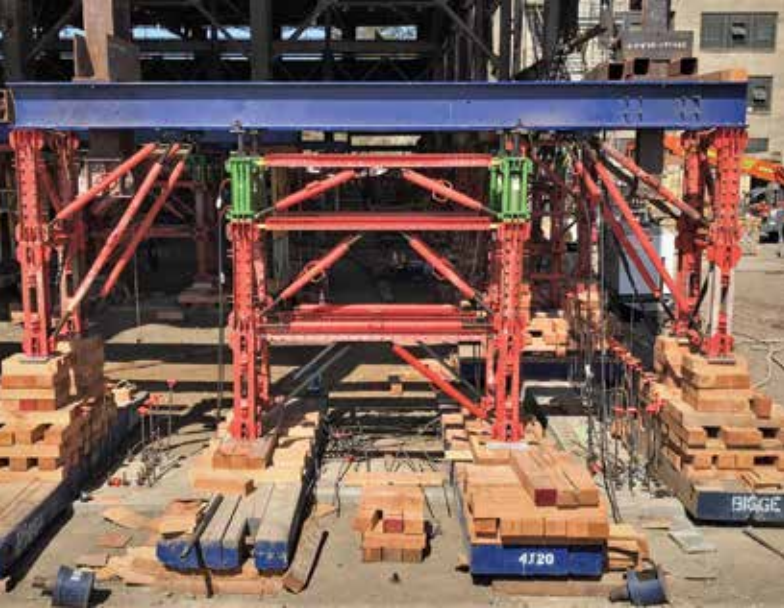
Figure 4. Full lift shoring.

This process continued until the wood cribbing stacks became tall enough to be replaced with new steel shoring 'modules' (*Figure 4*). Then, the process continued in a similar rhythmic fashion until the building was lifted to 11 feet above its original elevation. Throughout the process, immense manpower was needed to install wood cribbing, monitor control points, and install shoring modules at all 66 column locations.

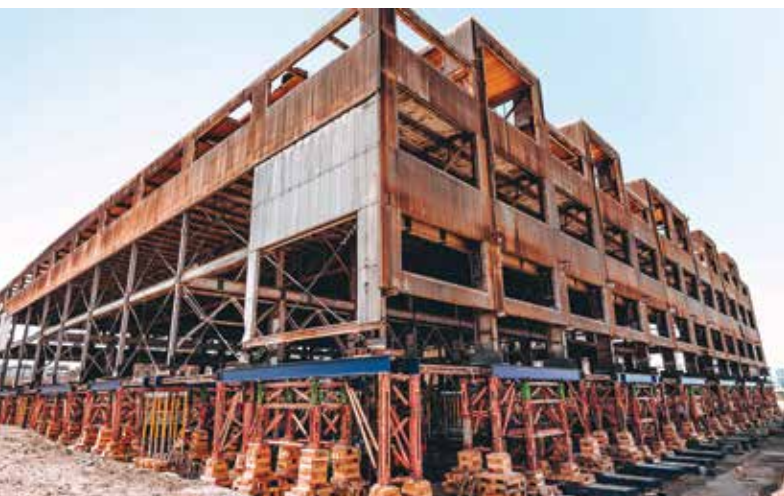
Figure 5. Building after the main lift.

With the main lift complete (*Figure 5*), the new steel building columns could be installed below the existing columns. The columns' splices were welded at the smaller wide flange columns and bolted up to the truss-supporting columns. The bolted connections preserved the original base plate connections so they could be exposed in the finished building. Because the lifting system is a costly rented item and hinders finishing construction, it was requested to determine if the shoring system could be removed once the column extensions were in place but without the first floor constructed. In this condition, the building columns would be two stories tall and only be braced in one direction by the cable bracing. The columns were checked and found to be adequate for the temporary condition (*Figure 6*).

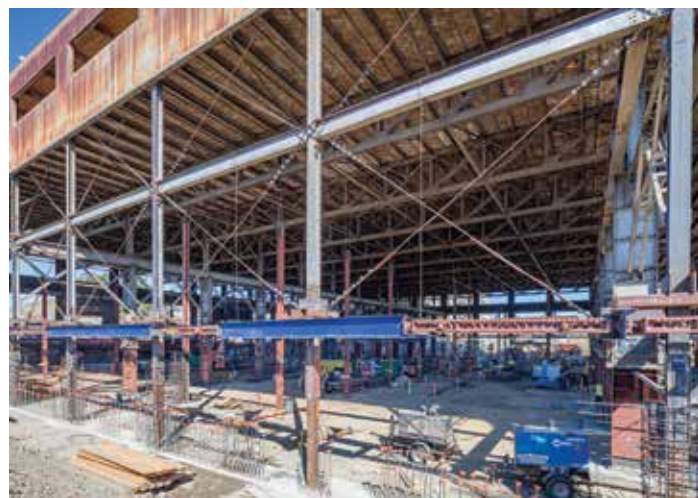
Figure 6. Shoring removed – the blue lifting beams and cable bracing remain.

Without the internally braced shoring modules, lateral wind loads were a significant concern. Therefore, a few negotiated basement walls were cast early to provide adequate temporary lateral resistance. In addition, the lifting beams remained to collect and deliver the lateral loads from the building above to the individual walls below. Once the new basement walls were cast and the new first-floor diaphragm was in place, the building was stable again, and the remaining shoring and bracing were removed.
