PERFORMING AT HIGH ALTITUDES

By DIANA GONZALEZ, EIT

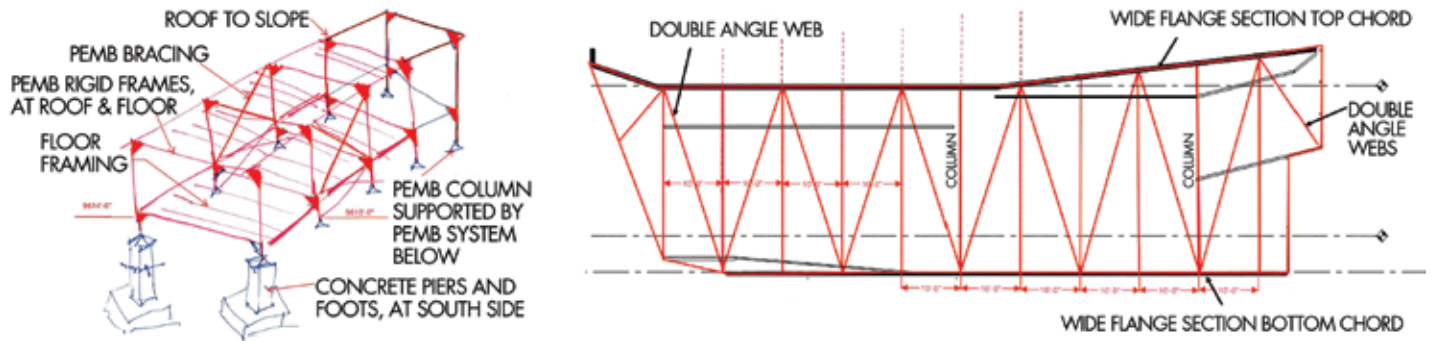
Figure 3. The structural design team explored various framing options for the Jewel Box, including a truss system and PEMB framing.

In its initial concept, the Jewel Box was framed as a truss, independent from the rest of the structure. The truss design, however, became expensive and cumbersome as it was challenging to coordinate the truss webs with the floor plan. The budget constraints associated with the initial truss design led to the next solution – a pre-engineered metal building (PEMB). However, the Jewel Box's extensive cantilevers and sloped geometry made the PEMB inefficient.

The Jewel Box was ultimately framed with conventional steel (Figure 3), and the team achieved cost savings in the project by having the gym and the weight room constructed as a PEMB. This hybrid framing system worked creatively to deliver on the program requirements and the unique, high-performance spaces within the athletic center. An innovative hybrid of PEMB and conventional framing provided a world-class design in a manner that delivered on budget but did not compromise the overall architectural design and high-performance needs (Figure 4, page 36). In addition, the creative use of the exterior paneling and curtain walls ensured building continuity, elevated these otherwise conventional systems, and provided a cohesive look and design.

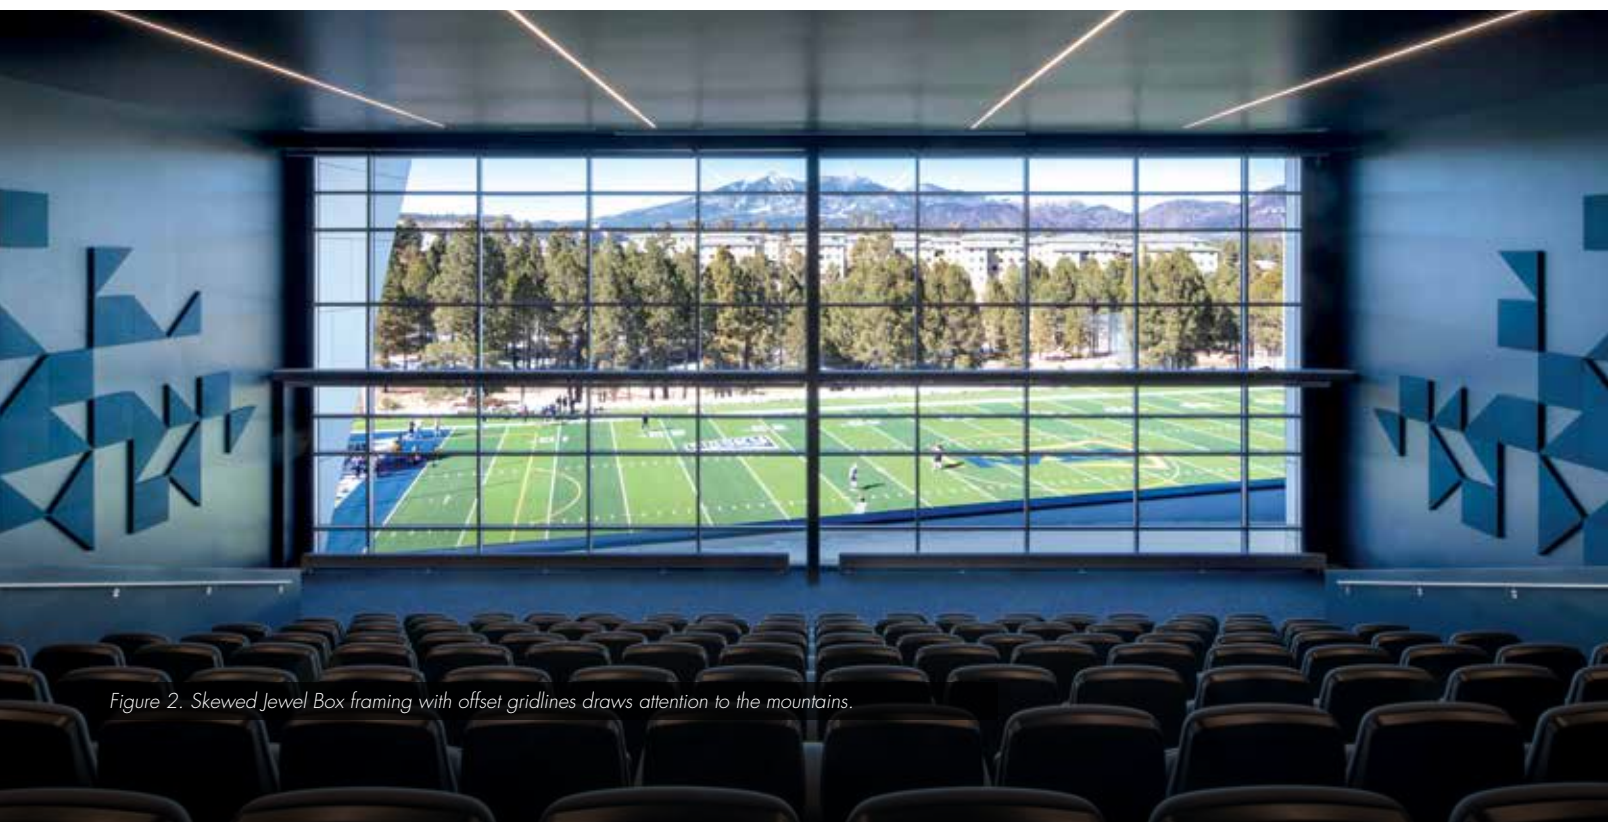
Figure 2. Skewed Jewel Box framing with offset gridlines draws attention to the mountains.

Incorporating high-performance features and honoring the environment demanded creativity in the structural design of the athletic center. For example, to achieve unobstructed views of Humphrey's Peak, the orientation of the third-level auditorium and hall of fame, referred to as the *Jewel Box*, was strategically rotated 15 degrees (Figure 2). The rotation, causing geometric and cost challenges to the structure and design, required the design team to explore multiple framing options.

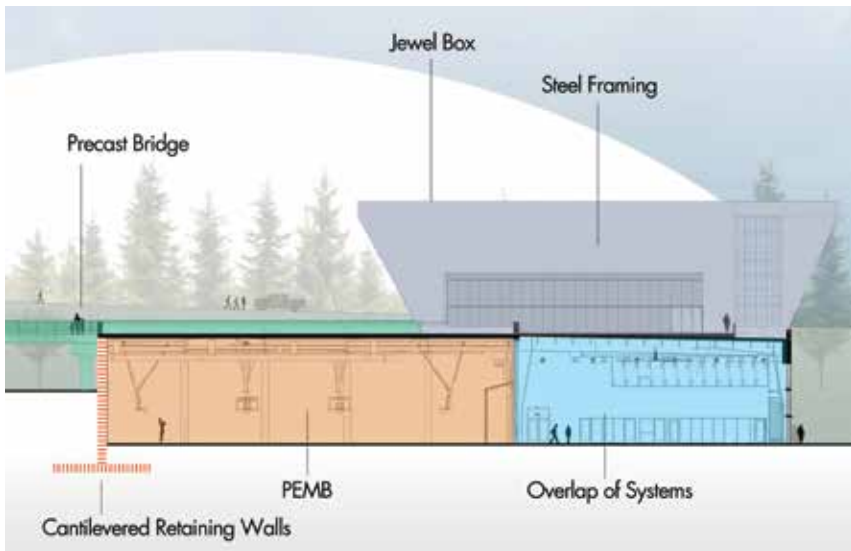
Figure 4. An innovative hybrid of PEMB and conventional framing delivered a world-class design.

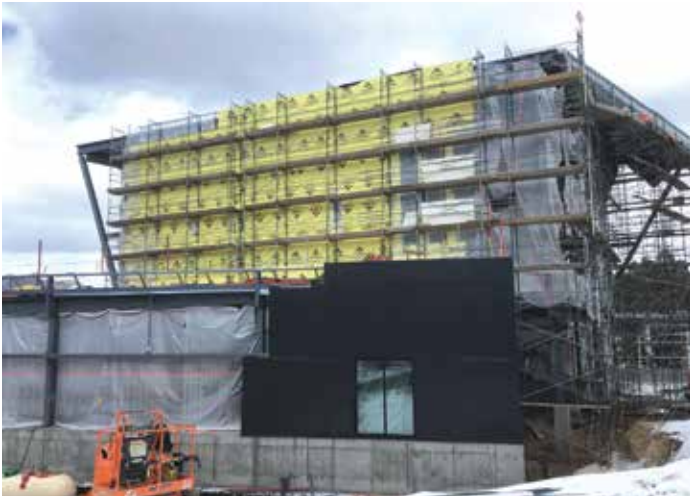
Figure 5. The structural team coordinated multiple systems and unique deflections while maintaining a cohesive design.

The success was largely attributed to an amplified focus on performance criteria. An example of this can be seen in the connections of the wall paneling system. The structural team coordinated the expected 0.07-inch deflection of the 12-foot cantilevered retaining walls with the connection requirements of the 2½-inch insulated wall panels and the expected ¾-inch drift of the steel building superstructure.

The steel columns were placed 1 inch from the retaining wall, and custom wind girt connections were designed for the metal wall panels. HSS wind girts were placed at 8-foot vertical increments – coinciding with the height of the insulated metal wall panels. The custom connection from the HSS wind girts to the panels resulted in an easy installation anchor point for the contractor. The connection of these different systems, each designed by different parties under the guidance of the structural team, created an urgent need for constant communication to anticipate and resolve any constructability issues and ensure the performance criteria were met (Figure 5, page 36).

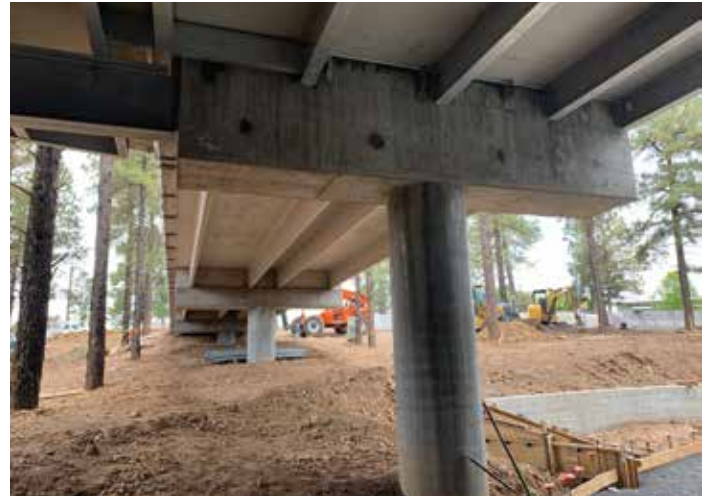
Figure 6. Bridge connected pedestrians to nature while reducing cost and preserving trees.

Using the 138-foot-long pedestrian bridge as a design solution provided massive cost savings and schedule benefits (Figure 6). The

retaining wall height was reduced to 15 feet, leaving the existing grade vastly undisturbed, gaining daylight at the second floor, and keeping the mature ponderosas in place. Furthermore, a precast patio, benches, and donor monument signs were added to the 20-foot-wide pedestrian bridge, promoting a mall concept where athletes, faculty, and staff could gather before an event. Originally a challenge, access to the third floor has now become a design feature that allows visitors to walk through the trees as they approach the building (Figure 7).

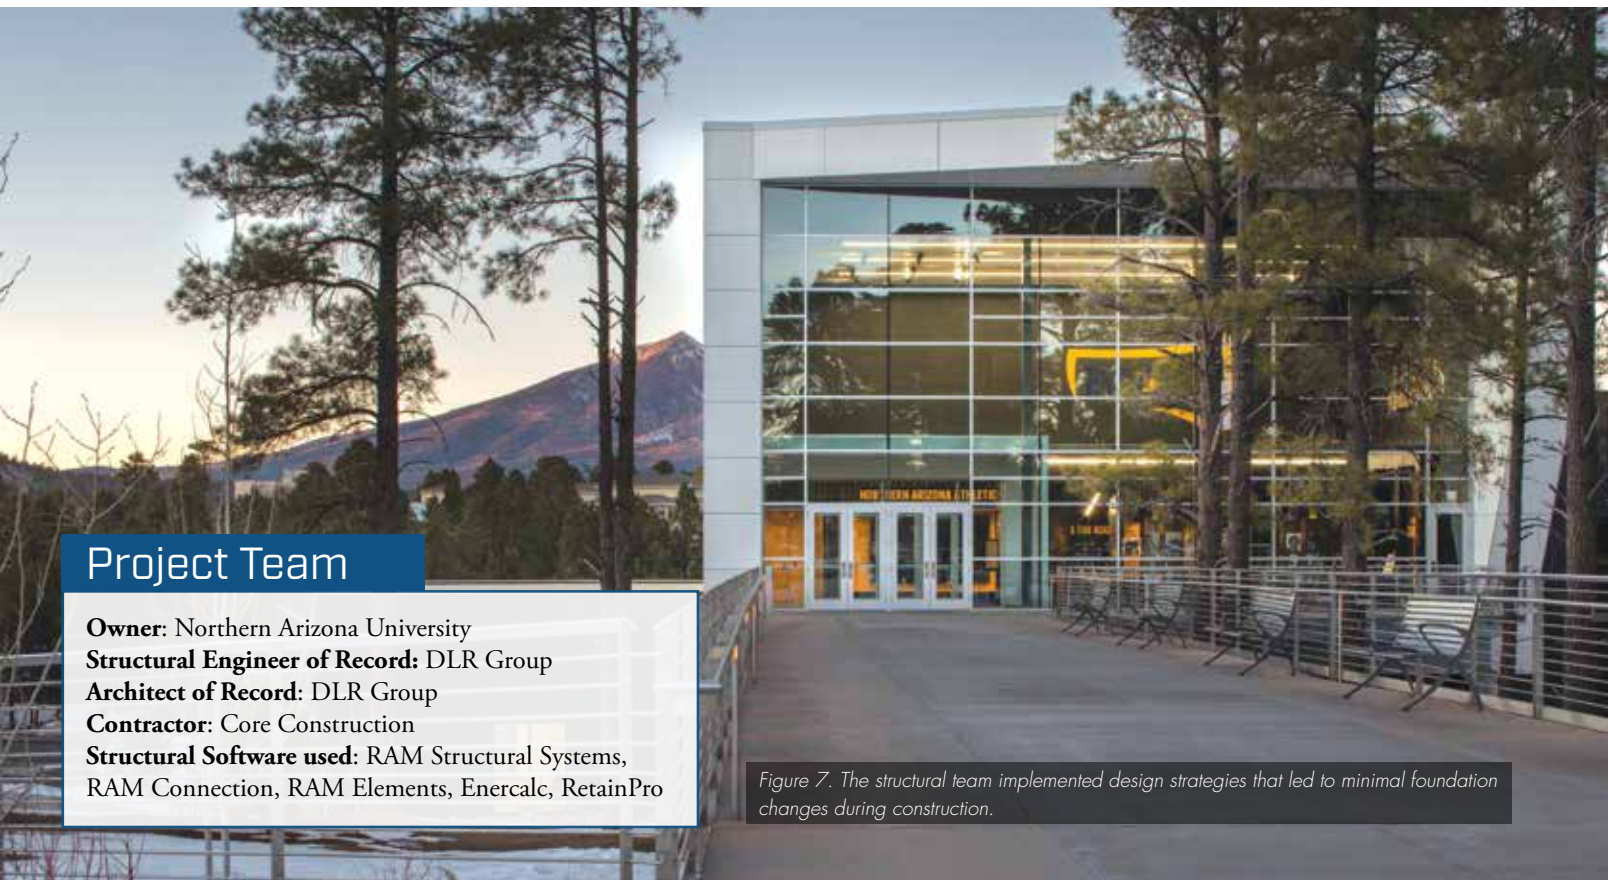
Figure 7. The structural team implemented design strategies that led to minimal foundation changes during construction.

Addressing these concerns, the structural team worked with the architects to lock down grid locations and loading early. The team increased all initial reactions by 20% and limited foundations to a 50% design/capacity ratio. The resulting combination of these two strategies led to minimal changes to the foundations during construction once the final reactions were computed and backchecked against the existing footing design. Any changes that did occur during construction were more efficiently managed and overcome due to this foresight.
