Modeling of Historic Structures

Simulation-Based Structural Analysis of Fort Sumter Considering Foundation Settlement

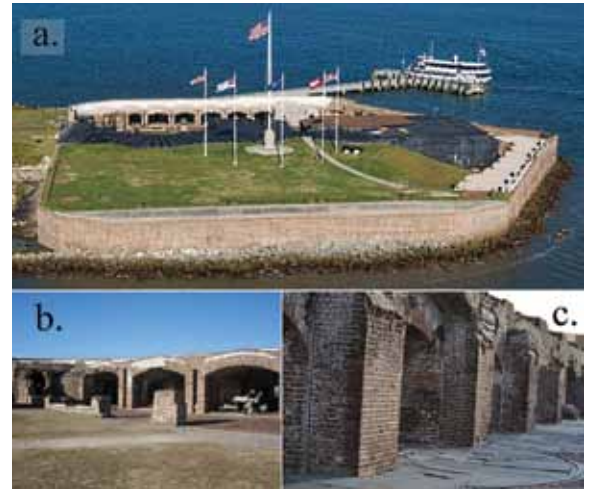
Figure 1: The current state of Fort Sumter National Monument: (a) aerial view, (b) barrel vaulted casemates, and (c) degradation of brick and mortar piers.

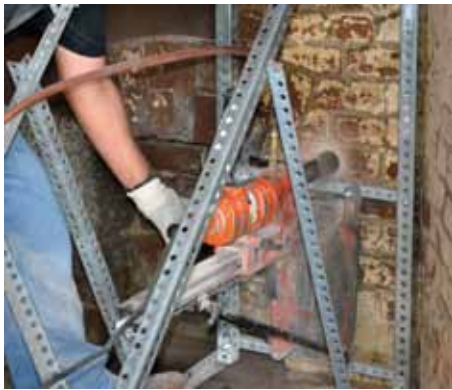
Figure 2: Coring of material samples revealed that although the construction drawings indicate a brick wall across the width, the construction of the fort is composite with tabby concrete infill.

During our studies on Fort Sumter, a prism sample along with 2.5-inch diameter cored samples were obtained on site (Figure 2, page 28). The compressive strength and modulus of elasticity were determined according to ASTM standard tests parallel and perpendicular to the mortar bed joints. The tensile strengths of the brick and mortar samples are determined via three-point flexural tests. The tensile capacity
