STRUCTURAL DESIGN

Brick Curtainwall for Essential Buildings

By John G. Tawressey S.E., F.TMS, F. SEI

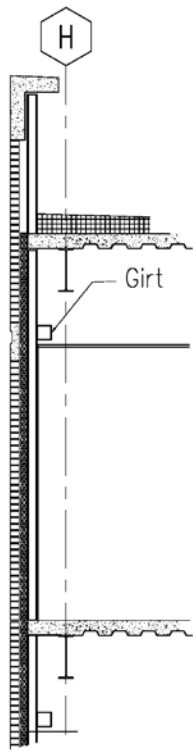
Figure 1. Girt system.

changing to another curtainwall material. But, the owner was set on brick. Could we use thin brick set in 7½-inch precast panels and forget about the cavity? This was rejected because of the weight impact on the seismic design and the appearance, which usually does not look natural, not to mention the loss of the 2 inches of insulation. We could also add a horizontal girt system below the floor at the ceiling level to reduce the span. This last option, while adding significant cost, was the selected solution and solves the deflection issue (Figure 1).

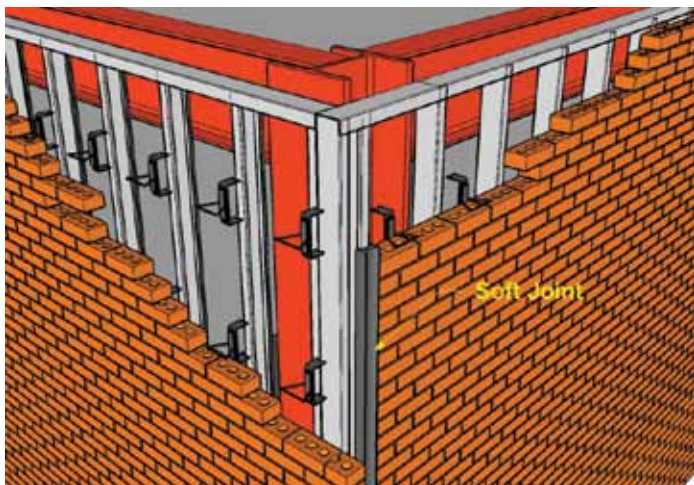
Figure 2. Soft joint corner.

A suggestion was made to provide a control joint at the corner. This is a common solution. Architects hate the wide joints required, but sometimes accept them. The width of the joint would need to be 1½ inches or wider to allow for construction tolerances. Additionally, the joint would need to be close to the corner to minimize the stiffness of the return brick. The “eliminate the corner” option worked and sketches were prepared (Figure 2).

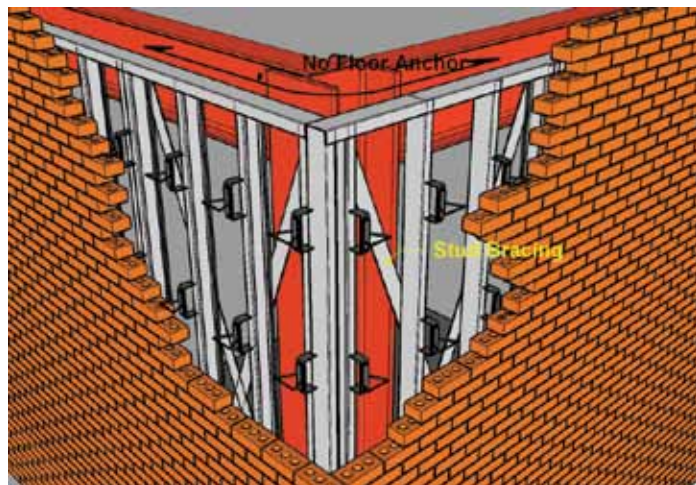
Figure 3. Isolated veneer backing.

Another engineer suggested isolating the backup stud wall system. This would require a detailed design of the stud wall. Bracing would be required and the stud-head-track would be designed not to attach to the floor above at the corner. This would also reduce damages to the interior finishes and the brick could be detailed as the conventional veneer (Figure 3).

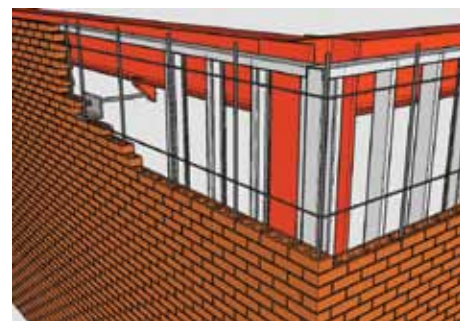
Figure 4. Reinforced veneer.

The author suggested reinforcing the veneer as a possible solution. This concept would replace the ties with floor and girt connectors. The reinforced structural masonry would span to the connectors. Connectors could be placed a distance from the corners, allowing the deflection to occur by warping of the wall [like a curtainwall]. The savings from the elimination of the ties [stainless steel was contemplated] equaled or exceeded the added cost of grout and reinforcement. But, past experience with owners, contractors and architects was mixed. The concept of warping brick corners was difficult to explain. Moreover, some of our own SE’s doubted it would work. Brick is a brittle material.

Despite the doubt, a reinforced veneer is added as a solution along with a fee proposal (Figure 4).
