STRUCTURAL FORENSICS

Decayed Wood Structures

Reconstructing a History of Impairment

By Lee Dunham, P.E., S.E.

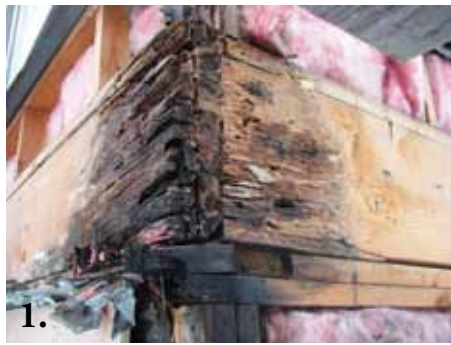
1.

“The Hidden Menace”. Advanced brown rot decay in wood framing members in Pacific Northwest buildings; 1 – despite their appearance as rim joists, these are actually double 2x12 beams bearing at a corner post in a multi-family residential building; 2 – impaired elevated walkway beam, rim and studs; 3 – glulam header with advanced decay and structural impairment at right side bearing; 4 – double 2x10 rim with full section loss below a low-slope roof in a single family residence.

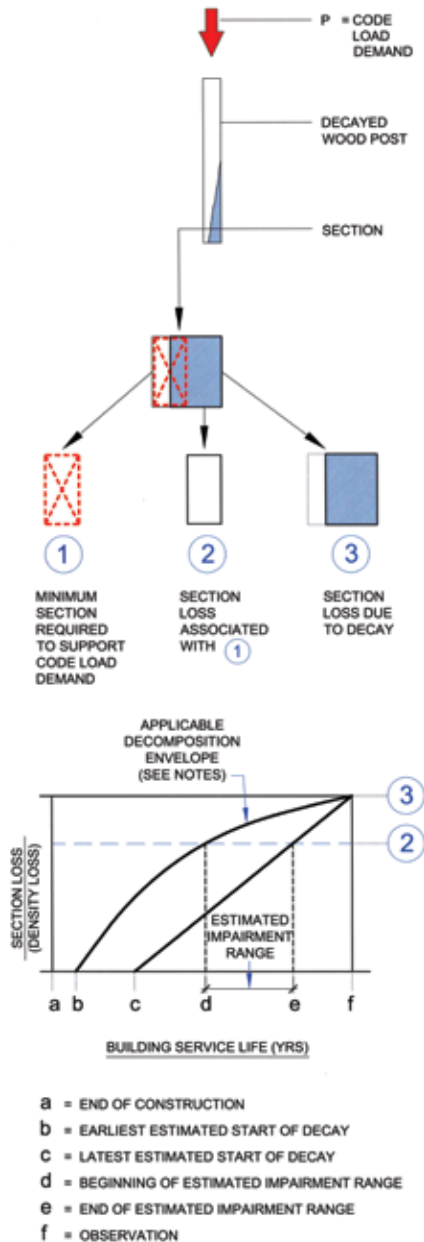
Figure 1: Impairment range example (illustrative only).

For each member affected by decay, measure the section loss at the time of observation. As described in *Figure 1*, next calculate the section loss that corresponds to the point at which the member's load carrying capacity becomes impaired. Then plot the impaired section loss relative to the observed loss on a graph. Superimposing this on the estimated decay envelope, determine the points in time when the impairment threshold intersects the upper and lower bounds of the decomposition envelope. This gives a range of years – the impairment range – for each member. Repeating this exercise for other affected members in the structure provides a group of impairment ranges. If the sample is representative of the different types of structural damage documented at the building, so too is the set of impairment ranges.

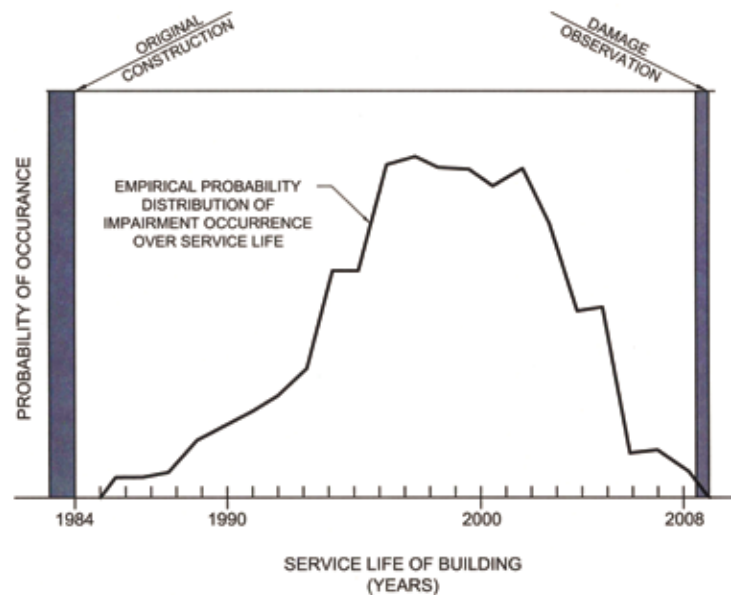
Figure 2: Empirical probability distribution of impairment over service life.

Step 2 results in a set of ranges that represent likely time frames for various members to have entered a state of impairment. Plotting all the impairment ranges on a graph provides a relative frequency distribution of impairment over the service life of the building. With a straightforward mathematical calculation, this frequency distribution can be converted to an empirical probability distribution. These plots can then be used to estimate the percentage of structural impairment in any period of interest throughout the service life of the building.

Figure 2 is the result of analyses performed on a series of wood framed buildings in Seattle, based on the methodology summarized in this article. The author collaborated with Professor Robert Edmonds, Emeritus Professor and wood decay expert at the University of Washington, to model the decay envelope applicable to these buildings. The buildings were constructed in the mid-1980s; observation of decay damage was documented during a 2008 re-clad. Building enclosure conditions permitting long-term water intrusion (such as failed sealant joints) were documented. Known areas of past framing repairs were used as a check on the decomposition envelope. The total area under the curve represents 100% of the impaired framing members. When long term decay meets a range of residual capacity, there is a smaller percentage of members entering a state of impairment in the early and later years, and a larger percentage in the middle years.
