# STRUCTURAL PERFORMANCE

## Post-Fire Analysis of Solid-Sawn Heavy Timber Beams

By Robert H. White, Ph.D. and Frank E. Woeste, P.E., Ph.D.

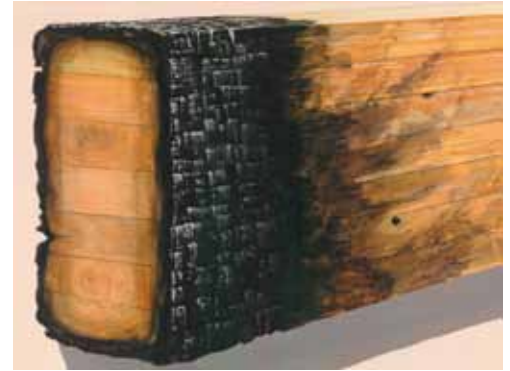
*Figure 1: The evaluation of a glued laminated timber or other structural composite lumber will require considerations of factors beyond those discussed in this article.*

After fire exposure, design professionals are sometimes called upon to determine if the charred heavy timbers (*Figure 1*) are safe for future use without additional support or repairs. In this article, the authors present a sequence of reasoned steps that will help design professionals analyze charred timbers and gain the type of information needed to decide whether the charred timbers are adequate based on the applicable building code.

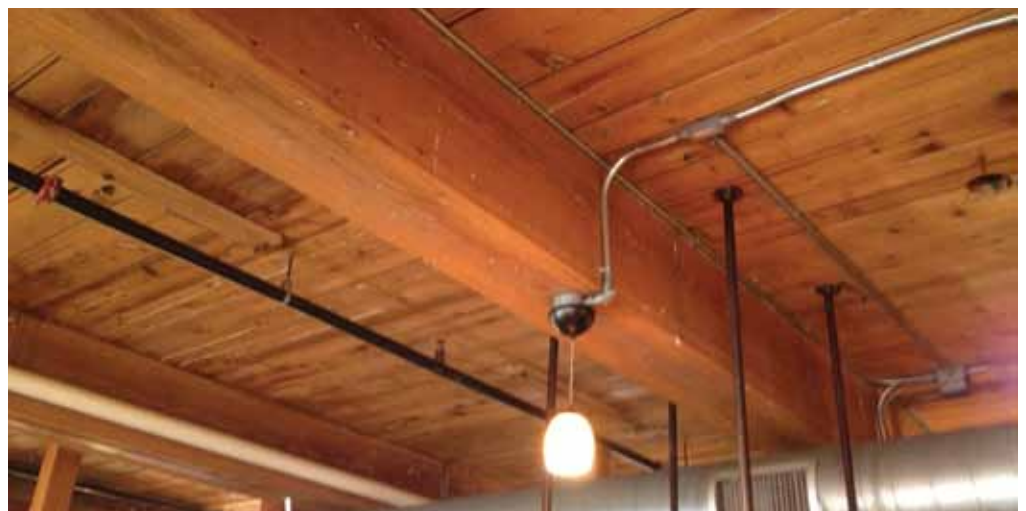
*Figure 2: Large timber ceiling beam in renovated 1850 textile mill.*

What follows is a series of recommended steps for analysis of charred timbers. This approach should allow a registered design professional to determine the adequacy of post-fire timbers to carry structural loads. For example, *Figure 2* shows a beam in a renovated textile mill that was constructed in 1850. The timbers are valuable and replacement would be extremely costly in the event of a fire event. Replacement of timbers may not be an economical option, thus an in-depth structural engineering analysis, post-fire timber evaluation, and code-conforming re-design could establish that the timbers could be saved for future use.

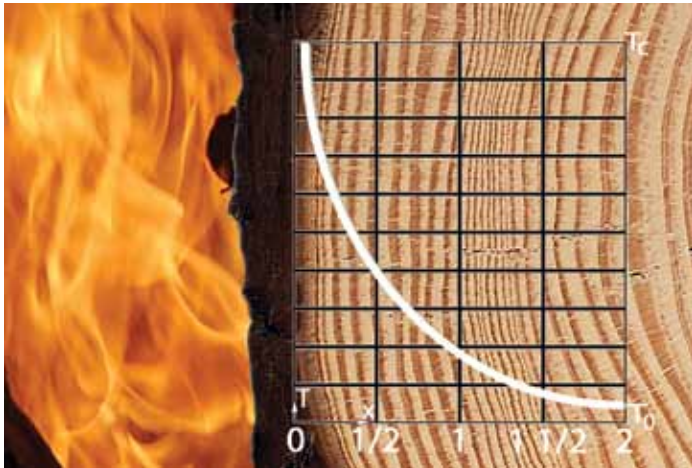
Figure 3: Illustration of temperature gradient in fire-exposed wood member.

Since wood is an insulator, the temperature gradient in the cross-section is typically fairly steep during a fully developed fire (Figure 3). In heavy timbers subjected to fire exposure of the standard fire resistance test (ASTM E119), the 212°F temperature location (or front) will be approximately 0.5 inch inward from the base of the char layer after the first 15 or 20 minutes of fire exposure. In an actual fire, the temperature profile within the wood section will depend on the severity and duration of the fire exposure and post-fire exposure. One

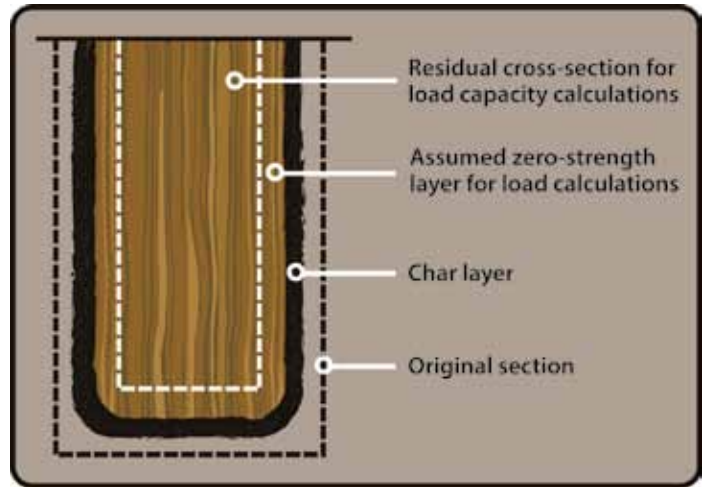
Figure 4: Illustration of zero-strength layer model of fire-damaged wood beam.

can account for additional thermal damage to uncharred wood in the load capacity calculations by including a zero-strength layer in the dimensions of the residual cross section (Figure 4).
