THE TRANSFORMATION OF THE HISTORIC FIRST NATIONAL STATE BANK BUILDING

Newark New Jersey – Part 2

By D. Matthew Stuart, P.E., S.E., FASCE, F.SEI, SECB, MgtEng
and Ed D. Cahan, P.E., S.E.

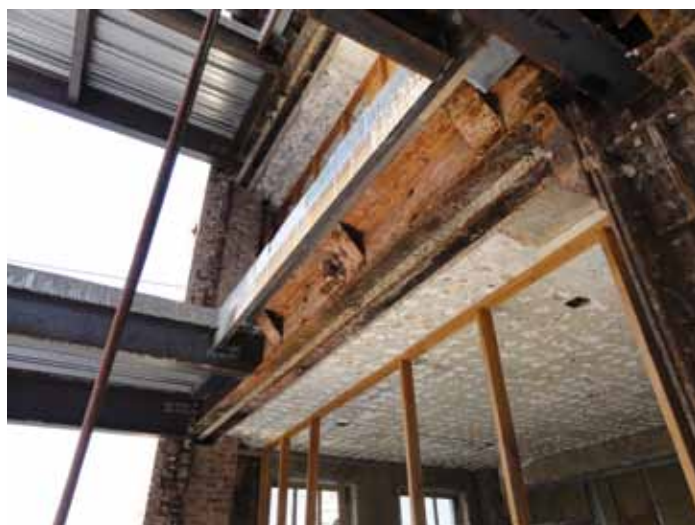
Figure 2: New tie-in conditions at existing spandrels.

Because the outer beam was primarily designed to support only the east exterior brick cladding that was being removed to allow for the addition, it was able to support the new beams of the stair tower without the need for reinforcement (*Figure 2*). Furthermore, the new net reaction at the columns supporting the outer beam of the double spandrel was approximately the same as the original condition. Transferring the lateral load of the stair tower addition into the lateral-load-resisting system of the existing mid-rise structure involved drilling horizontal epoxy dowels into the existing concrete slab at each level. Additionally, placing continuous reinforcing steel at the north and south ends of the addition, and doweling it into the adjacent existing concrete slab, created diaphragm chord members in the new slab.

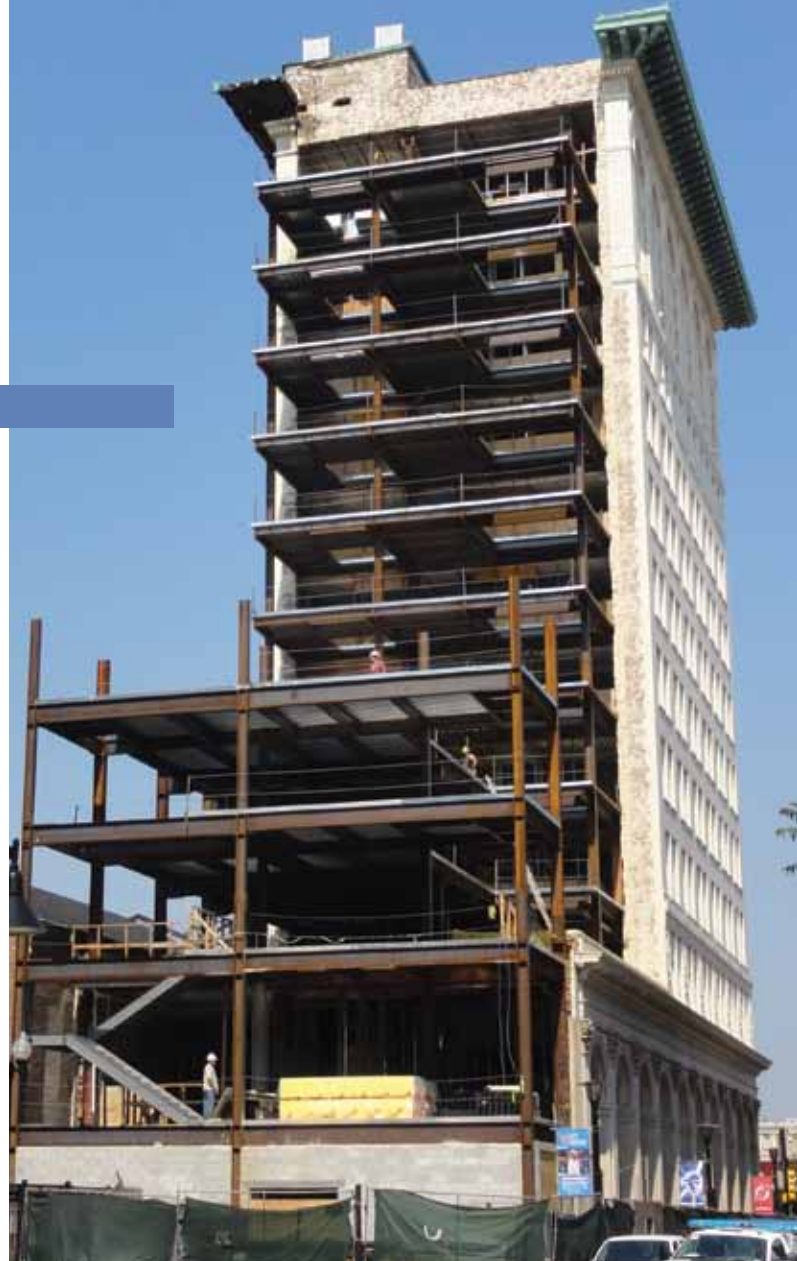
Figure 1: Partially erected stair and addition framing.

Pennoni's involvement with the adaptive reuse of an existing historic building included the development of several innovative structural solutions. Part 1 of this article (February 2014) provided a history of the building and the initial major renovation challenges (*Figure 1*). This article will discuss life safety improvements and enhancements to utilization of the 12th floor and roof spaces.

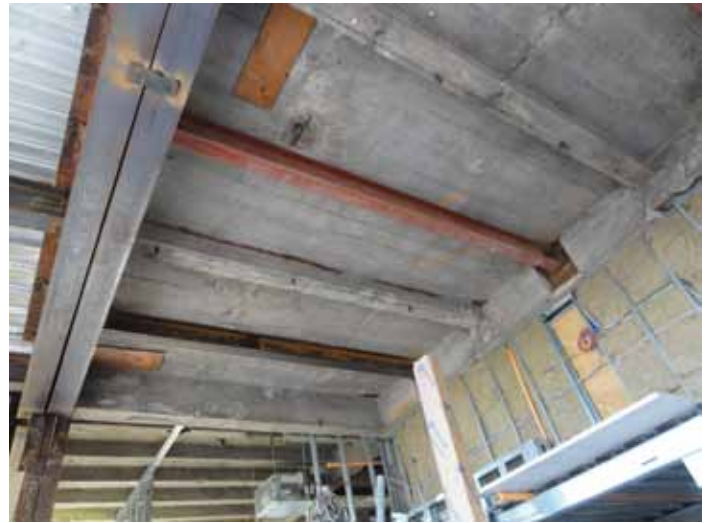
Figure 4: Existing beam and slab strengthening.

The existing roof beams spanning between girders would be overstressed as a result of the heavier loading associated with the new terrace. In order to prevent this, new steel roof beams were added between the existing ones in order to decrease the tributary width (Figure 4). The higher yield strength of the existing steel was taken into consideration, determined via coupon tests, as opposed to the strength provided by historical databases. An alternate method to reinforce the roof structure was to weld steel split T or WT sections to the underside of the existing beams and girders. However, this method was not used because of the excessive demolition that would have been required in order to remove a portion of the concrete encasement that provided fire protection for the existing beams.

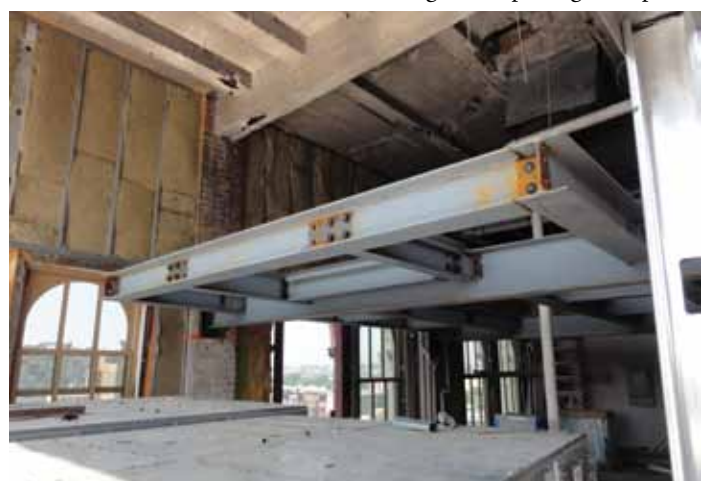
Figure 5: New 12th floor interior dunnage frame.
