THE PENNSYLVANIA STATE CAPITOL

By R. Scott Silvester, P.E.,
Christina T. Parker, P.E.
and Niklas W. Vigener, P.E.

Evaluating the Structural Performance of Unreinforced Monumental Masonry Structures

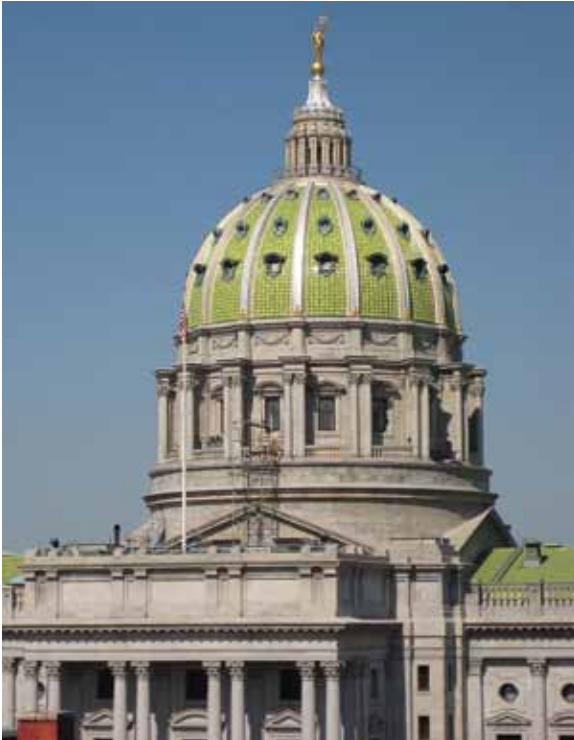
Figure 1: Pennsylvania State Capitol Building.

The Pennsylvania State Capitol Building (Figure 1) in Harrisburg, Pennsylvania, constructed circa 1906, is an example of a monumental masonry structure assessed using finite element techniques. The Capitol

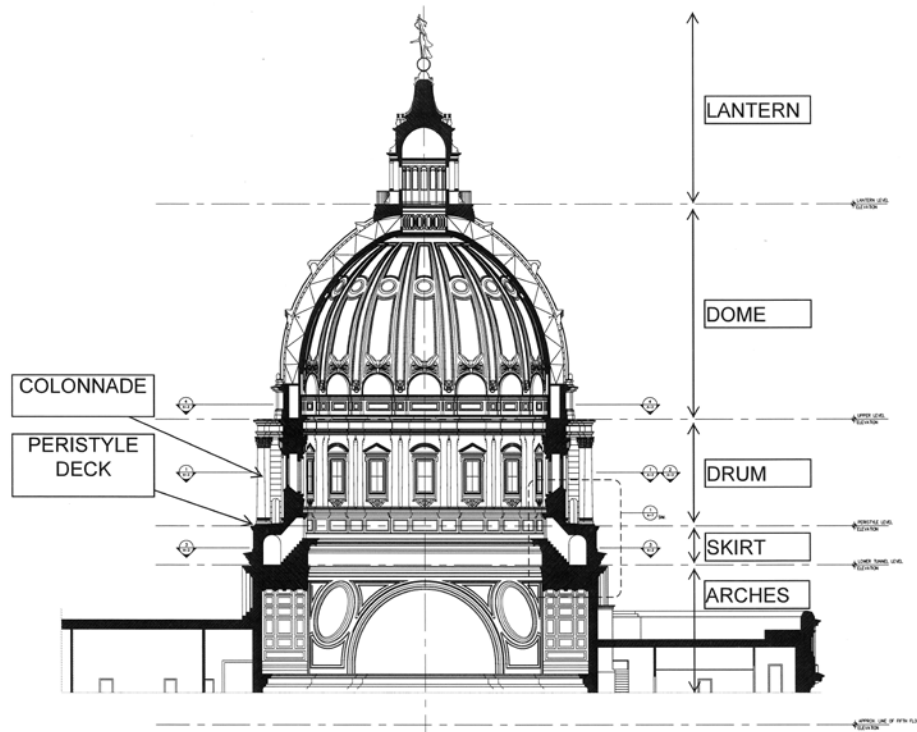
Figure 2: Central dome structure. Detail from drawing A-6: Restoration of the Peristyle Deck by Perfido Weiskopf Wagstaff & Goettel dated 2008 with annotations by SGH.

structure has complicated geometries with an upper drum and colonnaded peristyle, lower drum, and four supporting vaulted arches with intersecting pendentives (Figures 2 and 3). This unreinforced load-bearing masonry construction supports a truss framed dome, a colonnaded lantern, and a statue above. The lower drum contains a circumferential arched tunnel below the peristyle deck.

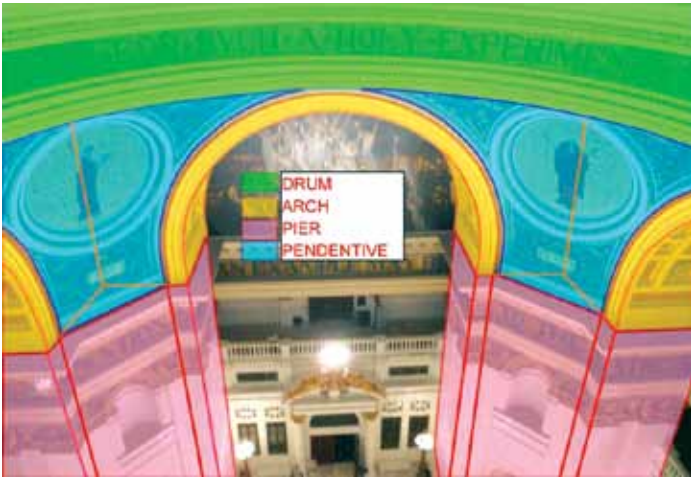
Figure 3: Computer enhanced image identifying components of central dome structure.

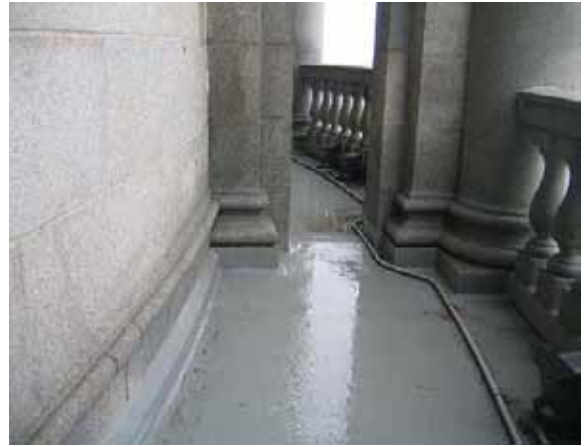
During work associated with restoration of the peristyle deck (Figure 4) to address leakage below the dome structure, the restoration team noted cracking and moisture-related deterioration of the brick and granite masonry drum below the deck. The State of Pennsylvania's Office of General Services, concerned about this distress, commissioned an engineering study to evaluate the structural performance of the brick masonry of the lower drum, including consideration of the observed masonry deterioration and cracks.

Figure 4: Peristyle deck above the lower drum.

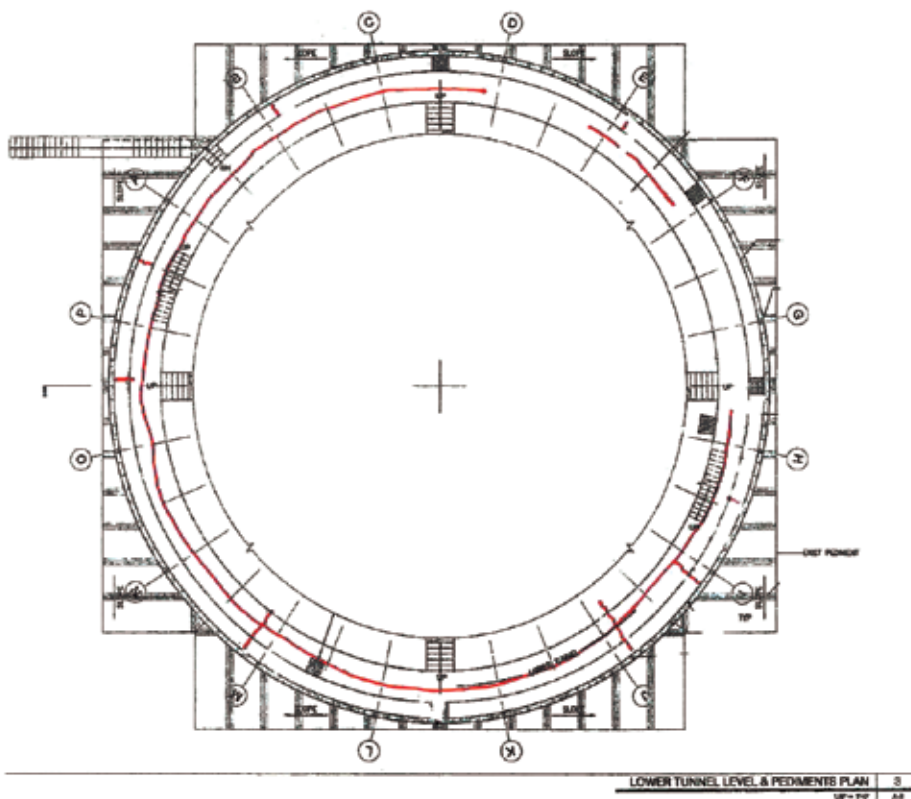
Figure 6: Crack survey in tunnel of lower drum.

The arch of the circumferential tunnel had a continuous crack at its crown and transverse cracks below the colonnades (Figure 6). Longitudinal cracks near the intersection of the exterior wall and tunnel floor were also observed. The systemic nature of longitudinal cracks appeared to relate to the outward thrust of the tunnel arch. The repetitive nature of the transverse cracks appeared more likely caused by the intrinsic stress pattern derived from the complicated, indeterminate configuration of the dome structure – perhaps a combination of flexural stresses from superimposed colonnades and hoop stresses. No cracks were found that were consistent with cracking due to differential settlement.

the stresses in the remaining competent masonry, cause further deformations of the lower drum, and increase the width of the circumferential cracks in the crown of the tunnel. Since moisture likely contributed to existing deterioration, it was prudent to continue a planned program of masonry repairs to protect the structure from moisture intrusion along with recommending future monitoring.

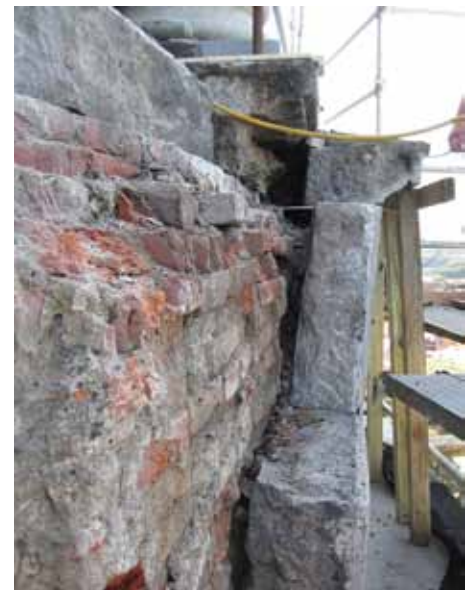
The Capitol structure had washed out mortar and deteriorated brick masonry behind granite ashlar cladding (Figure 7). Some delaminated masonry in the circumferential tunnel was associated with corrosion of embedded metal pipes.

Figure 7: Deteriorated masonry behind granite ashlar cladding at exterior of lower drum.

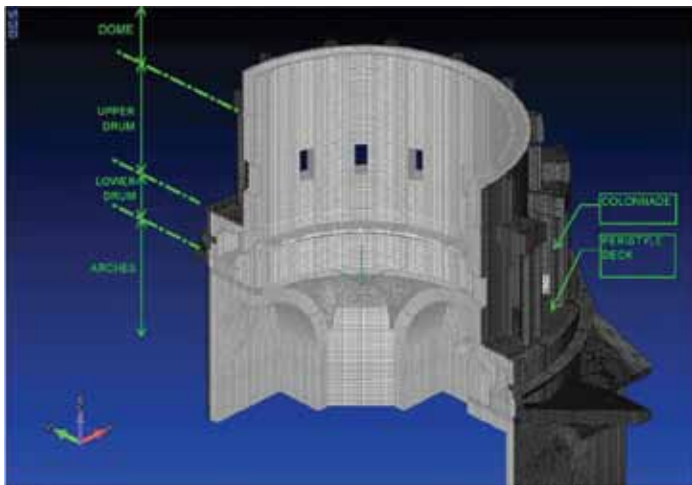
Figure 8: Finite element model of upper drum/lower drum/arches.

Once assumptions for geometry, material, and boundary conditions were established based on the two-dimensional models, a partial three-dimensional linear elastic model of half the axisymmetric structure was prepared, applying symmetry boundary conditions to represent the rest of the structure (Figure 8). Since obvious signs of settlement issues on the building were not evident, fixed boundary conditions were used at the bottom of the masonry arches.

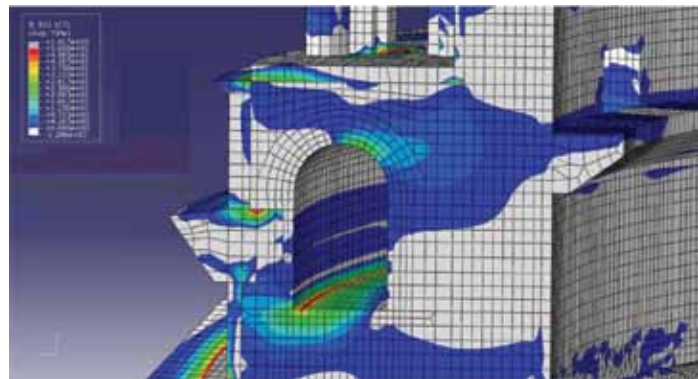
Figure 9: Radial tensile stress in lower drum.

The results of the analysis correlated well with the observed conditions of the masonry construction. Under gravity loads, the model showed tensile stresses that exceed tested capacities where there were cracks in the actual brick masonry (Figure 9). The results of the iterative analysis demonstrated redistribution of tensile and compressive stresses with reasonable magnitudes and continuity of load path through the masonry of the lower drum, even with cracks and deterioration. Consequently, the cracking and deterioration were not cause for concern about the structural integrity of the lower drum. Finite element analyses raised confidence levels in this conclusion.
