Bridge Service Life Extension Study

I-70 Blanchette Bridge Concrete Substructures

By Christopher A. Ligozio, S.E., P.E., Scott T. Wyatt, S.E., P.E. and Ernst H. Petzold, P.E.

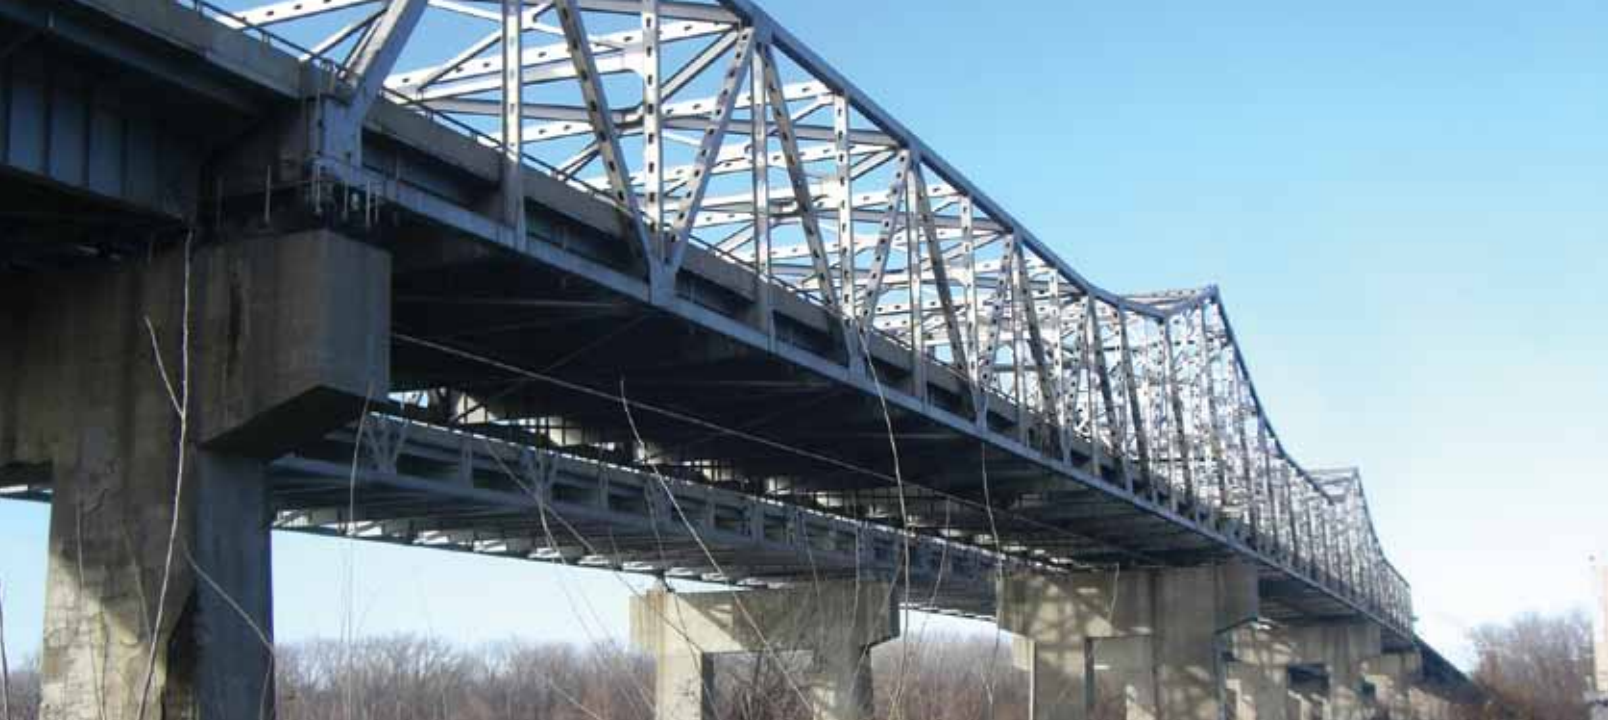
Figure 1: I-70 Blanchette Bridge.

The 4,083-foot long, westbound I-70 Blanchette Bridge (*Figure 1*), consists of 23 steel girder and truss spans, supported on reinforced concrete piers. The structure was originally constructed in 1958 and underwent a significant rehabilitation in the 1980s, including deck replacement, substructure repairs, and strengthening. The bridge presently carries 70,000 vehicles daily.

The reinforced concrete piers are comprised of a cap beam supported on two columns. Pier geometry varies along the length of the bridge.

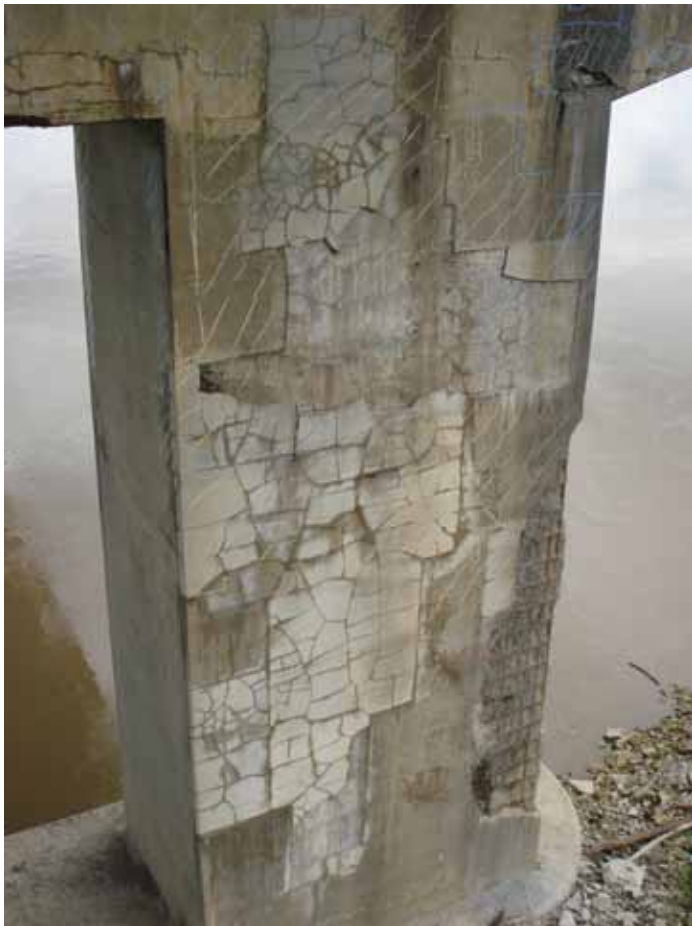
Figure 2: Pier Deterioration beneath deck joint.

Inspection revealed the condition of the piers was highly dependent on their location with respect to deck joints. Piers beneath continuous deck sections were generally in good condition, with minor, localized deterioration and isolated areas of delaminated concrete. Piers beneath or adjacent to deck joints had been subjected to deck runoff and were in poor condition (*Figure 2*). Significant cracking, localized to widespread spalling, and widespread areas of delaminated concrete (as much as 50% of area) were evident in these latter piers.

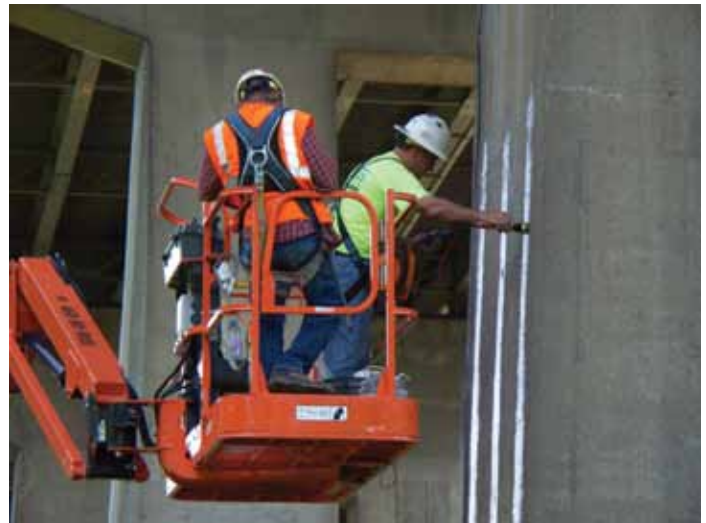
Figure 3: Measuring corrosion potential.

Corrosion potential measurements were used to evaluate the likelihood of active corrosion (*Figure 3*). Measured potential values were in general agreement with the inspection results: piers away from deck joints indicated a high probability that no corrosion was occurring at the time of testing; measurements of sound areas of piers under or adjacent to deck joints indicated significant areas of active corrosion, signifying a strong potential for additional delaminations and accelerated deterioration in these piers.

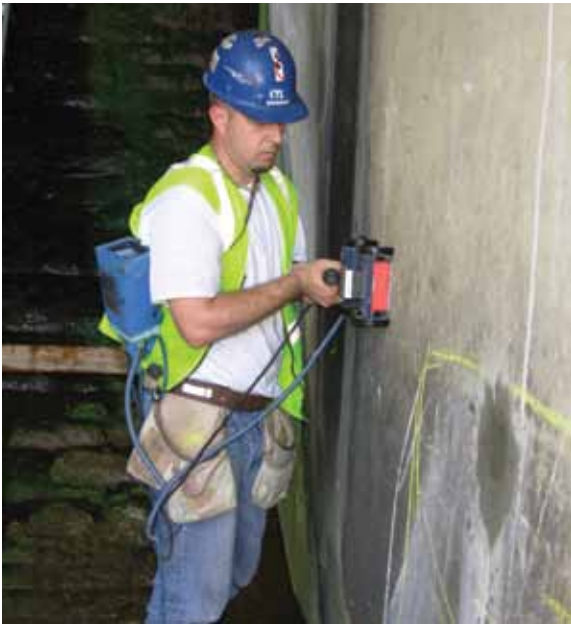
Figure 4: Collecting concrete cover profile data.

Chloride content was evaluated for piers under joints separately from piers without joints, since chloride levels were an order of magnitude greater for piers under joints. Within each group of piers, critical cover depth (Figure 4, page 24) was determined separately for the cap beams and columns, as average cover in the columns was generally an inch greater than in the cap beams.
