ederal Center South Building 1202 is a state-of-the-art, high performance office space for the Seattle District Headquarters of the United States Army Corps of Engineers (USACE). KPFF Consulting Engineers provided both civil and structural engineering services, from the design competition phase through to completion of this showcase High Performance Green Building project. Top among the many innovative design features that the project boasts is perhaps the largest use of a composite concrete and timber floor system in the United States.

Composite concrete and wood floors were not part of the original design concept but ultimately became critical to achieving the project goals. This is that story.

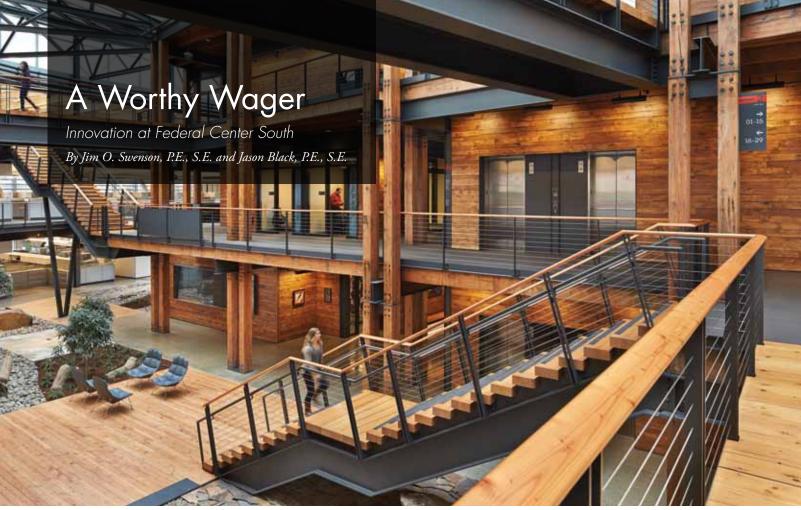
The Commons. Courtesy of Benjamin Benschneider.

One of the more striking spaces in the building is the centrally located atrium, or the "Commons," which includes a gathering place, conference rooms and shared facilities. The design called for a beautifully finished, exposed, concrete floor that could also be used to encapsulate and hide some building system elements such as conduit. A concrete floor also had the advantage of being highly durable and low maintenance, and could be used as a structural diaphragm to transmit lateral forces to concrete shear walls. There was also a strong desire that the structure of the Commons feature the salvaged timber. The final architectural/structural floor solution in the Commons consisted of 4 inches of concrete over salvaged 2x6 timber decking supported by 8x16 wood beams spanning an average of 22 feet.

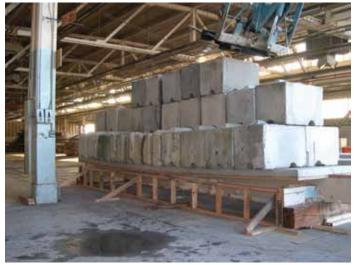
Beam #3 test just prior to failure.

Due to the experiences with beams #1 and #2, the loading procedure for beam #3 was altered to use larger eco-blocks for the initial loading course to allow more weight to be stacked with a lower center of gravity. At just over 500% of the design live load, a small crack was detected around a knot at about a third point in the beam span. At about 650% of design live load, the crack lengthened and a series of cracking sounds were heard. Finally, at 61,250 pounds of load, it was decided that it wasn't safe to load the beam any further. About 10 minutes after this last load increment was placed, the wood beam failed in flexure with a sudden, loud crack!

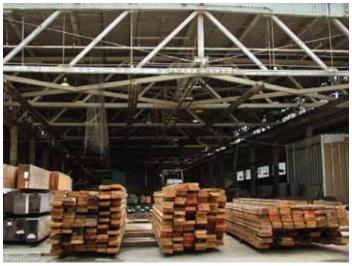
Deconstruction of the warehouse. Courtesy of Charles Lozner.

After deconstruction of the existing warehouse, a comprehensive timber inventory was developed by the GR Plume Company, the
