Rehabilitation of Historic Holmes Street Bridge

By Robert E. Mateega, P.E.

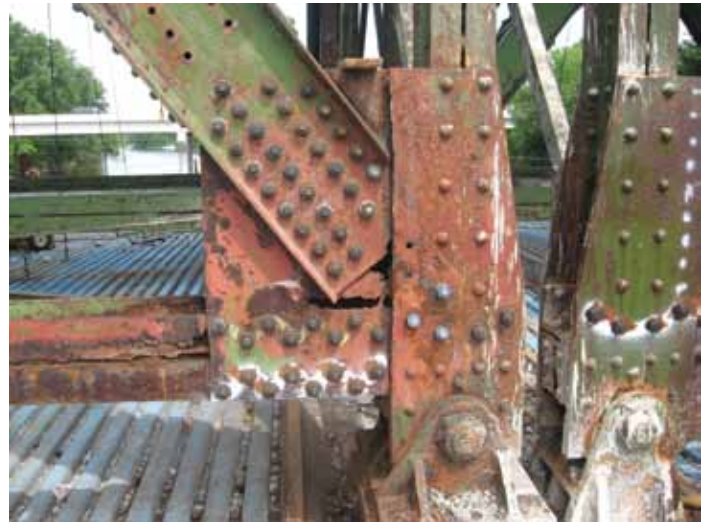
Deteriorated truss members and gusset plates prior to repair.

The in-depth inspection revealed delaminating and spalling concrete members; severely corroded ornamental railing members; severely corroded sections of stringers, floor beams and overhang brackets; severely corroded truss members; gusset plate section loss; pack rust; and frozen bearings. Most of the deterioration of the steel members was located in areas that were exposed to moisture, namely the exterior trusses on either side of the bridge and areas adjacent to the open joint at the end of each truss span.

in-depth inspection, revealed which portions of the bridge needed to be repaired or replaced. This included gusset plates, floor beams, stringers, overhang brackets, and truss members; the raised concrete sidewalks; the roadway deck; expansion joints; bearing pins; the ornamental metal railing; and concrete surfaces.

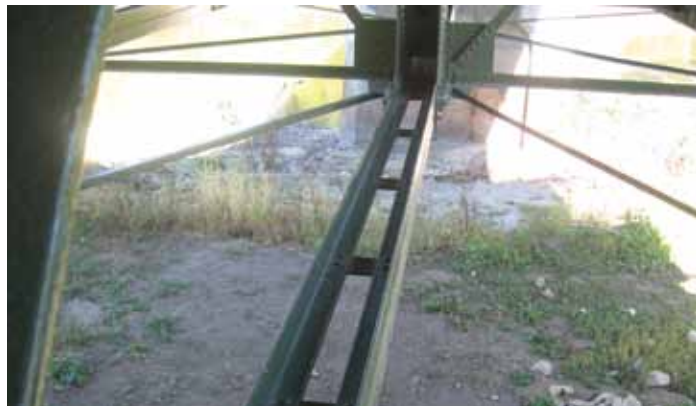
Shop-fabricated bottom chord truss member with rivets.

Rivets are a key feature of historic truss members, but few contractors today are able to install rivets in the field. When 30 steel sidewalk overhang brackets and six bottom chord members in highly visible areas were severely deteriorated and required replacement, the project team specified that the new members be shop-fabricated with rivets.

One of the lessons learned on the project was to pay close attention to member removal and the location of rivets with heads on only one side. Removal of bottom chord members was very challenging since the gusset plates at the bearing points were remaining in-place; some of the rivets in the gusset plate at the bearing point only had a head on one side and therefore could not be replaced. The contractor was able to remove the bottom chord member by removing rivets with heads on both sides, and prying the member out.
