# The Sky is Falling! NO, IT'S MARBLE!

## Stone Repair at the Fairmount Cemetery Mausoleum

By Stephen H. Getz, BSCE

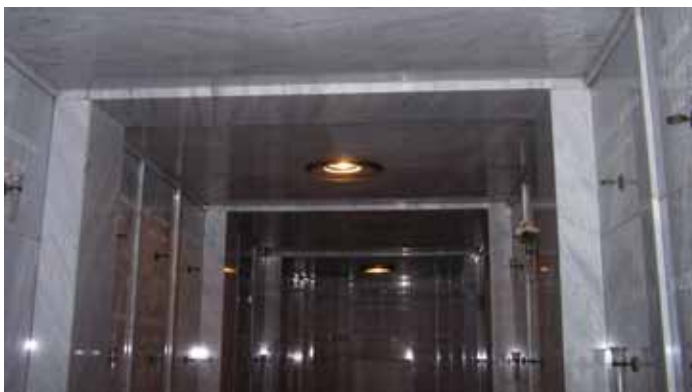
The stone ceiling panels (Figure 2) are configured such that four (4) panels are butted to form a square. Each of the four panels has two edges common to another panel. They are suspended near center by copper wire ties attached to the stone edges by field-bending the wire to achieve about a 1-inch deep embedment in the stone. The wire's opposing end is tied to the reinforcement bar of the floor above within a pocket created by chiseling the concrete cover to expose the ceiling rebar. The integrity and effectiveness of the existing ties are questionable, although such a system was not unusual at the time (Figure 3). Figure 4 illustrates the typical anchorage of the 8-gauge copper wire ties on a removed panel segment. Typically, the ties occurred at 12 to 16 inches from the unsupported free end, or mid-hallway location, of the panel. The outer perimeter of the 250 – 300 pound stone panels is supported by the vertical wall panels lining the hallway. The chase between ceiling panels and concrete differed by floor and the distance between the stone panel and concrete varied from 14 to 41 inches.

Figure 2. Interior of marble clad ceiling, beams, and walls.

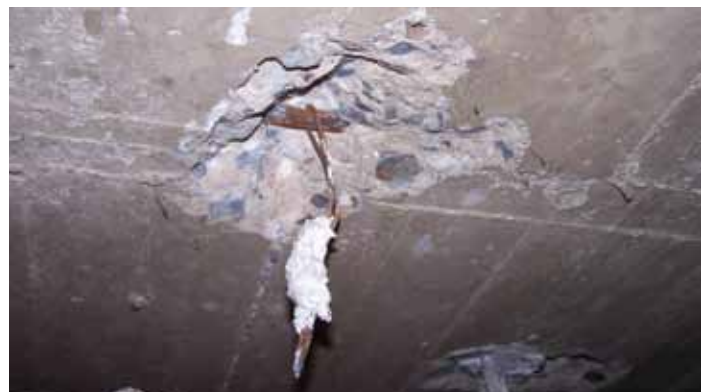
Figure 3. Corroded tie connection to steel.

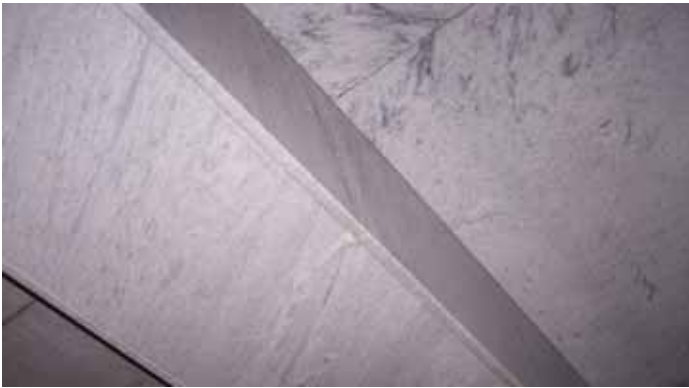
The hallways throughout the building have marble encased concrete beams (Figure 4) occurring at approximately 8- to 10-foot intervals. Where concrete beams did not exist, a faux marble beam was provided for aesthetic continuity. The beams are covered on three sides with

one inch thick marble. The marble pieces span the hallway and are simply supported at the end. A center wire tie was observed in an inspection of an exposed beam. The length of the beams varies from 7 feet to approximately 10 feet in some areas. At most locations, the marble box is a nominal 18 inches wide by 18 inches deep.

Figure 4. Typical 18- x 18-inch concrete beam enclosure in hallway.

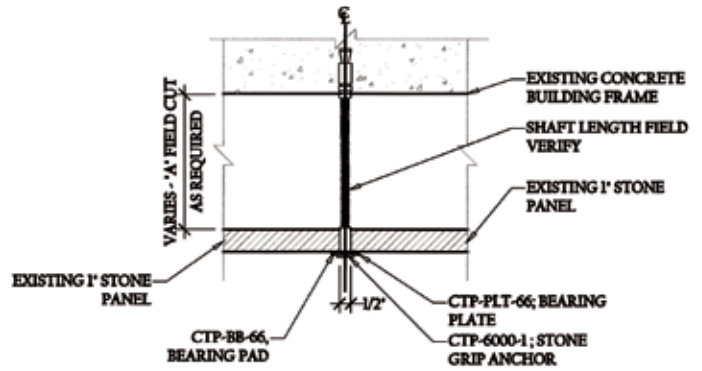
Figure 5. Details for ceiling anchors.

For the basic ceiling panel anchor, CTP developed a 1/2-inch diameter brass expander element, torque activated for the concrete connection. Torque provides an important means of inspection and performance

assurance. The anchor's embedment depth in the concrete was tested at a minimum of 1 1/2 inches that averaged over 1200 pounds capacity and induced a preload of 1060 pounds. These results provided safety factors greater than the industry standard of 4:1. The 4-inch floor in which the anchor would be fastened allowed the air space to vary 2 inches shorter, providing a standard shaft length for the variable condition. The head of the anchor is a 1/2-inch diameter stainless steel round bearing plate capable of supporting the stone. The two elements are connected by a suitably long stainless steel shaft assembly (Figure 5).

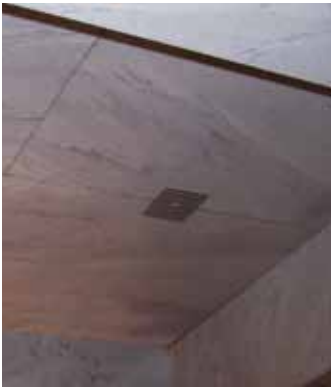
Figure 6. Typical ceiling support assembly.

The marble ceiling panels were installed with corners butted at the center of the hallway. The 1 1/2-inch diameter panel head would challenge the installation at this location due to the improbable ability to support each panel equivalently. As a result, a larger support area was required and a bearing plate was incorporated to support the panels in concert with the 1/2-inch round panel head (Figure 6, page 24). Each bearing plate is manufactured of Type 304 stainless steel with

a brushed finish. The bearing plate design was predicated upon the panels being supported at the outboard edge. As a result of this support configuration, the bearing plate will carry one half the weight of the panel. The ceiling panels are installed as pairs, meeting at center line of the aisle way ceiling. The bearing pad used was to cushion the contact area of the steel member against the stone.

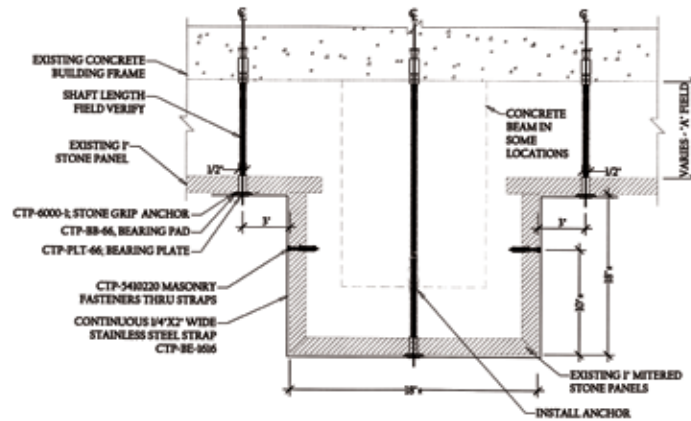
Figure 7. Beam enclosure anchor.

The beam enclosure support assembly incorporated the same style of anchorage to concrete used for other conditions. There are three (3) anchors per enclosure assembly and two encasements per beam (Figure 7). The anchor lengths vary with the depth of the beam.

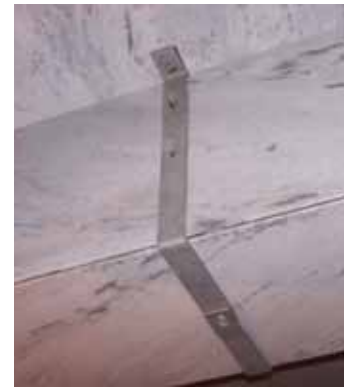
Figure 8. Box beam enclosure assembly for an 18- x 18-inch beam.

The box-style beams’ varying height and width required an adjustable support hardware configuration. Basically, in order to transfer gravity loads, intimate contact with the marble is essential for the support characteristics of the load carrying system to be effective. Each box beam assembly consists of two upper-side mounted brackets. They carry the weight of the box beam and can be adjusted both horizontally and vertically. Additionally, they provide support to the ceiling panel adjacent to the beam. Each bracket can carry 240 pounds.

The top-side brackets are connected to a left- and right-side bearing bracket. This strap system envelops the beam and overlaps at the center of the beam bottom. Here too, the strap is capable of both vertical and horizontal adjustment to assure stone contact is made. Once the side brackets are positioned, they are bolted to the top-side brackets via a 3/8-inch stainless steel stud, nut and washer. The stud is factory welded to the side strap bracket. The intent is to support the beam in the event of a primary failure of the original tie/support system. Similar to the bearing plate detail, a “bearing pad” is used in the gravity bearing support areas. The top-side brackets and the left

To prevent the box beam side-wall stone panels from collapsing inward, they are anchored to the left and right strap assemblies as a final connection of the hardware to the stone. A masonry fastener incorporating Type 360 brass expander elements with 18-8 stainless steel hardware was applied. These fasteners are torque activated to maintain intimate contact of the marble side wall panels with the support hardware. The anchor length allows a portion of the expander to project from the rear side of the marble. As the anchor is torque activated, it creates a “rivet” connection effect between the stone and steel strap.
