REHABILITATION

Expect the Unexpected

Lenox Hotel Façade Repairs

Restoration of Fraser Field Stadium

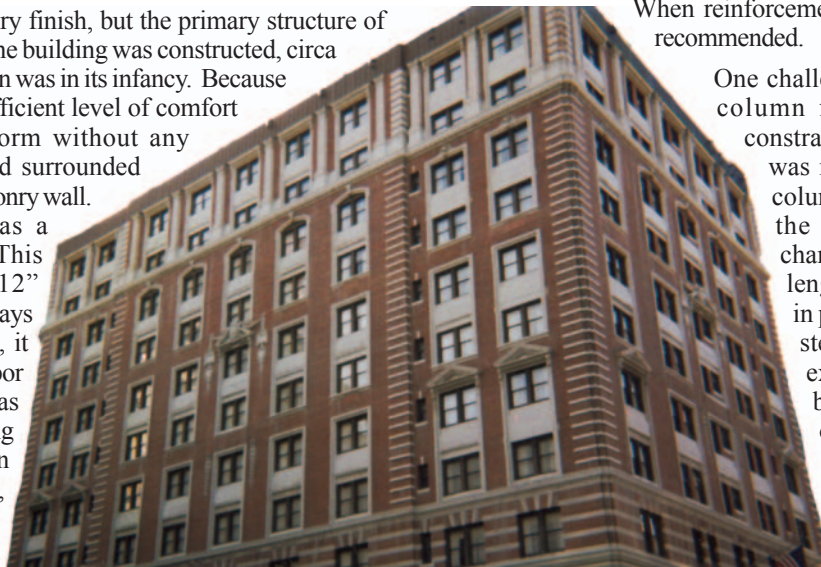
One challenge was in the understanding that a column fully embedded in masonry was constrained. When the surrounding masonry was removed for repair, large sections of column cross section were reduced so that the element's slenderness ratios were changed. Repairs were staged. A given length of column was often rehabilitated in phases, so that the corroded remaining steel would not be exposed to such an extent that local buckling would occur before it could be reinforced. In some of the worst situations, consideration was given to reducing the live load in certain locations to relieve column stresses. At no time, however, was this necessary.

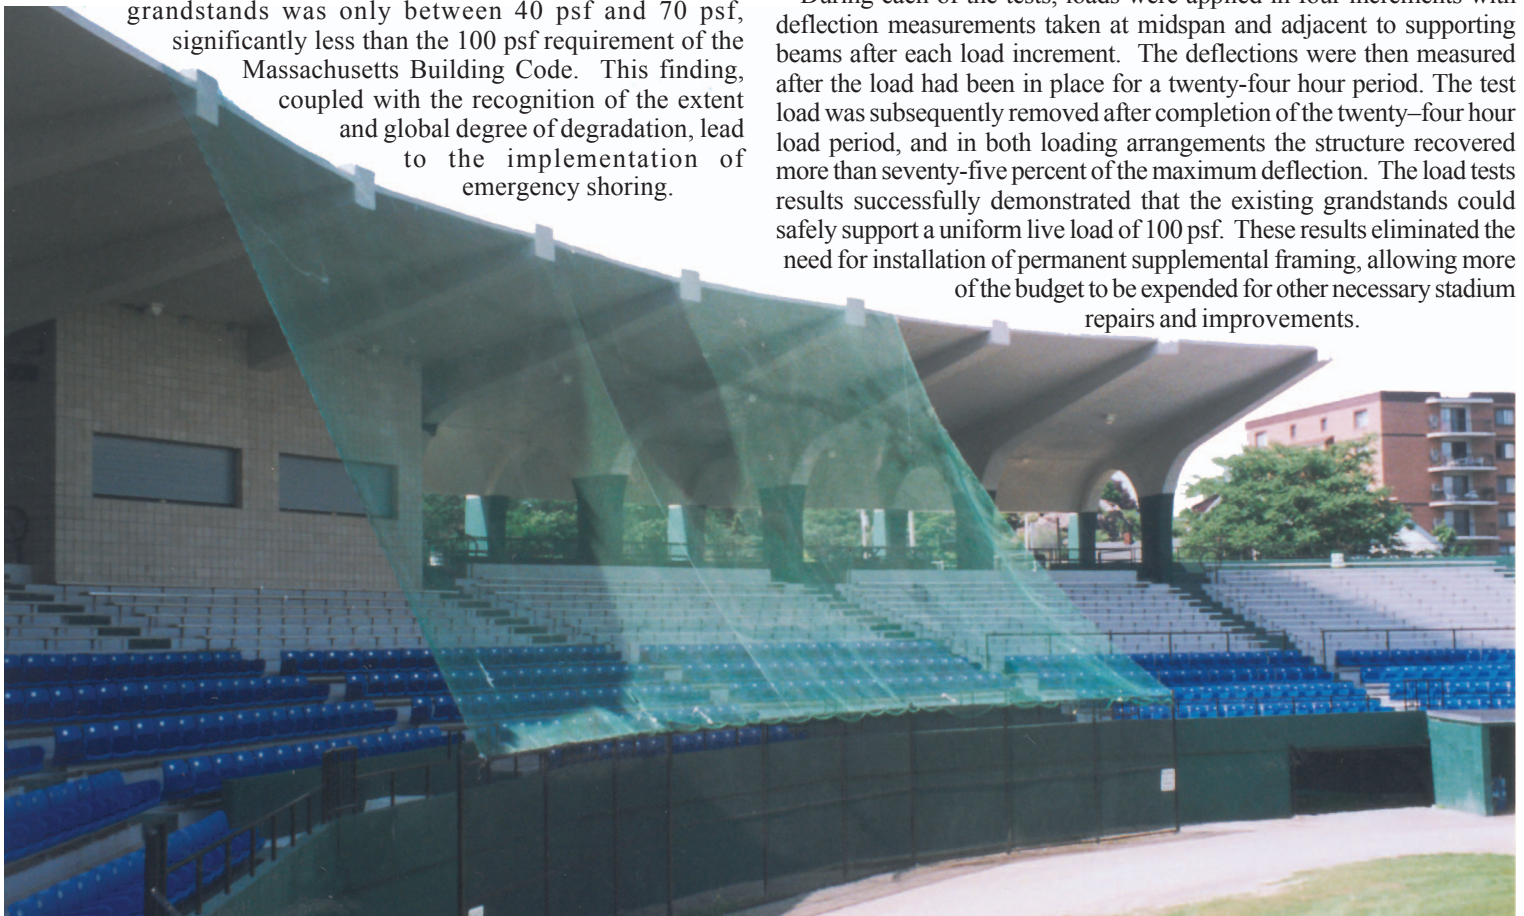
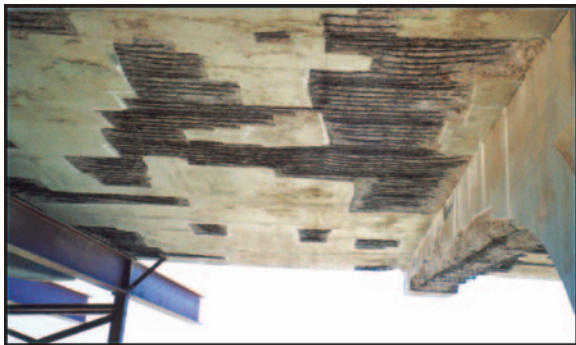
The loading for the tests was calculated in accordance with ACI. The test load was applied in the form of concrete blocks, 2'0" x 2'6" x 4'0" having an approximate weight of 3000 #/unit. A total of seventeen blocks were applied to the test area in phase I, for an equivalent uniform load of 187.5 psf. A total of 34 blocks were applied over the two test areas in phase 2, also for an equivalent uniform load of 187.5 psf.

During each of the tests, loads were applied in four increments with deflection measurements taken at midspan and adjacent to supporting beams after each load increment. The deflections were then measured after the load had been in place for a twenty-four hour period. The test load was subsequently removed after completion of the twenty-four hour load period, and in both loading arrangements the structure recovered more than seventy-five percent of the maximum deflection. The load tests results successfully demonstrated that the existing grandstands could safely support a uniform live load of 100 psf. These results eliminated the need for installation of permanent supplemental framing, allowing more of the budget to be expended for other necessary stadium repairs and improvements.

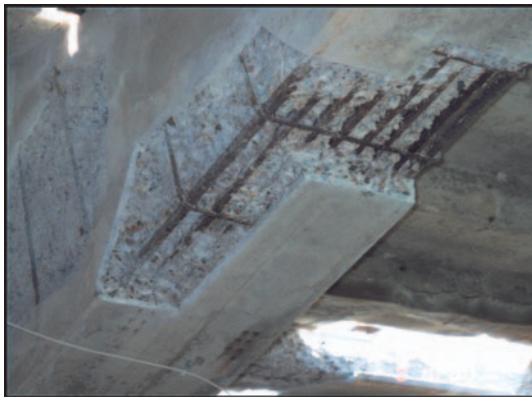
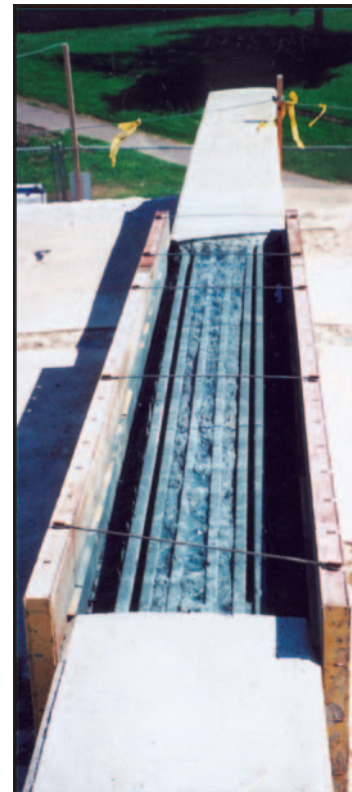
Deflection Measurement During Load Test

During repairs to the existing concrete roof beams, deposits of silica gel appeared to be present in the demolished concrete. CBI immediately coordinated a program of concrete cores and sampling for laboratory testing and petrographic analysis. The tests indicated that the concrete had acceptable compressive strength (4650 psi minimum). The silica gel deposits were not heavy and the concrete was not extensively cracked, which suggested only moderate ASR. As a result of ASR, the concrete durability was compromised, increasing the rate of leaching and freeze thaw deterioration. Given the budget constraints, complete removal and reconstruction of the roof beams was not a practical or economical solution. The areas of deteriorated concrete were removed to sound concrete, forms erected and new concrete placed. Visible cracks were routed and sealed, and an elastomeric coating was applied to top and underside roof surfaces to mitigate moisture intrusion and subsequent freeze thaw cycling. The condition of the existing beams will be monitored annually, and repairs and recoating made on an as needed basis.
