San Simeon Earthquake

December 22, 2003

By: Ronald O. Hamburger and Joshua M. Marrow

Ronald O. Hamburger, Vice President of NCSEA and Principal at Simpson, Gumpertz and Heger, Inc. (SGH), along with Joshua M. Marrow, Senior Engineer at SGH, prepared the following report for NCSEA News on the San Simeon Earthquake of December 22, 2003.

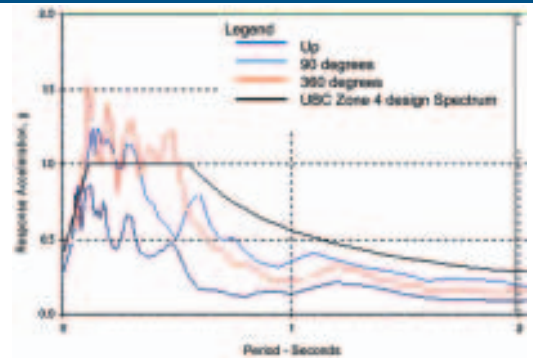
Figure 2 Response Spectra for Templeton (courtesy of California Department of Conservation)

Class D sites. As can be seen, for the short period structures that predominate in this region, the record matches the code spectrum well. However, energy from this event appears to have been strongly focused in the direction of this instrument, which was located almost directly along the fault rupture path. Other instruments recorded much less intense shaking. An instrument in San Luis Obispo, for example, recorded a peak ground acceleration of 0.17g. Based on observational estimates of intensity, it would appear that Paso Robles experienced MMI VII to VIII ground shaking, with probable accelerations in the range of 0.2g to 0.25g. Figure 3 is a preliminary attenuation diagram for the earthquake, plotting the recorded peak ground acceleration at various instruments vs. distance to the plane of fault rupture and an approximate statistical fit to this data. In the figure, peak acceleration is shown in units of cm/sec² where 980 cm/sec² is equal to 100% g.

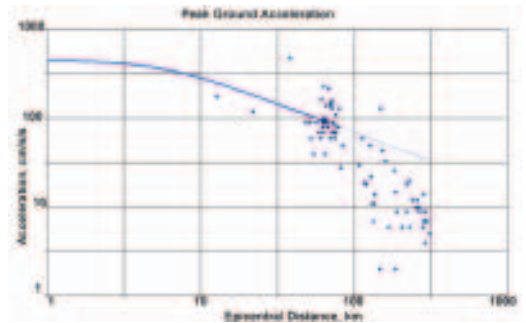
Figure 3 Approximate attenuation of shaking (courtesy of California Department of Conservation)
