Evaluating Historic Structures for Adaptive Re-Use

By Dominick R. Pilla, P.E., C.E., S.E., R.A. and Xiaoli Tong, P.E.

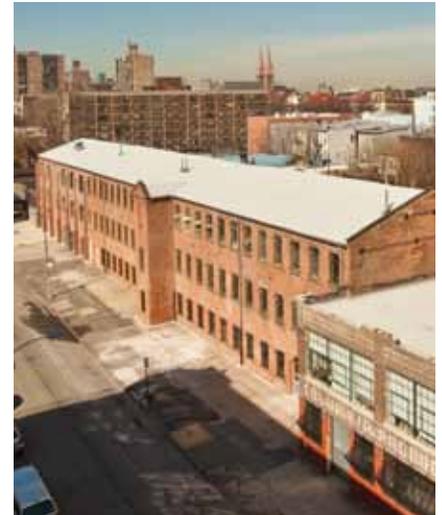
Figure 1: This former rope manufacturing complex now provides 72,000-square feet of light manufacturing and artisan workspace. Courtesy of Mireille Moga.

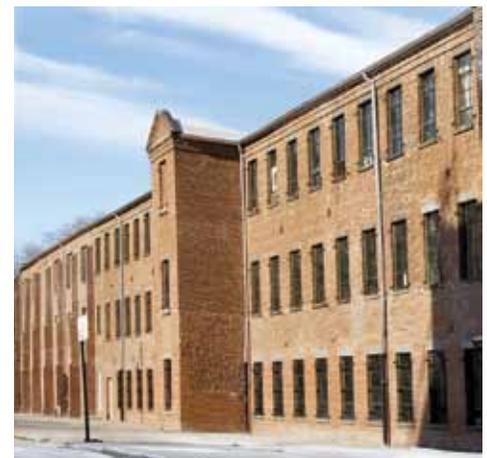
Figure 5: 221 McKibbin Street Industrial Center was recognized with an Historic Preservation Award in 2009.
