Fire Damaged Post Tensioned Slabs

By Douglas Sarkkinen, P.E., S.E.

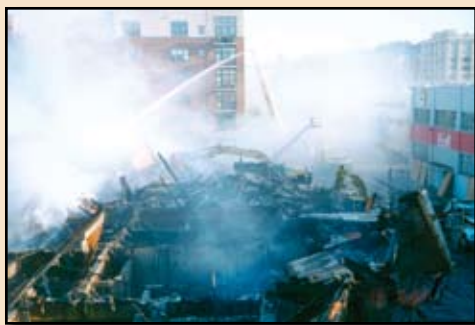
A systematic method was developed where small portions of the slab immediately in front of the excavation equipment were cleared, allowing structural engineers to verify the extent of damage for that portion of slab before proceeding. In addition, basement access was eventually granted. No signs of distortion, sagging, or adverse cracking on the slab underside were evident, except for some localized areas around stair and elevator penetrations. Additionally, concrete cores were taken at areas that spalled and appeared damaged to determine if slab delamination had occurred. The initial cores were found to be sound and intact. Based on this evidence, the Contractor was given approval to use equipment weighing up to 25 kips. Larger equipment or trucks would require shoring.

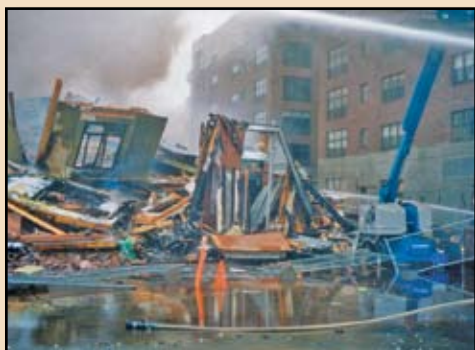
After removal of a majority of debris, investigators determined arson was the most probable cause. The investigators collected as much evidence as possible, eventually returning site authority to the Contractor. With most debris removed, the most difficult aspect of reconstruction was to determine how much structure could be saved and how much needed removal and replacement. This issue had significant ramifications in terms of reconstruction time and costs.

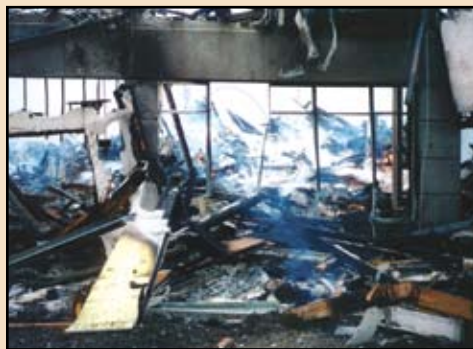
The post-tensioned plaza slab was the remaining critical element that could have been irreparably damaged. Because of potential impact to scheduling and costs, there was a strong desire from both the Owner and Contractor to save the slab. The main concern was determining the temperature level experienced during a fire that burned all day. At extremely high temperatures, concrete can be damaged and steel reinforcing and post-tensioning tendons can experience strength and stiffness loss. The table below indicates damage that might be expected as structural materials are exposed to the respective temperatures. This table is a compilation of information from Construction Technologies Laboratory (CTL), ACI, miscellaneous articles on fire damage and some testing by a local testing agency.

Spalling occurred throughout the top surface of the plaza slab, with some areas being heavily damaged while in other areas the damage was sparse. It was believed that con-

tact between the cold water used to extinguish the fire and the heated slab contributed to the concrete spalling. The depth of a majority of spalling was in the 1/2-inch to 3/4-inch range. Since the majority of tendons in the slab had a minimum 2 inches of cover, it was determined the spalling probably did not compromise slab structural integrity. Spalling was repaired by removing loose concrete and patching with a cementitious leveling compound.

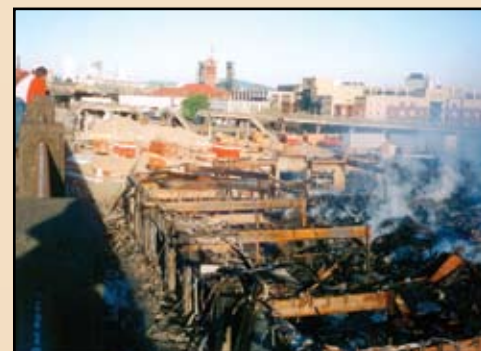
In review of all tests performed, experience of fire investigators and the extent of slab damage observed, the temperature attained was likely in the 500 degree Fahrenheit range. This conclusion was based on:

Discussions with Fire Investigators indicating that, although the fire was catastrophic, the majority of heat and energy went straight up as flames reached over 100 feet. The fire was described as being similar to a furnace, pulling cool air low into the fire along the slab and feeding from the base. This effect probably did not create intense heat at the slab surface. Subsequently however, as the fire progressed and the wood-framed components continued to burn, the building collapsed within itself and created 2 to 3 foot layers of charcoal on top of the slab. This possibly "baked" the slab;
