Old Masonry Schools

Garbage or Gold?

By Ronald G. Vandehey, P.E.

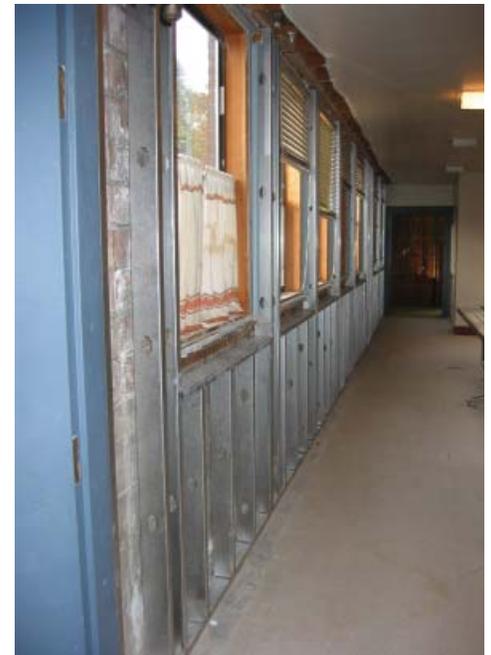
“...solutions were still cost prohibitive, and installing anchors into clay tile was difficult.”

of practice, I have realized that mechanical anchors that screw into the clay tile do not consistently make pull strength in clay tile, due to the variance in material and condition of the clay tile in the buildings. Since the anchors are applied every two square feet, it is not cost effective to test every anchor. Yet, if an anchor does not hold it can overload the surrounding anchors causing a significant failure.
