## The Existing Bridge

## The Existing Conditions

## Repair Design

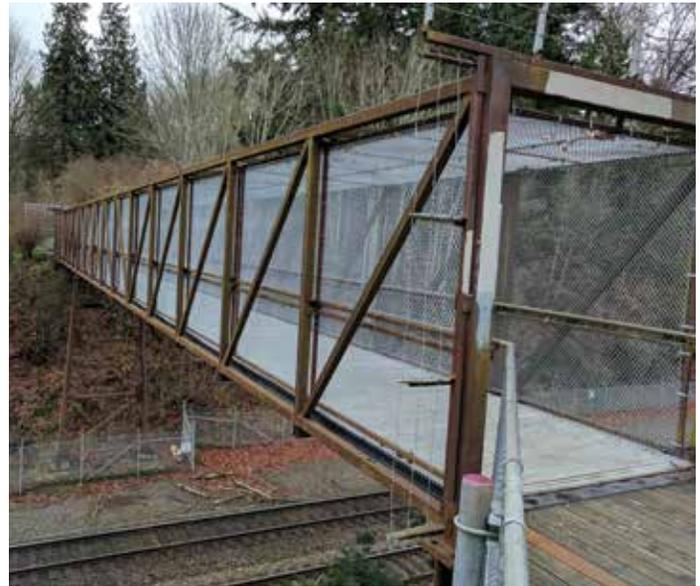
Completed project.

Over the course of its 30 years, a majority of the Howarth Park pedestrian bridge weathering steel members performed as intended with regard to corrosion, despite being located in a marine environment. Only where detailing or natural shielding of the bridge prevented adequate drying of the steel did the steel corrosion continue to a dangerous state. With weathering steel, proper design and detailing to allow air circulation and thus drying cycles is essential. The choice to replace some weathering steel members with FRP members allowed for efficient design and construction. Typically, FRP is used in caustic environments such as chemical plants or proximity to salt water, but the use of FRP structural members for this pedestrian bridge repair enabled the work to be completed efficiently with corrosion-resistant materials. The bridge is now re-opened to the public and will provide many years of additional service. ■
