Grant Street Pier

DRILLED SHAFT REPAIR

By Dominic A. Webber, P.E., S.E. and
Howard A. "Hod" Wells, P.E., LEED AP, ENV SP

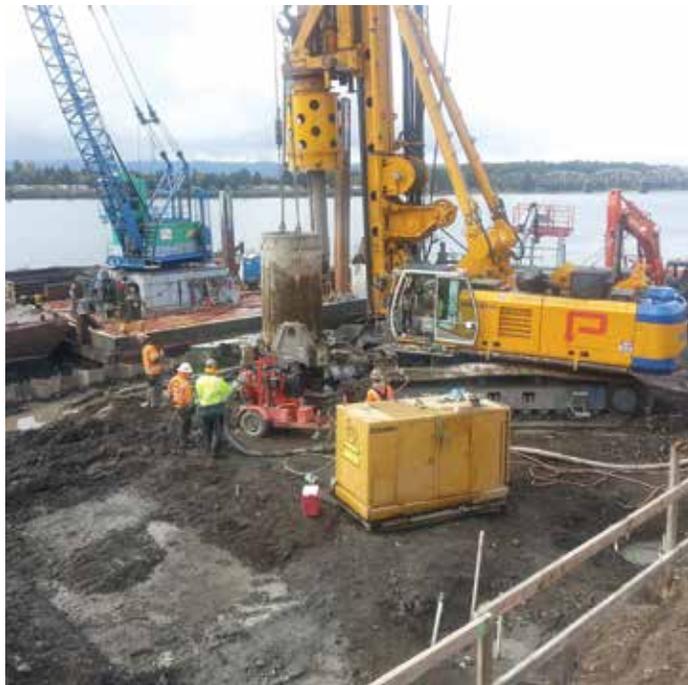
Installation of drilled shaft.

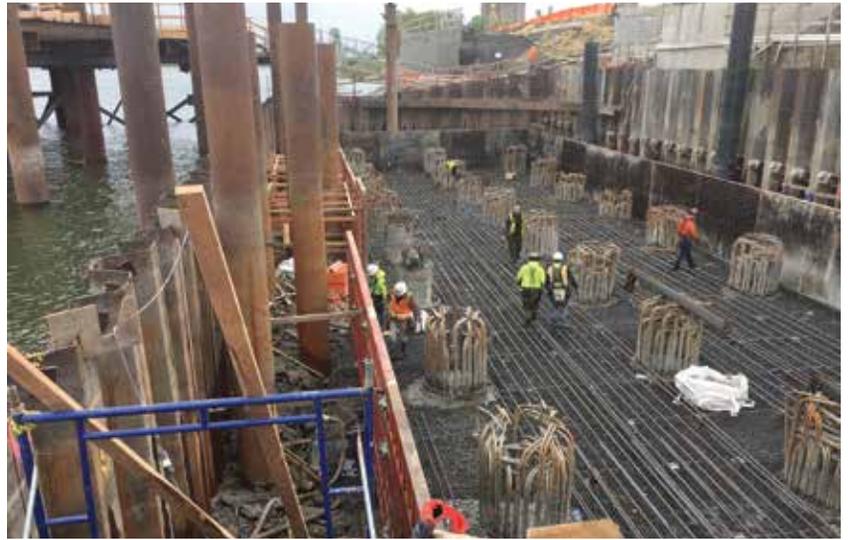
Foundation under construction: a repaired shaft (left) and bottom layer of reinforcement in mat slab (right).

Ultimately, a 36-inch diameter auger was used to core the center of each shaft a minimum of 12 feet below the location where it was believed, based on drilling and CSL data, each existing shaft was compromised. This allowed a 33-inch diameter x 1.25-inch thick steel pipe to be placed inside the core and extend 42 inches into the mat slab. Overall, a 28-foot length of pipe was needed for each shaft. This allowed the concrete-filled pipe to act over the compromised portion of the drilled shaft and ultimately transfer loads back to the existing shaft below.
