Second Opinion Leads to Substantial Savings in Evaluation and Repair of Marble Façade

By William D. Bast, PE., S.E., SECB, Scott G. Nacheman, M.Sc.Eng, AIA, R.A., Rachel L. Michelin, EIT, LEED® AP and Dziugas Reneckis, Ph.D., PE.

Water Tower Place is a 74-story, 859-foot tall reinforced concrete building, constructed between the years of 1973 and 1976 (Figure 1).

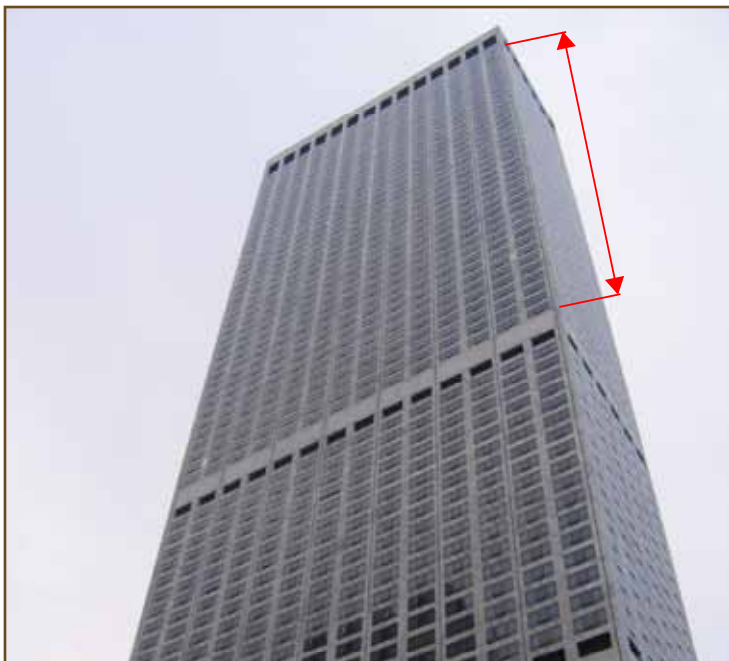
Figure 1: The condominium portion of Water Tower Place is from floors 33 to 72; the balance of the building is owned by commercial and hotel entities.
