# FULL METAL JACKET

## Part 3: Foundation Revisions

By D. Matthew Stuart, P.E., S.E., F. ASCE, F. SEI, SECB, MgtEng and Richard H. Antoine III, P.E., S.E.

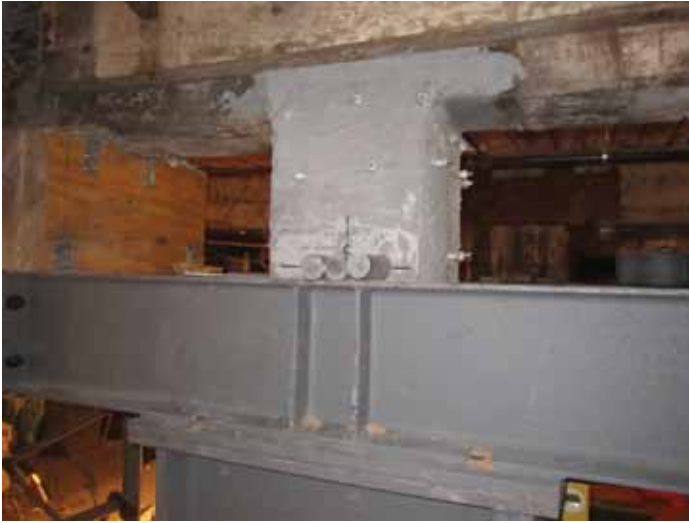
Figure 3.

The purpose of the steel column jacket solution was simply to stabilize the building in place, and not attempt to jack the structure back up to its original floor and roof elevations that existed before the column deterioration and settlement began (Figure 4). A similar approach was also taken for the repair of the horizontally distorted column, corbel and beam connection at the second floor. The fix used at the second-floor connection involved installing a stiffened steel side plate on each face of the joint that straddled the timber beam, pillow beam and top of the first-floor column. The side plates were attached to the wood framing via lag bolts, rather than through bolts. Although there may have been hidden mortise and tenon joints connecting each of the three individual timber members together at the joint, the steel side plates effectively stiffened and stabilized the connection.
