Unique and Effective Sampling Method Saves Money and Time

Bridge Post-Tensioning Inspection, Assessment and Evaluation Project

By Jerry Frost, P.E., MS, MBA, Troy Madlem, P.E., Don Kline, P.E. and John Crigler, P.E.

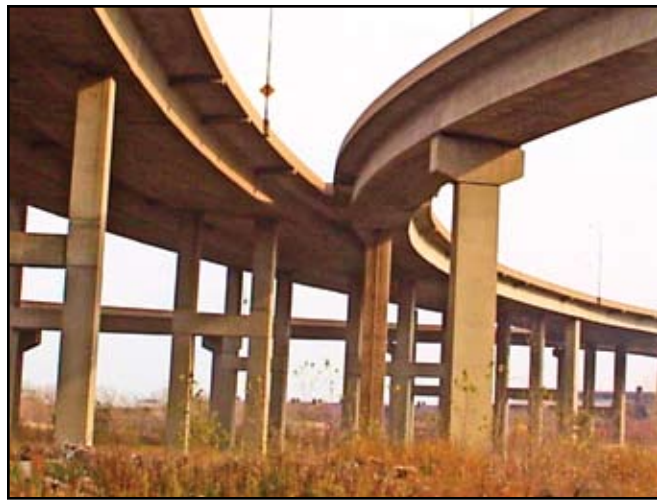
Figure 1: Cline Avenue Bridge Structures

After nearly 20 years of serving northwest Indiana near Gary, the Cline Avenue Bridges had begun to show signs of their age. But not all changes in the bridges' appearance were typical of a 20-year-old overpass. Inspectors for the Indiana Department of Transportation (INDOT) had observed unusual patterns of cracking, spalling and efflorescence in the bridge. Recent National Bridge Inspection Standard (NBIS) inspection efforts identified significant longitudinal and transverse cracking in the bridge deck, as well as cracking in the webs and diaphragms.
