Evaluation of Structural Damage

Reinforced Concrete Arch Culvert

By Steven J. Smith, Ph.D., P.E., Terry M. Sullivan, P.E., Jeremiah R. Nichols, P.E., Honggang Cao, P.E., Michael G. Carfagno, P.E. and Larry P. DeRoo, P.E.

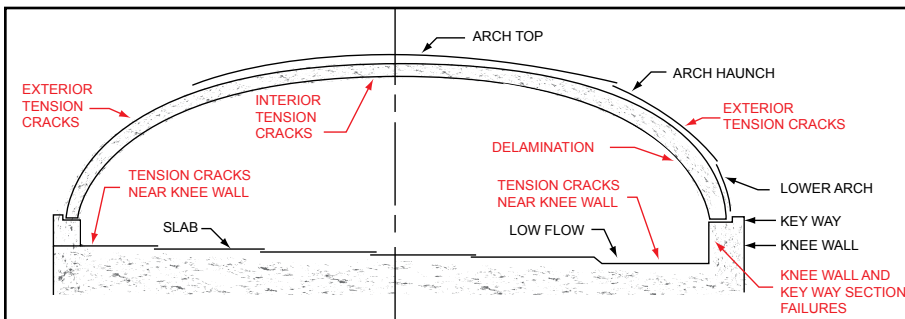
Figure 2: Key plan and damage map. The Duck Creek Culvert typical section. The precast concrete arch elements are placed on top of the knee walls, which were cast monolithically as part of the cast-in-place base slab.
