# A Case Study of Early Steel Curtain Wall

By Eric Hammarberg, Assoc. AIA

## The Chrysler Building,

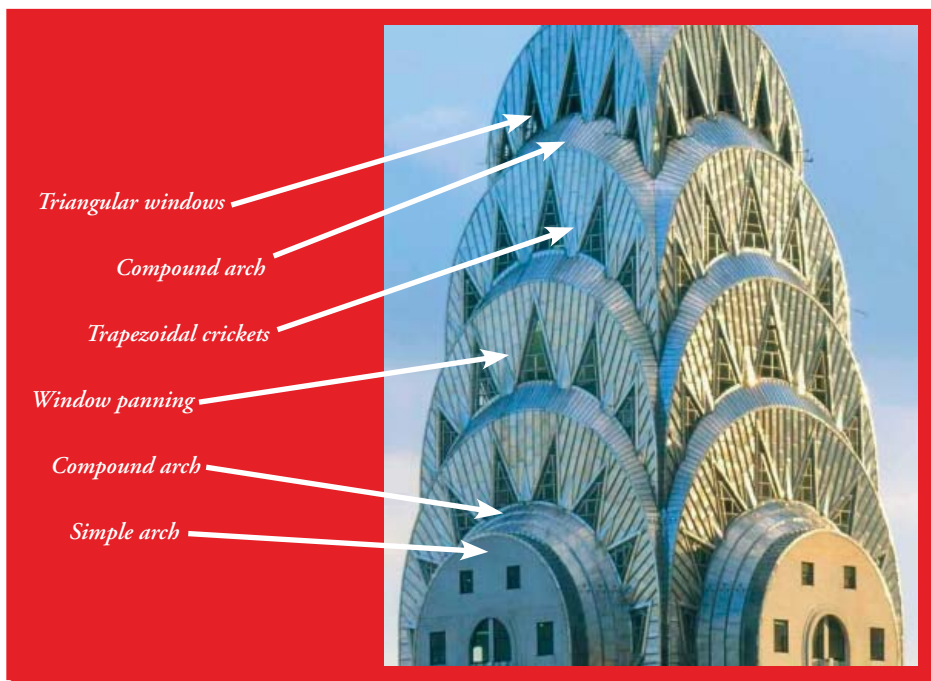
*Cracked solder*

Cracked solder typically occurred at complex intersections, where two panels of sheet metal were not parallel. Cracked solder and pinholes in the metal were repaired with either sealant or liquid applied membrane.

#### *Sealant and Liquid Applied Membrane Repairs at Failed Joints, Tears and Missing End Caps*

All sealants were Dow Corning Silicone, either 795 or 995 depending on desired modulus of elasticity. These were chosen for superior adhesion to the stainless and long life expectancy. Liquid applied membrane was Mathys Noxide. This was the only acceptably performing membrane available, at the time of this project, which included a color coating that matched the polished stainless steel... an aesthetic requirement.
