FRP STRENGTHENING OF A FIRE DAMAGED INDUSTRIAL PLANT

By Peter Milligan, P.E.

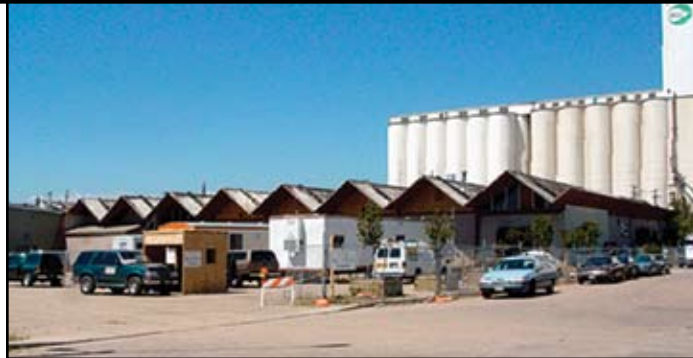
Figure 1: Facility Plan View.

The extent of the damage from the fire was fortunately confined to approximately 15% of the folded roof panel area. The comprehensive repairs of this area included:

Folded slab sections are essentially a beam element with maximum negative moments located at the peak of the folded roof slab, the interior column lines and the exterior column lines (Figure 1). The maximum positive moments are at mid-span of the folded roof slab and on the bottom of the valleys. The engineer of record conducted a SAP2000 finite element analysis of the fire-damaged area that quantified the deficient areas of the folded slabs requiring

- 1) shoring of the fire-damaged folded roof valleys,
- 2) hydrodemolition of the damaged interior concrete,
- 3) replacement of the damaged concrete areas by shotcreting,
- 4) epoxy injection of existing shear cracks,
- 5) application of carbon composite laminates to the peaks and valleys of the folded slab to increase positive and negative moment strength to compensate for the permanent loss in steel strength,
- 6) external shear strengthening for both the fire damaged area and other areas of folded roof slab not affected by fire, and finally,
- 7) fireproofing the structural FRP applications in the fire damaged areas.
