Quincy Mine Blacksmith Shop

Condition Assessment of Timbers

By Robert J. Ross and Xiping Wang

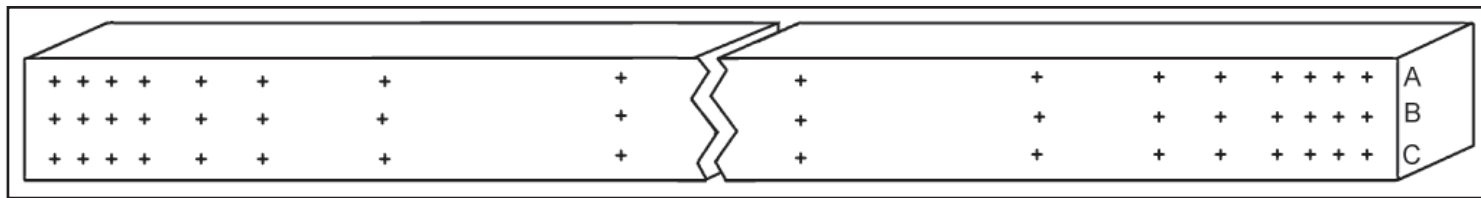
Figure 2: Scanning diagram for nondestructive evaluation of 12- by 12-inch white pine timbers

Figure 2 shows a typical scanning diagram used to conduct stress wave transmission tests. The timbers were supported on two beams. Each timber was stress wave scanned along three lines (A, B, and C) on the side surfaces, with A, the upper line, B, the middle line, and C, the lower line, through the height of each timber. Since the ends of the timber were usually considered to be the areas having a high risk of decay, stress wave transmission tests were more intensively performed at ends than other parts of the timber. The intervals between the two scanning

points in the longitudinal direction changed from 6 inches beginning at the end of the timber to 1-foot, 2-feet, and 4-feet, respectively, as the scanning position approached the middle part of the timber.
