# REMEDIATION OF MASSACHUSETTS INSTITUTE OF TECHNOLOGY'S W33 CAGE BUILDING

By Jeff D. Langlois P.E., Milan Vatovec, Ph.D., P.E., Philip L. Westover, P.E., and Randall Preston

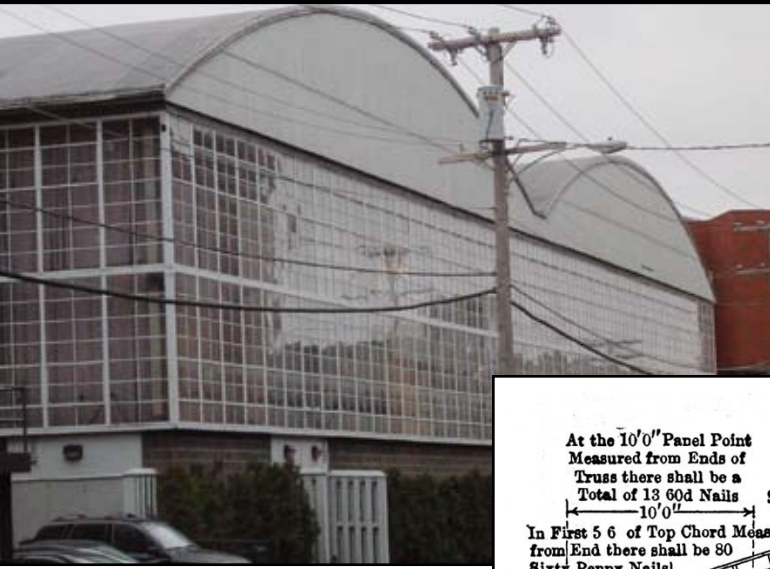
Figure 1: Double-barrel vault roof profile of MIT's W33 Cage Building.

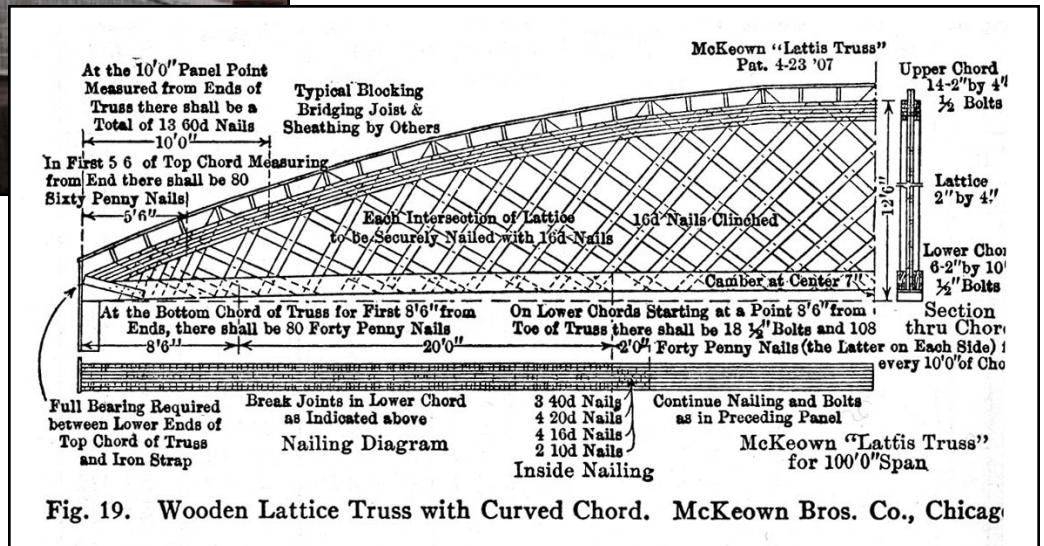
Wooden Lattice Truss with Curved Chord. McKeown Bros. Co., Chicago, IL.

The primary ailment observed was existing repairs at tension fractures along the bottom chord of several trusses. Generally, the existing repairs consisted of through-bolted steel sections sistered to the sides of the bottom chord. Top chords, however, appeared to be in excellent condition, with the exception of one truss, which had sustained damage and was visibly deflected (Figure 2).

While the observed tension failures can generally be attributed to the presence of knots and to the lack of splice connections in the bottom chord, it is also likely that these trusses were designed with fictitiously high allowable stress values assigned to the lumber. During the na-

As disassembly of existing repairs was deemed too risky, options for chord strengthening were limited. This was the key obstacle in detailing the strengthening scheme and led to recommending the installation of steel tension rods on each side of the bottom chord of the trusses. This an elegant means of avoiding contact with the existing repair; it also allowed for the option to post-tension the rods and remove existing dead load from the bottom chords, such that they were not overstressed during snow loading. Furthermore, since the capacity of existing repairs was unknown, the post-tensioning rods were sized to safely carry the entire lateral thrust of the compression chord under dead and live load combined.
