# STRUCTURAL TESTING

## Magnetic Flux Leakage for NDE

This article is a follow-up to one of the precast, prestressed thin slab parking garage structures described in *Precast, Prestressed Thin Slabs in Parking Garage Structures*, published in the January 2016 issue of STRUCTURE magazine.

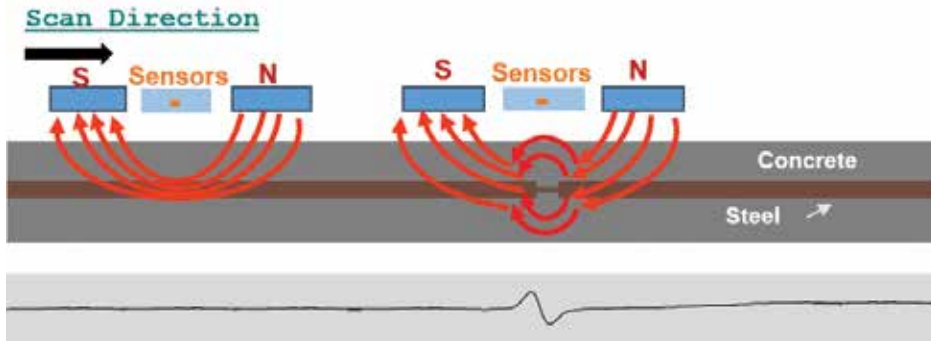
Figure 1.

A novel NDE method based upon the concept of MFL was used in the assessment of the prestressing strands in the thin precast concrete slabs in this parking garage structure. The MFL concept is based on detecting magnetic flux leakage in a magnetized strand where there is a loss of cross-sectional area. *Figure 1* illustrates this concept as the response of a Hall-effect sensor signifies a section loss and its location in a strand or rebar embedded in concrete. Hall-effect sensors are transducers that produce a varying output voltage in response to a changing magnetic field. The sensor output, or the shape of the MFL signature, including its amplitude and period, is influenced by the size, configuration, and orientation of the section loss as well as the distance between the steel reinforcing and the magnetic sensors.

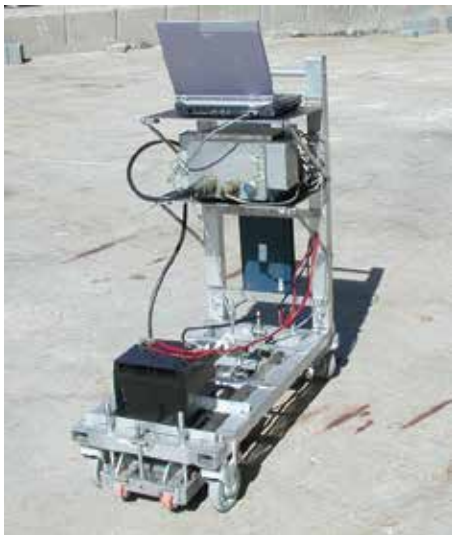
Figure 2.

The primary components of the MFL system are two strong permanent magnets and a set of Hall-effect sensors that are installed in a testing cart to

allow for portable testing of parking garages and bridge decks (Figure 2). The system is also equipped with an encoder device that allows recording of the precise location of each data point along the length of each scan. The system is designed to be durable for field use and requires only a small DC power source for its operation.
