## Straight-Line Wind Damage Analysis

By Karyn Beebe, P.E.

A straight-line wind event took place in Rockwall, Texas, March 29, 2017, producing significant structural damage resulting in four red- and five yellow-tagged homes. The National Weather Service in Fort Worth estimated the storm's wind speed to be 100 to 110 mph. Before demolition of the most impacted home (Figure 1), APA – The Engineered Wood Association (APA) field staff followed through with an opportunity to survey the damage.

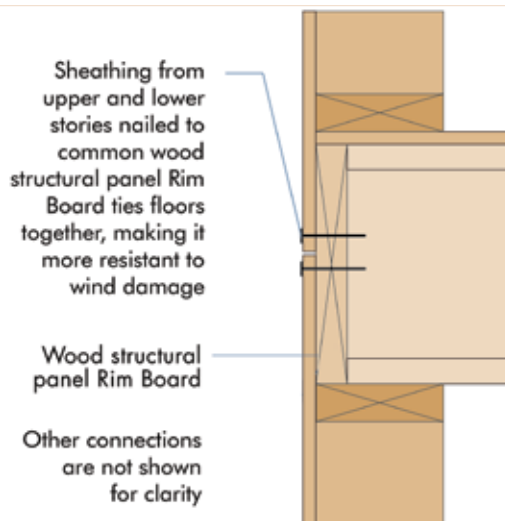
The detail in Figure 4 shows wall sheathing lapped over the Rim Board® and fastened as one way to create load path continuity from floor to floor. Another way is to use metal plates, such as Simpson Strong-Tie® LTP4s, although neither was done here. Instead, flexible sheathing of various grades (load capacities: structural grade and non-structural grade infill) was fastened using

Figure 4. Creating load path continuity from floor to floor using WSP wall sheathing lapped over the fastened.

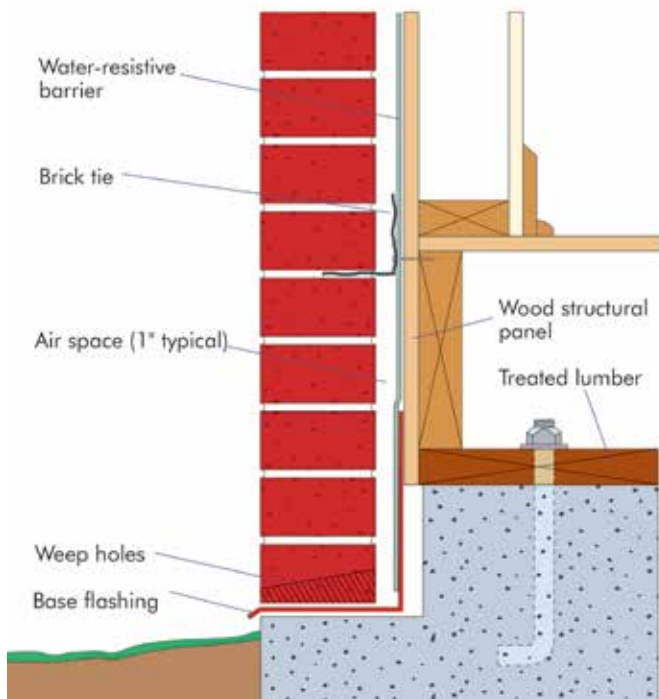
Figure 5. Code-required water-resistive barrier, flashing, and an air gap to separate the brick veneer from the wood wall.

Figure 5 and 6, APA's recommended drainage assembly with one of the walls observed. In Figure 5, the wall sheathing is protected by a code-required water-resistive barrier, flashing, and an air gap to separate the brick veneer from the wood wall. The arrow in Figure 6 points to mortar buildup which occurred between the bottom plate and the brick veneer. This could trap water behind the wall which could infiltrate the wood wall assembly.
