## Novel Solution for Strengthening Handrail Anchorage

By Ali Abu-Yosef, Ph.D., P.E., S.E., Joseph Klein, P.E., Michael Ahern, P.E., and Randall Poston, Ph.D., P.E., S.E., NAE

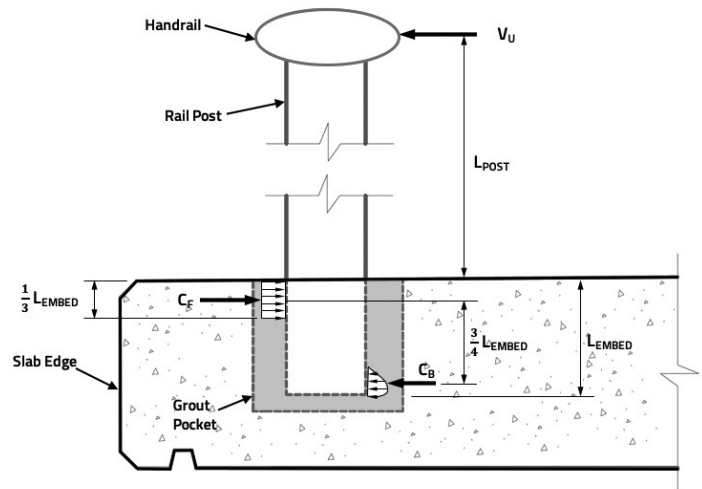
Figure 1. Free body diagram for the anchor reaction forces produced by handrail loading. Adapted from Raths 1974.

analytical methods can be used to provide rational estimates of the reaction forces that develop within the anchorage assembly due to externally applied shear and moment forces. The free-body diagram shown in *Figure 1* is based on the findings reported by Raths (1974) for steel embedments in concrete at the ultimate state. The externally applied handrail forces are resisted by a shear couple ( $C_F$  and  $C_B$ ) that develops within the embedded depth of the anchorage assembly. The free-body diagram can be used to calculate the breakout shear demand ( $C_F$ ). It should be noted that *Figure 1* does not include wind loading for simplicity, but the demands due to wind loading can be included similarly. In addition, a load reversal is possible but results in smaller concrete breakout stresses due to the relative magnitudes of  $C_F$  and  $C_B$  per the equation, ( $C_F = V_U + C_B$ ).
