DEADLY MIAMI PEDESTRIAN BRIDGE COLLAPSE

Why and How the Structure Failed

By Ran Cao, Ph.D., A.M.ASCE, Sherif El-Tawil, Ph.D., P.E., F.ASCE, F.SEI, and Anil Kumar Agrawal, Ph.D., P.E., M.ASCE, F.ACI

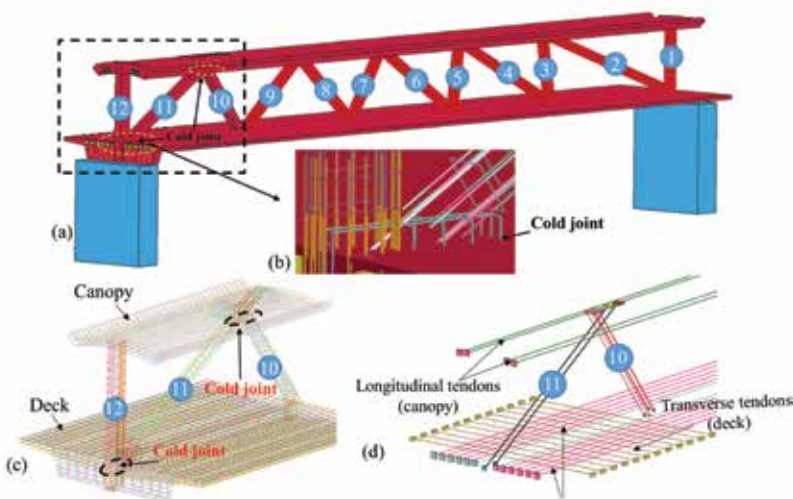
The computational model was constructed using the finite element method, wherein the structure and its components were discretized into a multitude of small *elements*, each with specific properties associated with its parent material. For example, steel bar elements could yield and fracture, while concrete elements could crush, crack, and exhibit confinement and tension stiffening effects. Tension stiffening is the beneficial effect of reinforcement on the mechanical behavior of surrounding concrete. Prestressing was explicitly accounted for through the introduction of prestressing tendon finite elements. The model was designed to represent member separation and falling of debris to represent the failure process faithfully. Figure 2 shows a schematic of the computational model of the main span of the bridge.

Figure 2. Simulation setup of the bridge: a) overall computer model of the bridge; b) close-up of reinforcement at the joint; c) steel rebars detailing; d) prestressing tendons detailing.
