Quebec Bridge Failure #2, 1916

By Frank Griggs, Jr., Dist. M.ASCE, D.Eng, P.E., P.L.S.

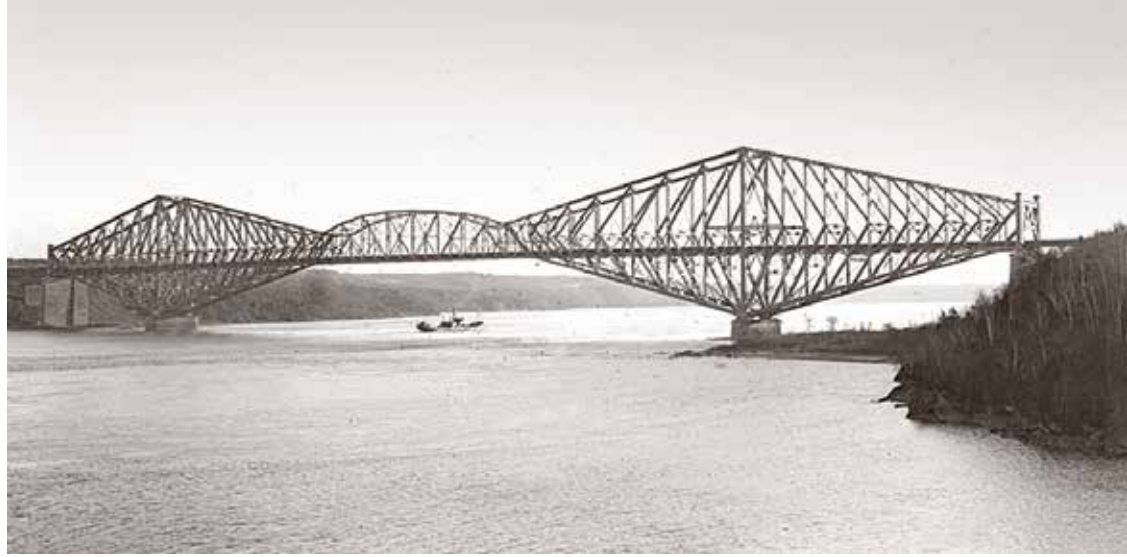
Quebec Bridge.

The Railroad Gazette wrote, “From examinations of the hangers since the accident, it is evident that the intermediate or roller casting under the southwest hanger gave way. The fracture of the front lower pin bracket of this rocker threw the lower pin out of service, and the concentration of the 1,200-ton load on the remaining pieces

crushed and tipped the remainder of the rocker at the same time kicking out the swinging girder and allowing the corner to fall. With the supports at this corner gone, the long, heavy span could not maintain its equilibrium, and it dropped into the river... The

The investigating team submitted its report on October 19, 1916. The most significant finding was that the disaster was due solely to a failure of the casting.

On September 13, 1916, the St. Lawrence Bridge Company accepted full responsibility for the failure and took “immediate steps to replace the span.” The Board and the Bridge Company decided that the entire lifting apparatus would have to be rebuilt due to excessive deformations of the lifting links occasioned by the fall.
