News and Events

Structural Drawings Article Creates Flood of Emails

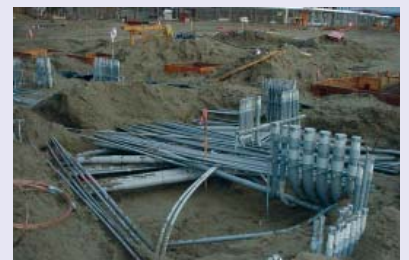
Where's OSHA When You Need Them... Those lines on the electrical drawings didn't look like this. The stake in the center is where a column and spread footing are supposed to be.
