# STRUCTURAL REHABILITATION

## Divine Design: Renovating and Preserving Historic Houses of Worship

### Part 3: Roof Structures

By Nathaniel B. Smith, P.E. and  
Milan Vatovec, P.E., Ph.D.

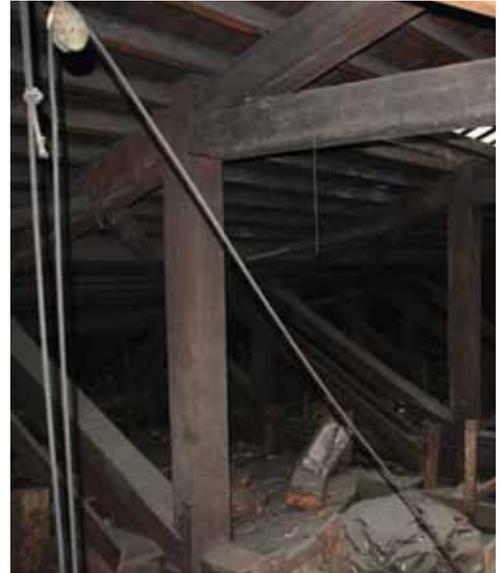
Heavy timber roof framing.

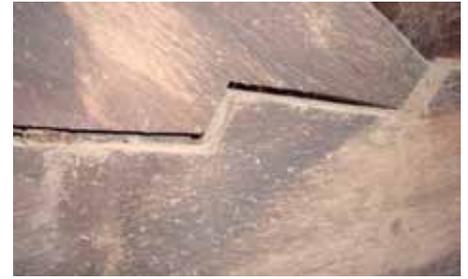
*Opening of joint due to shrinkage.*

Timbers were typically green (moisture content greater than 19%) when originally installed. As they dried in service, the associated shrinkage may have caused the joints to loosen or open with time. Typical truss maintenance should therefore include inspection and occasional tightening of the bolted connections, aimed at maintaining their serviceability and effectiveness.

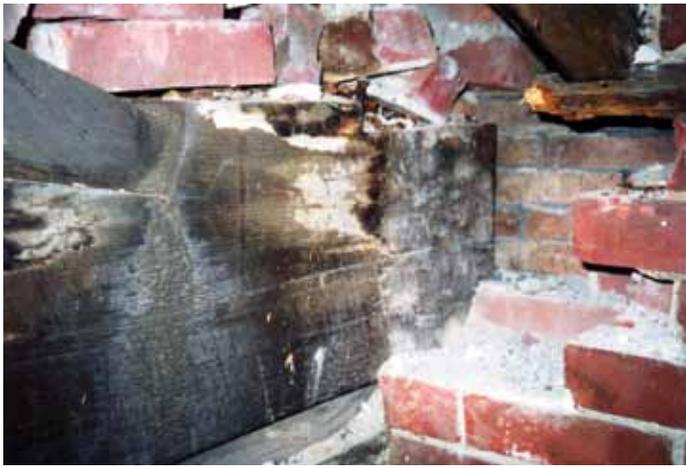
*Fungal deterioration at truss bearing.*

As discussed in Part 2 of this series, ends of timber elements (e.g. roof trusses) bearing in pockets in masonry walls are typically the most vulnerable to the effects of moisture absorbed by the masonry. To compound the issue, bearing ends of the roof-structure timbers are typically in the vicinity of the roof gutters; any associated leakage or masonry saturation could further contribute to deterioration of the roof-structure timbers.

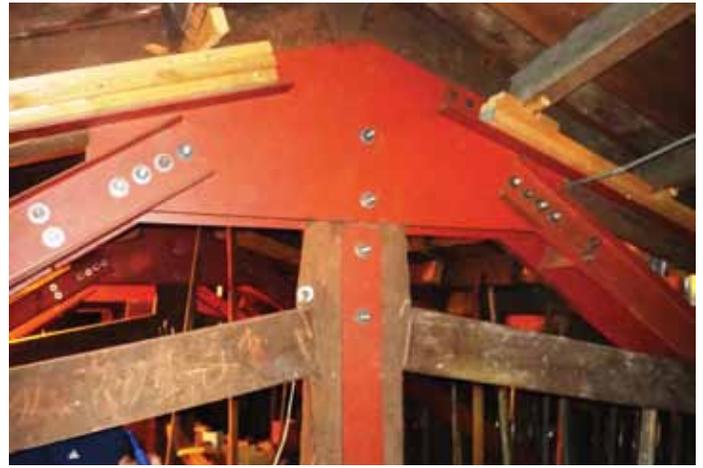
*Truss reinforcement.*

In some cases, strengthening of the truss members may be necessary due to alterations (addition of insulation, HVAC equipment, change of roofing type, etc.), or to address existing distress or deterioration of the timbers. Strengthening can often be accomplished by reinforcing the existing members with additional wood framing, steel plates, or channels. The reinforcing is commonly attached to the existing timbers using through bolts or lag screws. To arrive at an effective strengthening solution, compatibility of displacements, load sharing, or any geometric or other constraints introduced to the existing structure need to be carefully examined. Also, if temporary removal of truss elements is needed, shoring, load transfer sequencing, and temporary lateral bracing of often tall and slender masonry walls need to be considered. Finally, if any change in the overall truss behavior is introduced (e.g. when tie rods are added to prevent further spreading of scissor trusses), all members and their connections along the load path should be examined to determine if they are adequate to resist the new loads (in some cases compression members become tensile members, etc.).

Since the dead loads from the roof are already being supported by the existing truss framing, the reinforcing is typically designed to only support the live loads (snow, wind, seismic) and any new dead loads (HVAC equipment, catwalks, lighting, etc.). If the existing structural dead loads need to also be carried by the reinforcing (e.g. due to the amount of overstress or due to deterioration), the existing dead loads will need to be taken out of the system by a combination of jacking, temporary shoring, and other methods.
