STRUCTURAL PERFORMANCE

Engineered Wood Products Exposed to Floodwaters

By Adam Pittman, P.E.

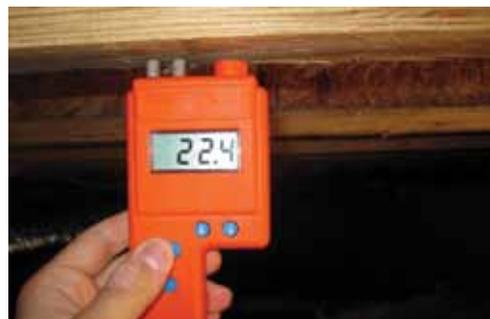
Moisture meter with pins inserted into bottom of I-joist.

A moisture meter will be necessary to determine if wood members are properly dried. A handheld electrical resistance meter with pins is the most common type of moisture meter used in the field. For engineered wood products, the pins of the meter should be put in the wide face

of the beam or panel. They should be inserted parallel to the grain. It should be noted that the resins in engineered wood products affect the electrical resistance and often cause readings to be higher than the actual moisture content. Rather than attempting to account for this potential difference, it is recommended that the moisture meter output be used directly with knowledge that it may be slightly conservative.

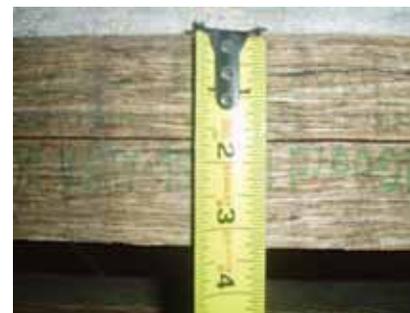
Laminated strand lumber (LSL) sill plates show post-flood swelling from 3 inches to 3¼ inches.

Conversely, engineered wood products are typically manufactured at a moisture content of 5 to 7%. If wood products are exposed to flooding, the moisture content will likely be elevated to more than 15%, which could result in substantial swelling. Thus, it is important to give consideration to potential dimensional stability issues. SCL products swell more in the thickness direction than the depth direction, because this is the orientation of pressing during the manufacturing process. After significant exposure to moisture, a SCL beam can be expected to shrink back to approximately half of its swollen dimension upon redrying, also known as springback. For example, a 3½-inch x 16-inch PSL beam that has swollen to 16½ inches can be expected to shrink back to 16¼ inches when it is properly redried to its original manufactured moisture content. An example of dimensional changes SCL products experience when exposed to varying moisture contents is shown in the *Table*.
